By Appointment To HM The Queen
Building Façade Restoration
and Conservation
PAYE Stonework & Restoration Ltd
London

Camden Town Hall

SAMPLE ISSUE SHEET # 002

Sample Ref #: 19038-SAMPLE-002

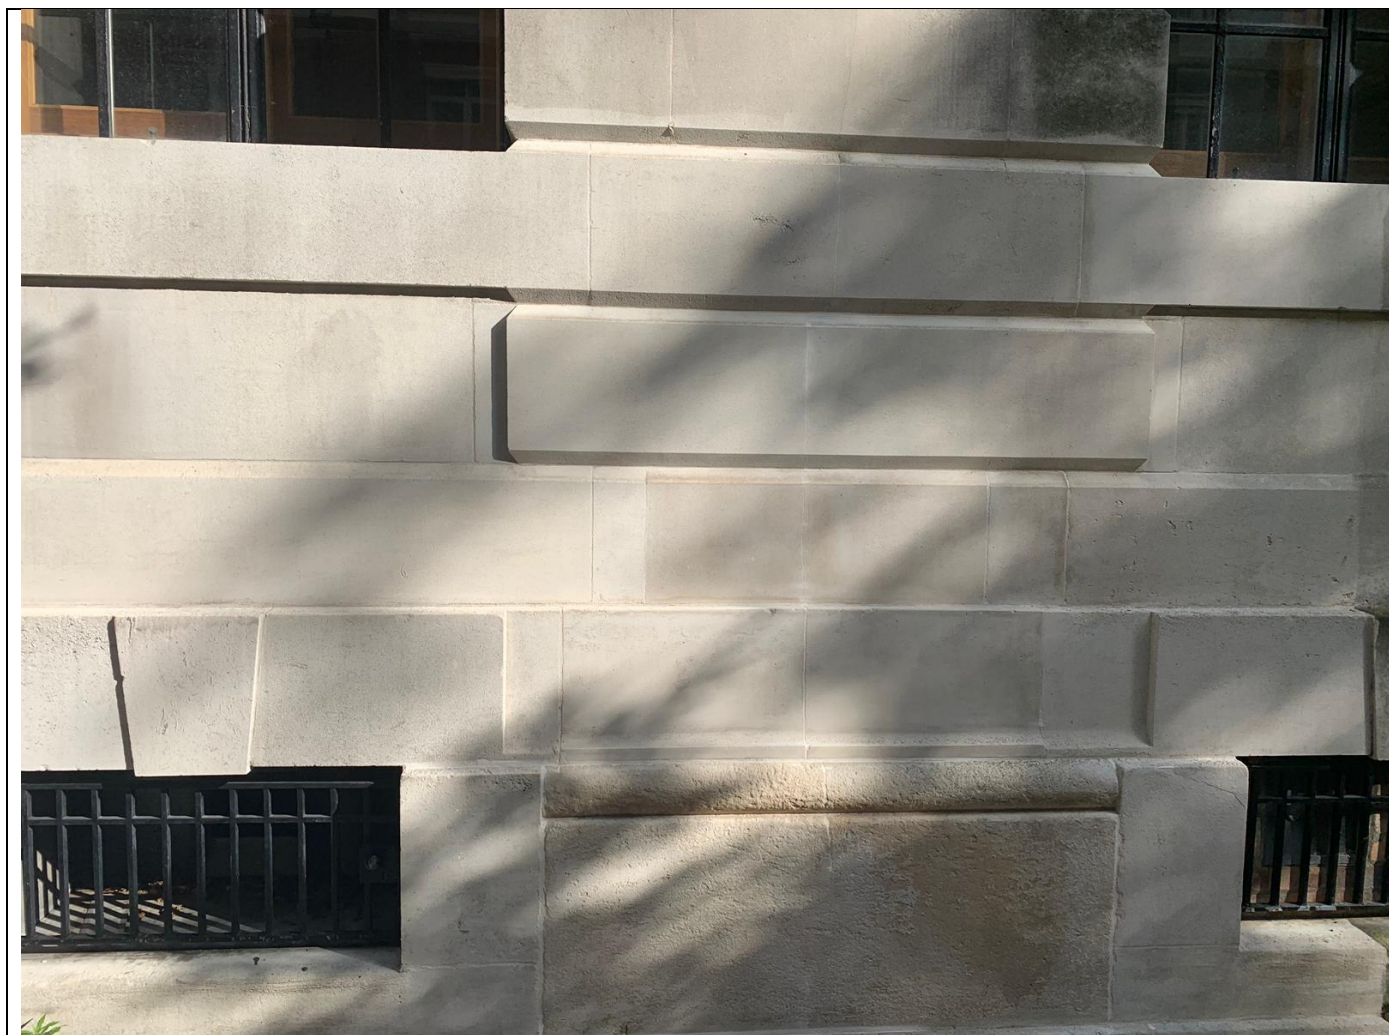
Pointing Sample Panel Area

Pointing sample panel; repointing loose and open joints and hairline cracks within stone units using a portland stone dust, fine sand and NHL3.5 lime premixed mortar.
