**28 REDINGTON ROAD, LONDON NW3 7RB**

## REVISIONS AND ADDITIONAL MATERIAL

| <b>Path</b> | <a href="#">19117-SYM-RP-S-0001 - Rev A - BIA, 28 Redington Road, London NW3 7RB.docx</a> |

**1.0 Non-technical summary**

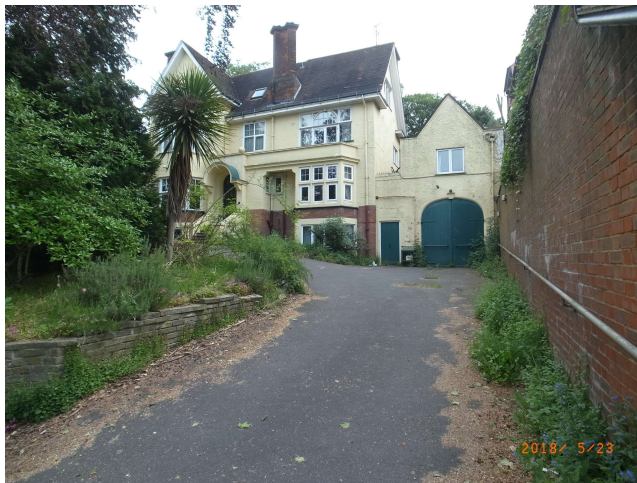
**Figure 1** – Front Elevation

1.1.2 The current site arrangement is a four-storey residential building, with an existing basement. The main building is partially connected to a garage, towards the boundary wall with No. 26 Redington Road. The existing structure is load-bearing masonry with timber floors spanning between party walls and supported on internal load bearing walls.
