# LEVEL MONITORING

## for Subsidence Management Services

**59 Hillway, London, N6 6AD**

Client: Subsidence Management Services  
Client Contact: Kevin Phillips  
Claim Number: [REDACTED]  
Client Reference: [REDACTED]  
Policy Holder: Mr John Alderton  
Report Date: 19 November 2019  
Our Ref: [REDACTED]

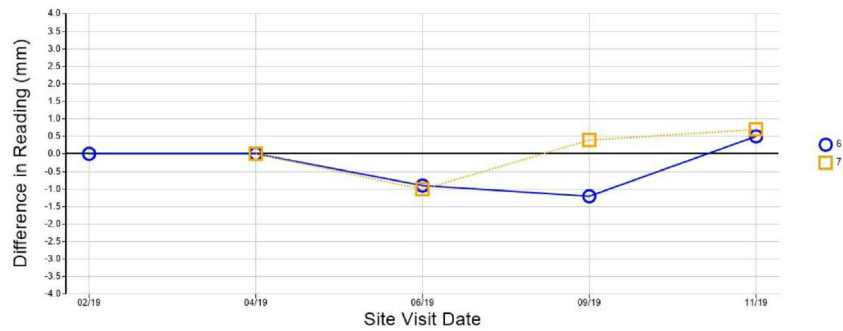
### Level Monitoring Difference Graphs

The following graphs display the progressive movement that each Level Monitoring Station recorded at each separate site visit date to give an overall look at how much the property is moving.
