LEVEL MONITORING - RELATIVE SURVEY READINGS

File MHN Level Monitoring 14.05.19 - 06.01.20.xls.XLS.XLS

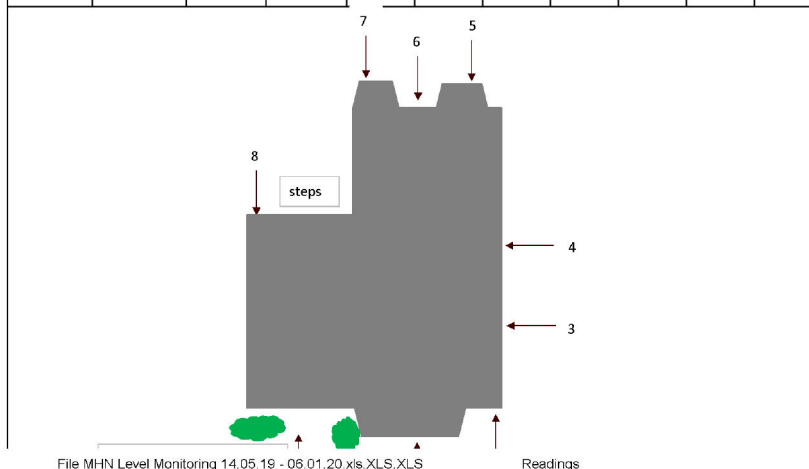
FRONT 1 2

- 09/01/2020
Points 6,7 & 8 double checked, n noted.
- It was not possible to install all sta within a common brickcourse. The initial readings cannot be interpreted as Distortion Data.
- Readings have been made relative point on the drain. It has an assurance of 10.0000m. If this is not appropriate please advise if a deep datum is required.
- No further readings to be taken.

No stations fitted here due to scaffolding.
