| ISSUE | DATE | DRAWN | CHECKED | DESCRIPTION |
|---|---|---|---|---|
| DRAWING TITLE | Elevation - Bidborough Street Camden Centre Entrance | | | |
| DRAWING NO. | CTH-PUR-MB-G0-DR-A-94001 | | | |

I 94001 PROPOSED CAMDEN CENTRE ENTRANCE ELEVATION 1:50 @ A1

PROJECT Camden Town Hall

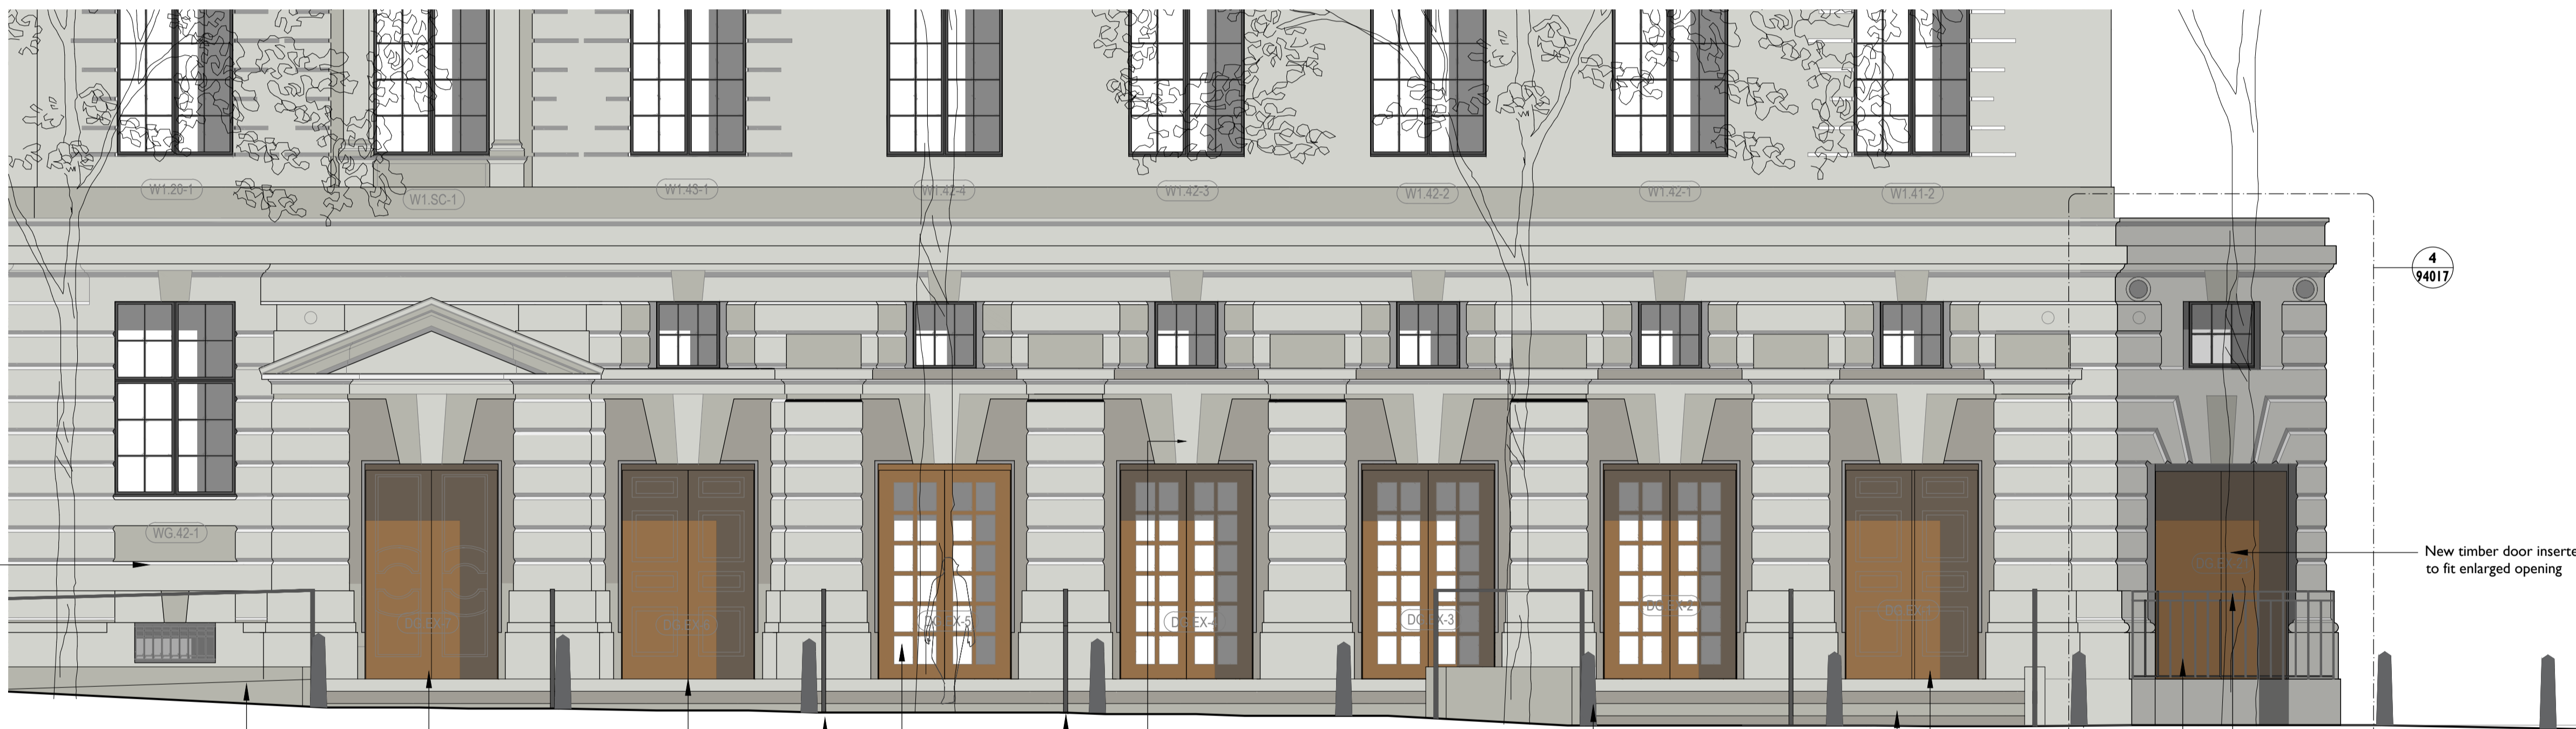
Existing Portland stone repaired and cleaned

New stone faced access ramp with stone upstand

2.No Existing Service core doors retained and refurbished

4.No Existing Camden Centre doors retained and refurbished

Existing bollards retained

Existing sign to be removed. Localised stone repairs required

Proposed black PPC steel handrail introduced

Proposed bollards to match the existing

Existing Service core doors retained and refurbished
Proposed stone clad stairs to Camden Centre

Existing door arrangement retained. Access utilised for Camden centre refuse collection

Existing railings stripped back, sanded and redecorated

New timber door inserted to fit enlarged opening
