PROPOSED REINSTATEMENT OF ORIGINAL FIREPLACES

AS CONSENTED ref: 2017/6975/L

FIREPLACES REINSTATEMENT AS PROPOSED

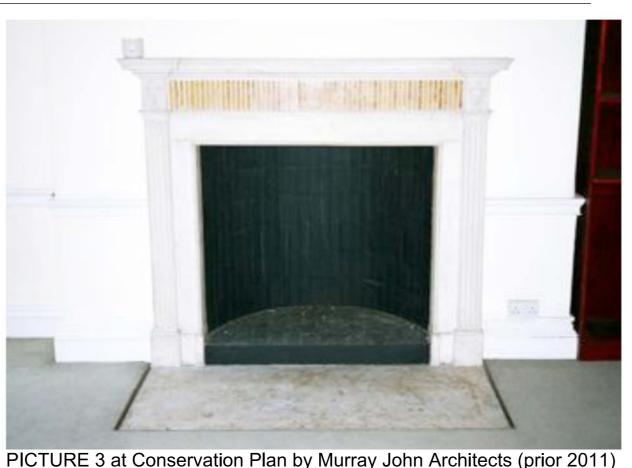
PICTURE 3 at Conservation Plan by Murray John Architects (prior 2011) Reproduction to be specified by specialist.

Reintegrate original hearth (if existing). Reproduction of original chimneypiece to be reinstated as recorded PICTURE 3, specified

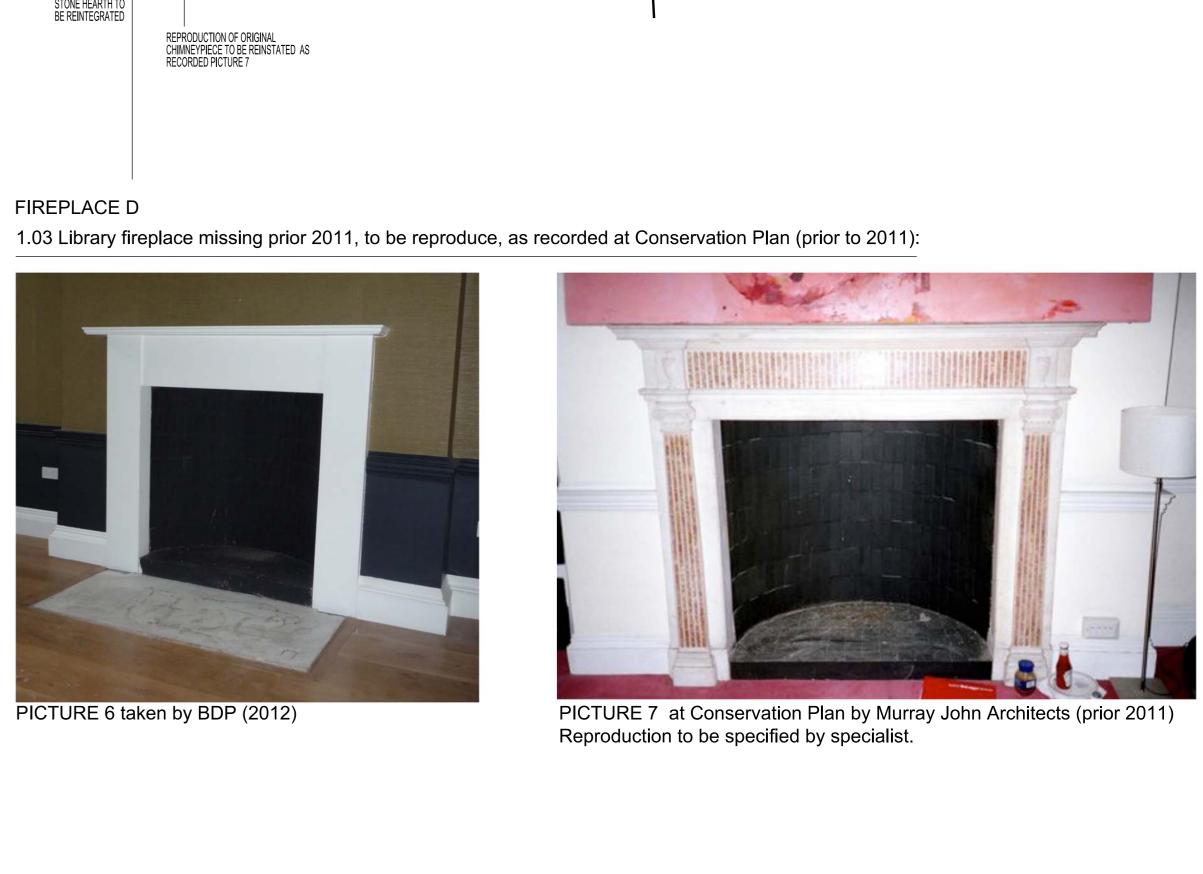
PICTURE 5 taken by BDP (2012)

FIREBOX TO BE RESTORED

EXISTING CHIMNEYPIECE IN SAFE STORAGE TO BE CAREFULLY REINSTATED

STONE HEARTH TO BE REINTEGRATED

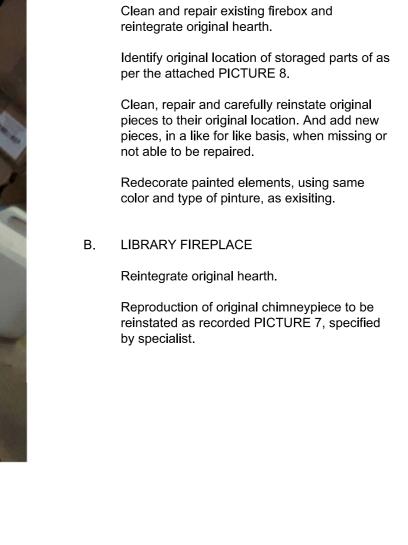
PICTURE 1 taken by BDP (2012)

(A) Existing fireplace in safe storage to be reinstated

FIREBOX TO BE RESTORED

STONE HEARTH TO BE REINTEGRATED

Clean, repair and carefully reinstate original pieces to their original location. And add new pieces, in a like for like basis, when missing or not able to be repaired.
