DESIGN & ACCESS STATEMENT

RECONSTRUCTION OF FRONT ACCESS STEPS FOLLOWING SUBSIDENCE RELATED DAMAGE

32 South Villas, LONDON, NW1 9BT

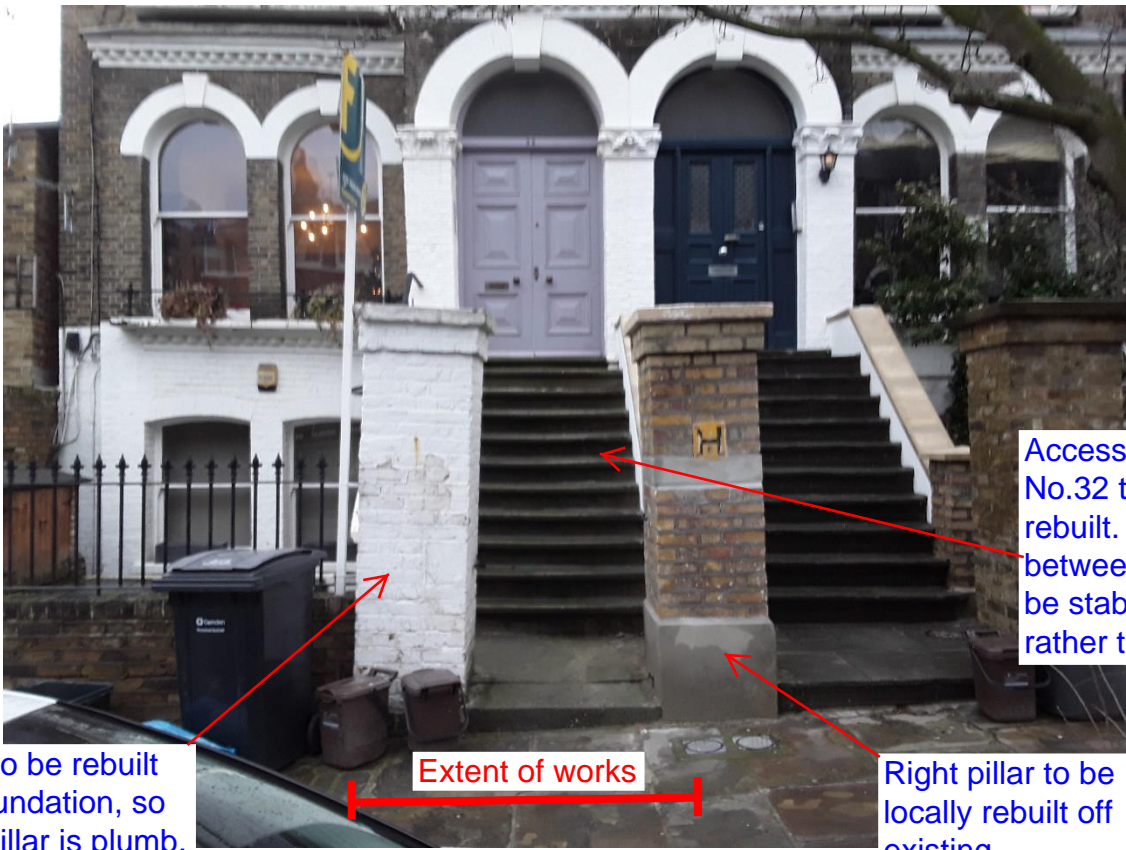
Extent of works

Left pillar to be rebuilt off new foundation, so that new pillar is plumb.

Right pillar to be locally rebuilt off existing foundation so that

Access steps to No.32 to be rebuilt. (Party wall between stairs to be stabilised rather than rebuilt)

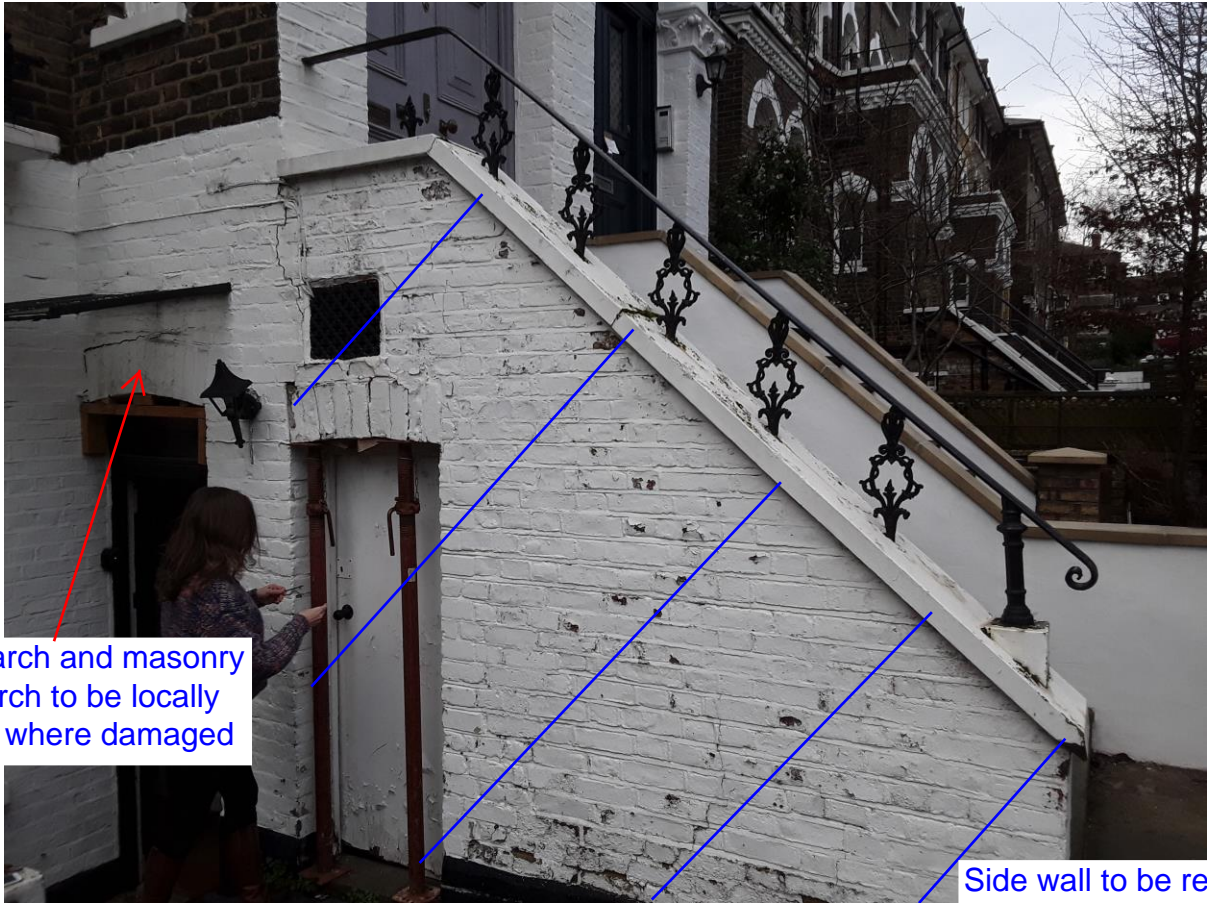
Brick arch and masonry over arch to be locally rebuilt where damaged

Side wall to be rebuilt along with the steps and front pillars.

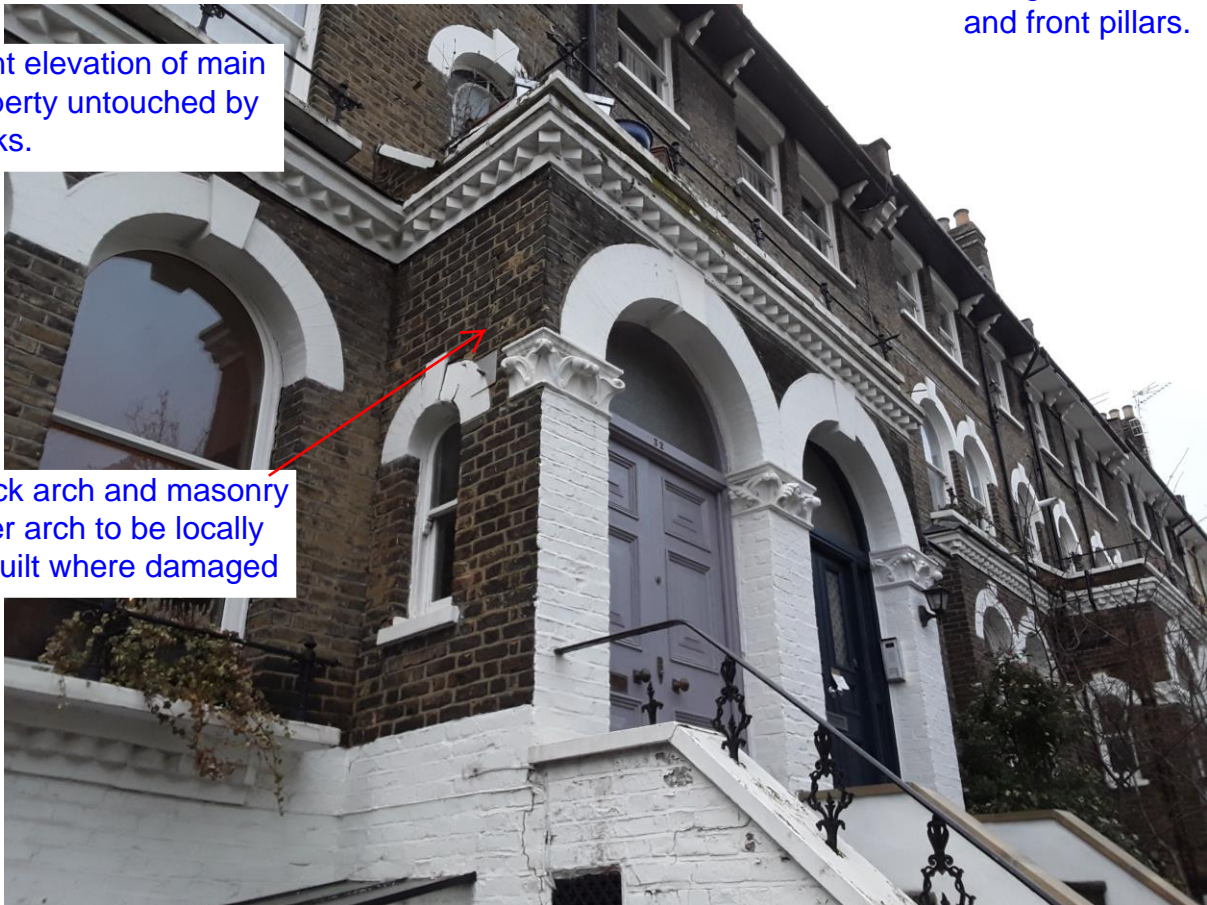
Front elevation of main property untouched by works.

Brick arch and masonry over arch to be locally rebuilt where damaged
