DESK STUDY, GROUND INVESTIGATION, BASEMENT IMPACT ASSESSMENT & GROUND MOVEMENT ASSESSMENT REPORT

**35 TEMPLEWOOD AVENUE
LONDON
NW3 7UY**

Report Title: Geotechnical Desk Study, Ground Investigation, Basement Impact Assessment & Ground Movement Assessment for 35 Templewood Avenue, London, NW3 7UY

Job No: P1019J1129

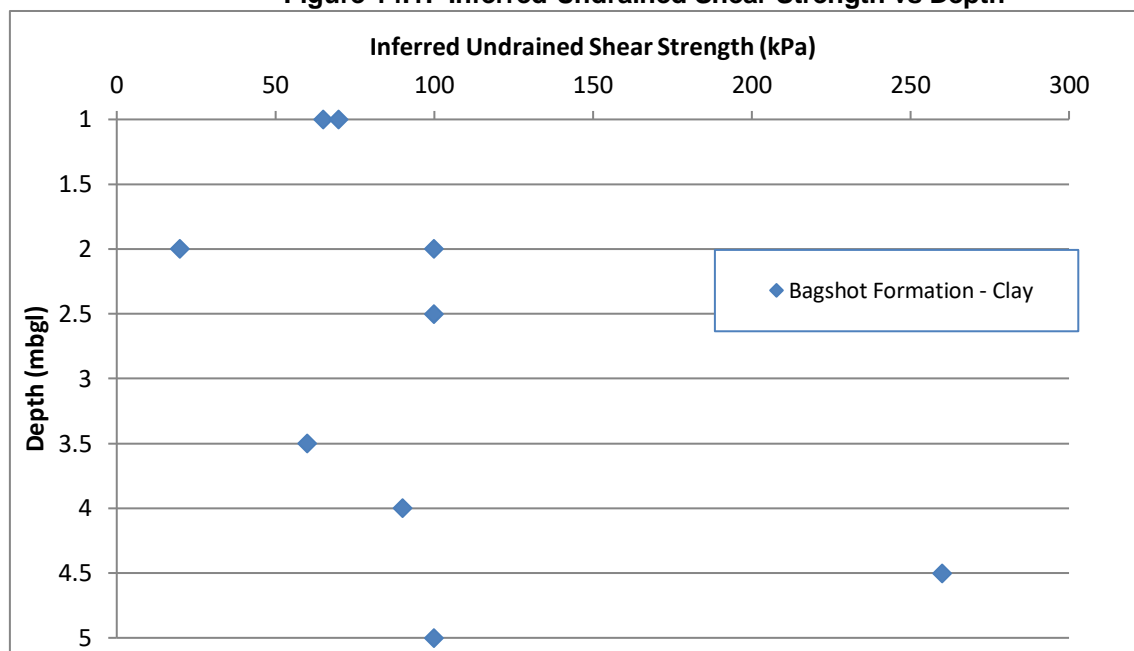
Figure 14.1: Inferred Undrained Shear Strength vs Depth

- 14.3.2 The f_1 constant is dependent on the plasticity of the material. For the Bagshot Formation - Clay the plasticity index has been shown to average 25% and therefore a value of 5 has been adopted.
- 14.3.3 The graph below shows the shear strength profile of the Bagshot Formation - Clay encountered at the site, based on the SPT to shear strength correlation described above.

- 14.3.4 An SPT 'N' value of 22 was reported for the layer of Bagshot Formation - Sand at 3.50mbgl. This is slightly higher than the values recorded in the clay at around the same depth.

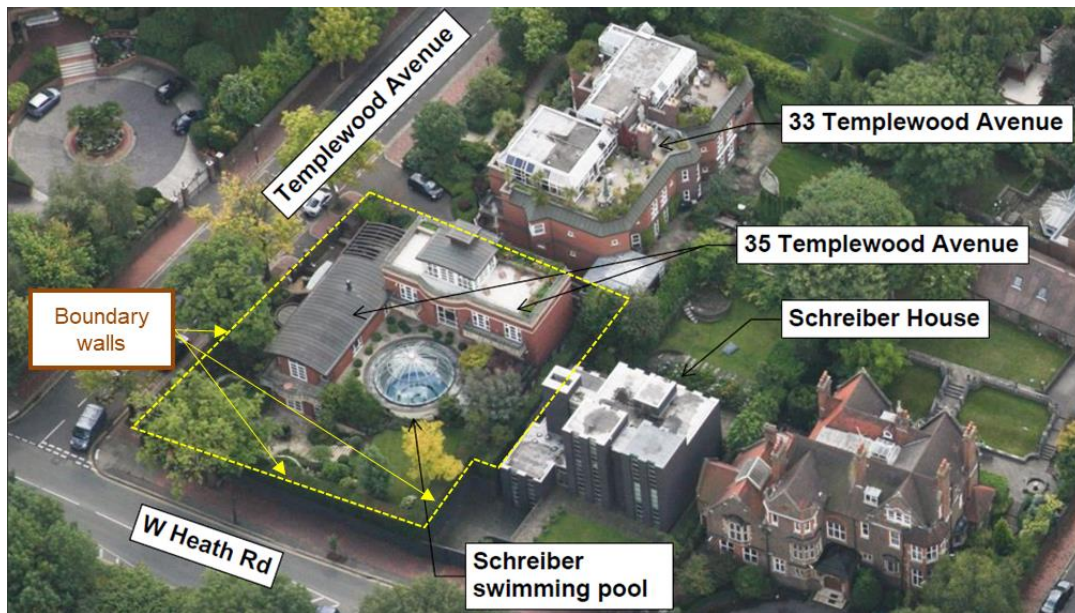
Figure 16.1: Development Site Under Consideration

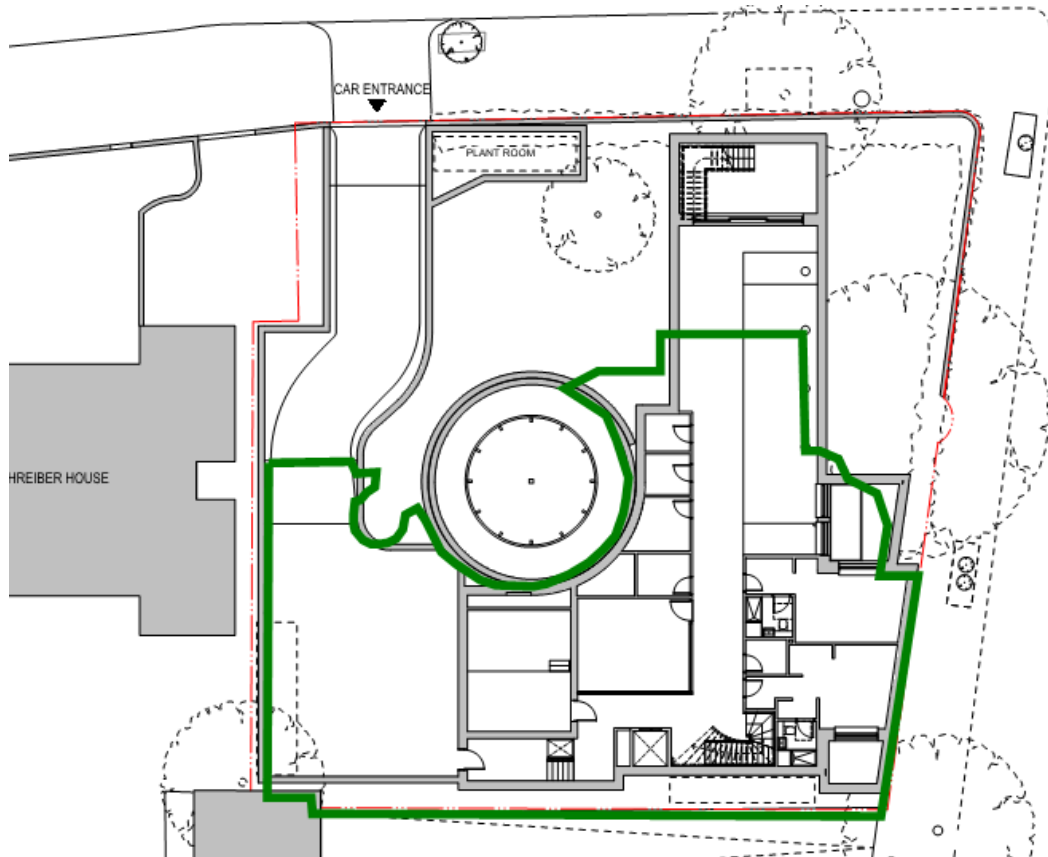
Figure 16.2: Proposed lower ground floor plan. Approximate outline of existing ground floor marked in green. Approximate Basement 2 footprint indicated with dashed lines.

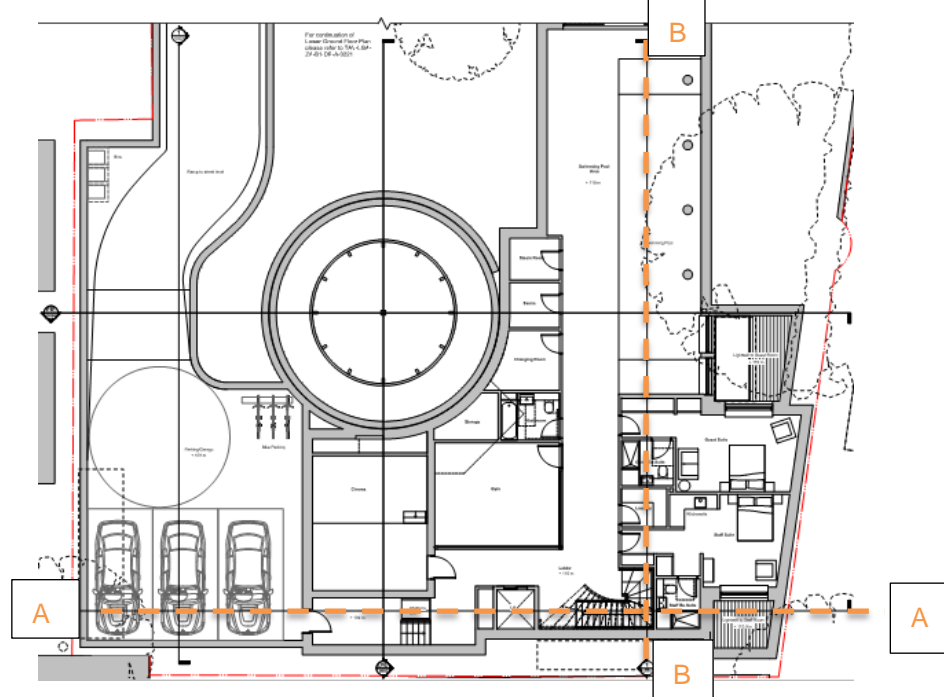
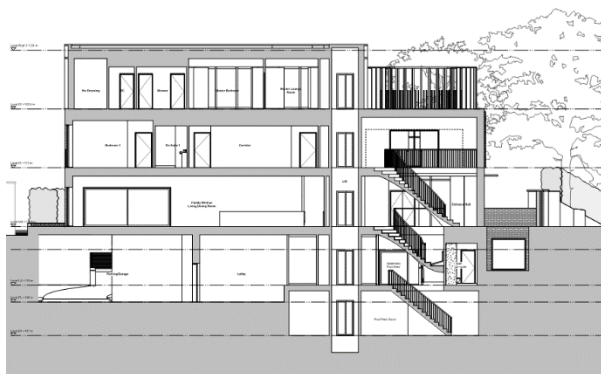
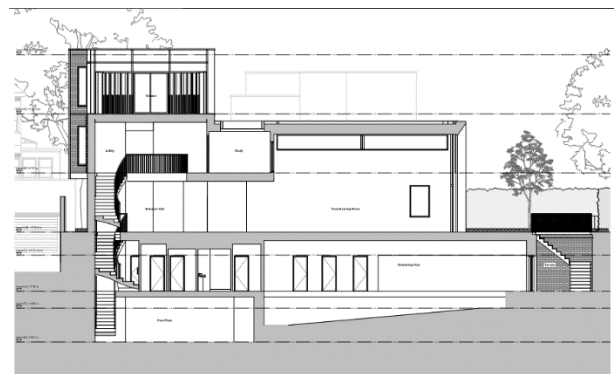
Figure 16.3: Plan view of the proposed ground floor and key cross sections.

(a) Proposed scheme ground level plan

(b) Proposed section A-A

(c) Proposed Section B-B

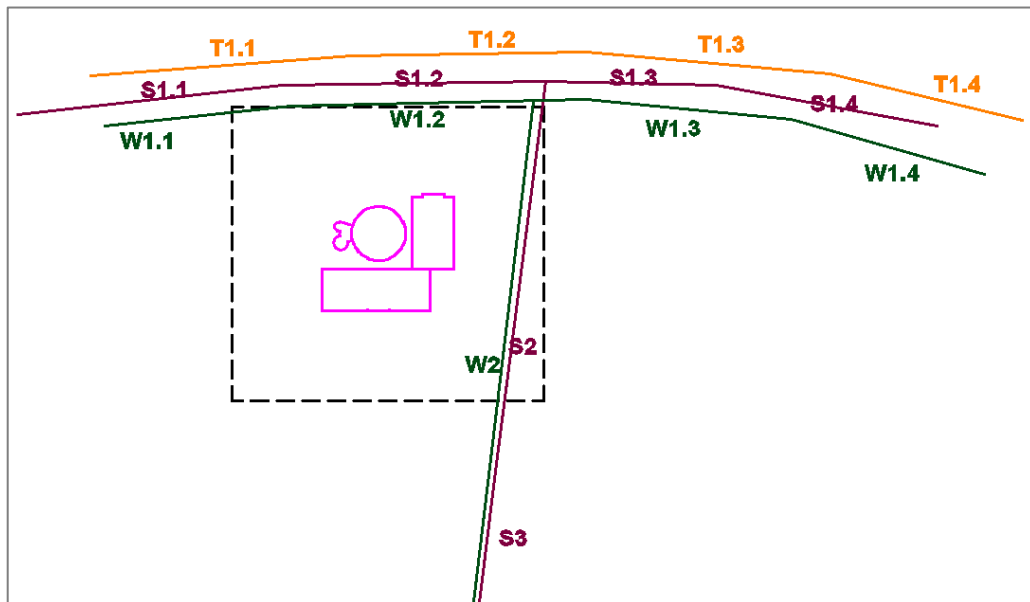
Figure 16.4: Location of the TW assets with respect to the existing 35 Templewood Avenue property (outlined in magenta)

- 16.3.1 Thames Water (TW) assets are present adjacent to the Site. The assets comprise a number of sewers and water mains. Details relating to these utilities are summarised in Figure 16.4 and Table 16.1. Their relative locations are based on the currently available survey information and the Thames Water Asset Search Location Map.

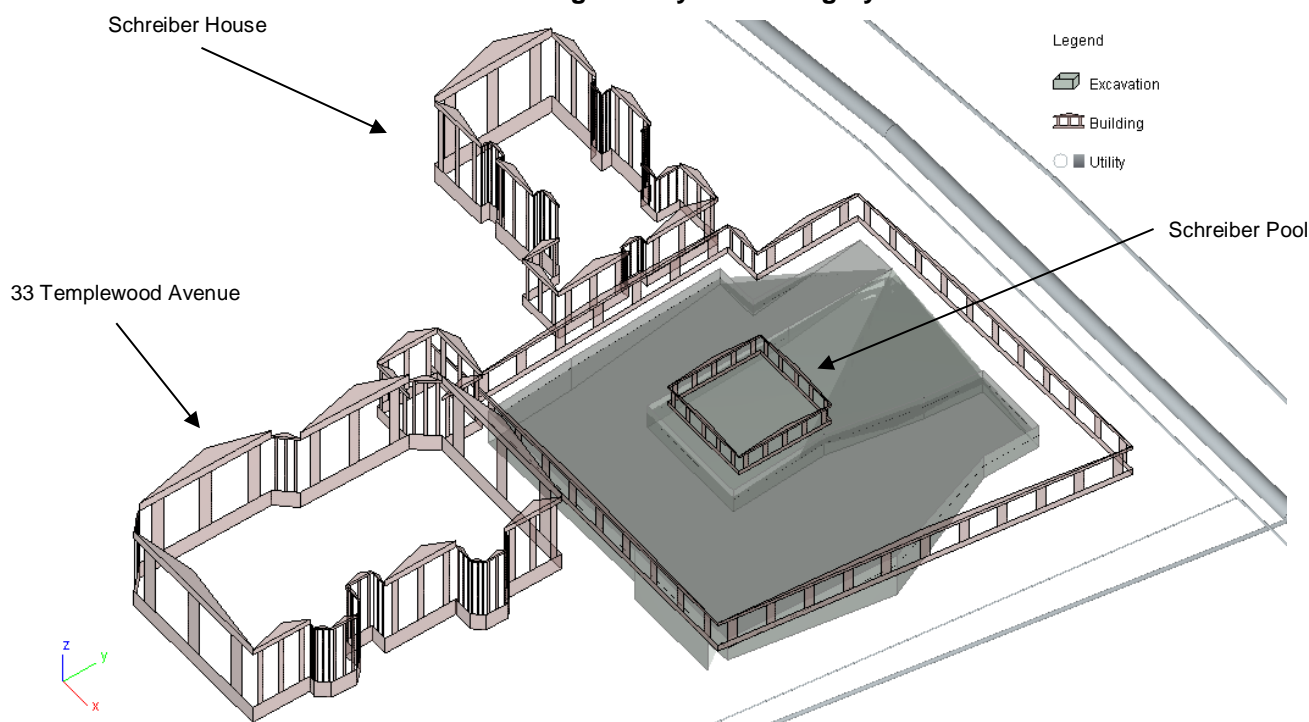
Figure 16.6: Indicative plot of the three-dimensional analytical model produced using the Oasys software suite (soil and Thames Water assets removed for clarity of presentation). Simplified excavation geometry shown in grey.

- 16.4.4 A series of three-dimensional models of the proposed scheme have been developed in both software packages outlined previously and have been combined by means of superposition to represent the various ground displacement fields summarised above.
- 16.4.5 An indicative plot of the analytical model is presented below in Figure 16.6. The model includes a number of conservative simplifications relating to the geometry of the proposed scheme and topography/geomorphology. These have been adopted in an effort to overcome the limitations of the software used for the purposes of this assessment, which represents current industry best practice means and methods.

- 16.6.7 The potential impact induced on the adjacent Thames Water assets has been evaluated on the basis of the calculated ground movement field. The same methodology has been followed for the Thames Water assets (Method 1 and Method 2), using XDISP to conduct the utility damage assessment. Figure 16.9 shows the Xdisp model geometry, which considers a simplified excavation area as previously discussed in Figure 16.6.

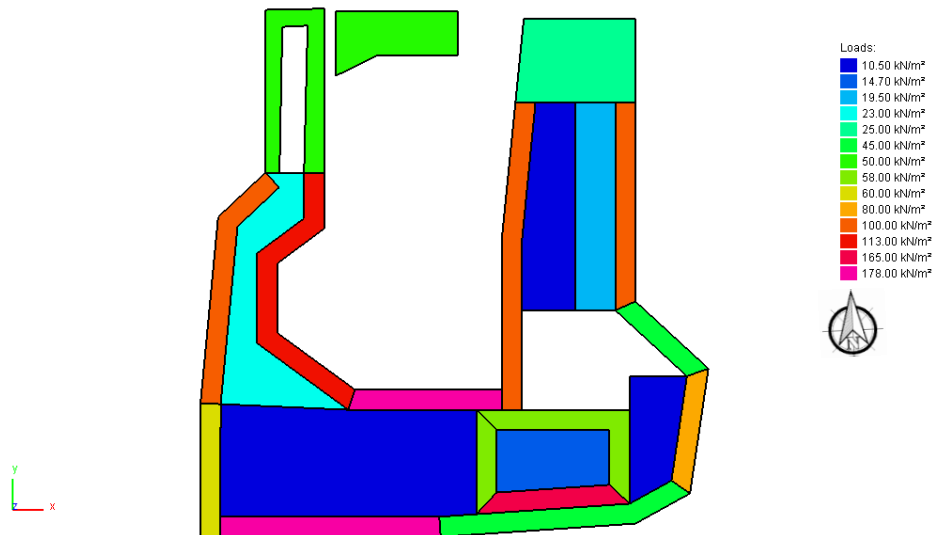
Figure 16.7: Idealised long-term loading regime modelled in Pdisp

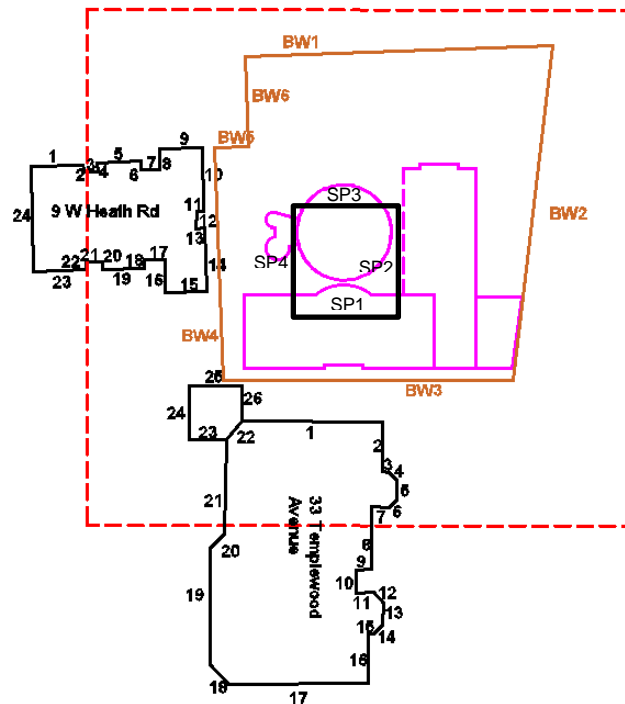
Figure 16.8: Nomenclature for building façades/masonry wall elements/Shreiber pool (black), existing 35 Templewood Avenue property (magenta), boundary walls (brown) and excavation zone of influence (dashed red).

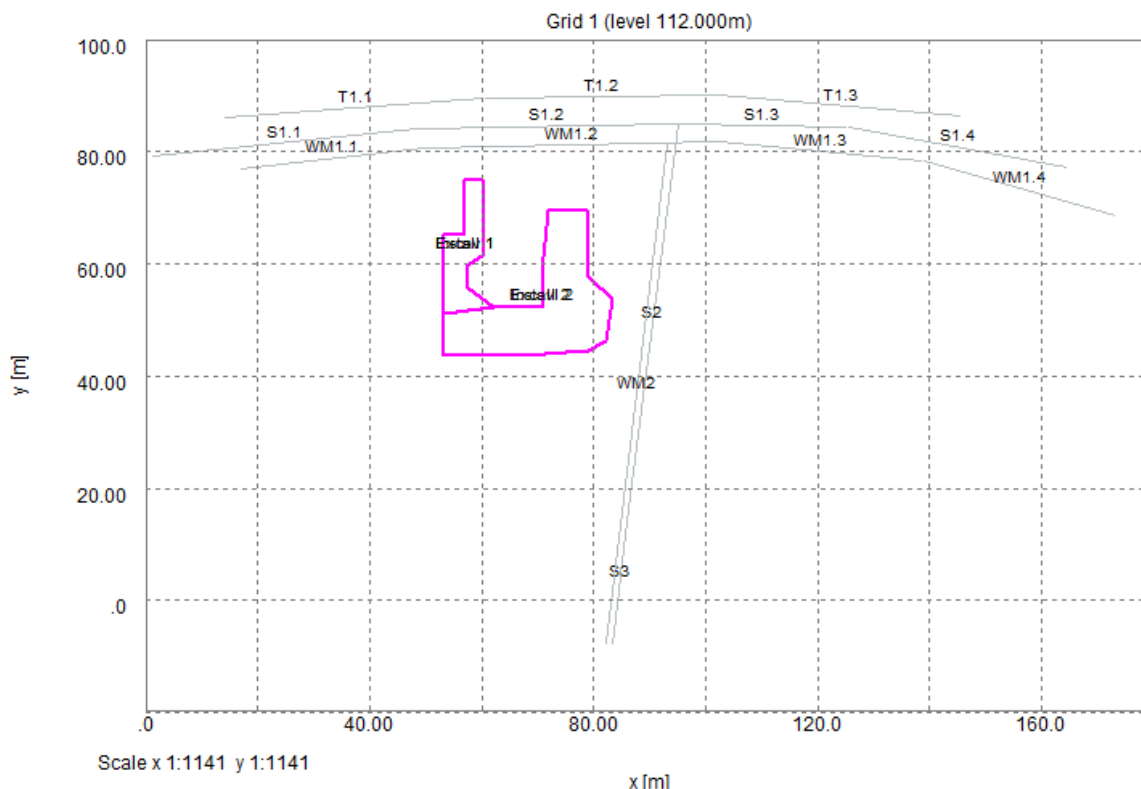
Figure 16.9: Xdisp model indicating the proposed excavation works (outlined in magenta) and the TW assets analysed (blue lines)

- 16.6.8 Details of the material and size of each asset were input in accordance with Table 16.1 for XDISP to calculate curvature, compressive and tensile strains due to the assessed movements. All utilities were assumed to be near surface assets.

- 16.6.9 A maximum allowable tensile strain of $500\mu\epsilon$ has been used for masonry sewer (S1). For the assumed concrete sewer (S2 & S3), an allowable limit of 3mm has been used for pull-out checks, 2° for rotation checks and $40\mu\epsilon$ and $400\mu\epsilon$ for tensile and compressive strain checks, respectively.

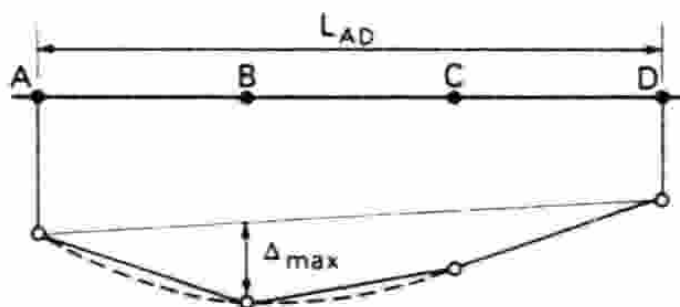
Figure 16.10: Definition of relative deflection Δ and deflection ratio Δ/L .

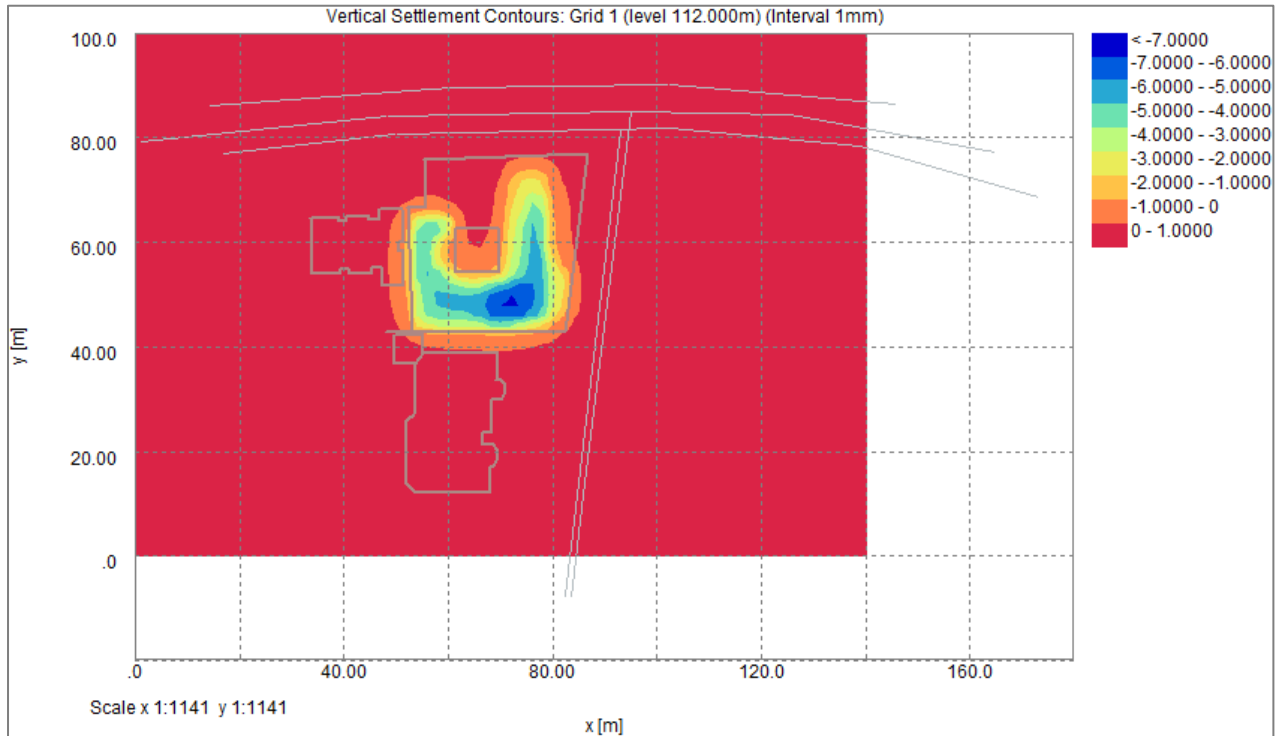
Figure 16.11: Vertical Movement – Method 1 after Excavation

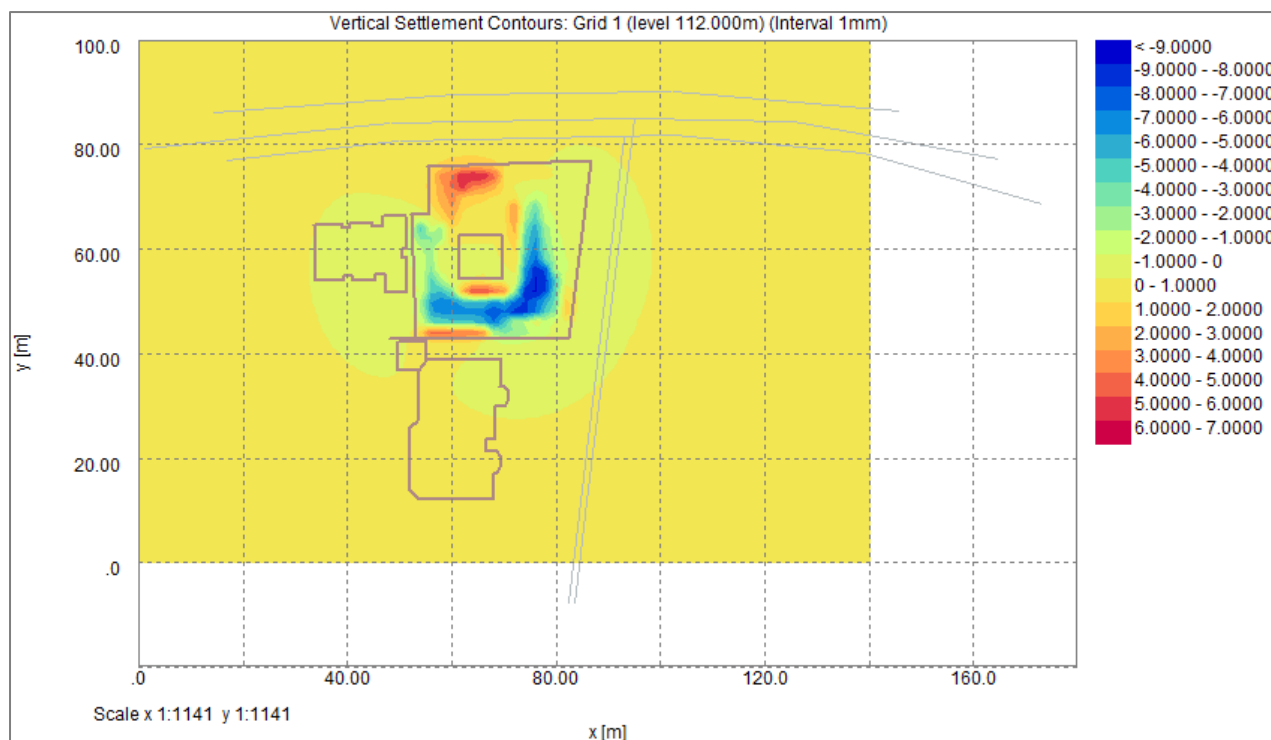
Figure 16.12: Vertical Movement – Method 1 Long-term

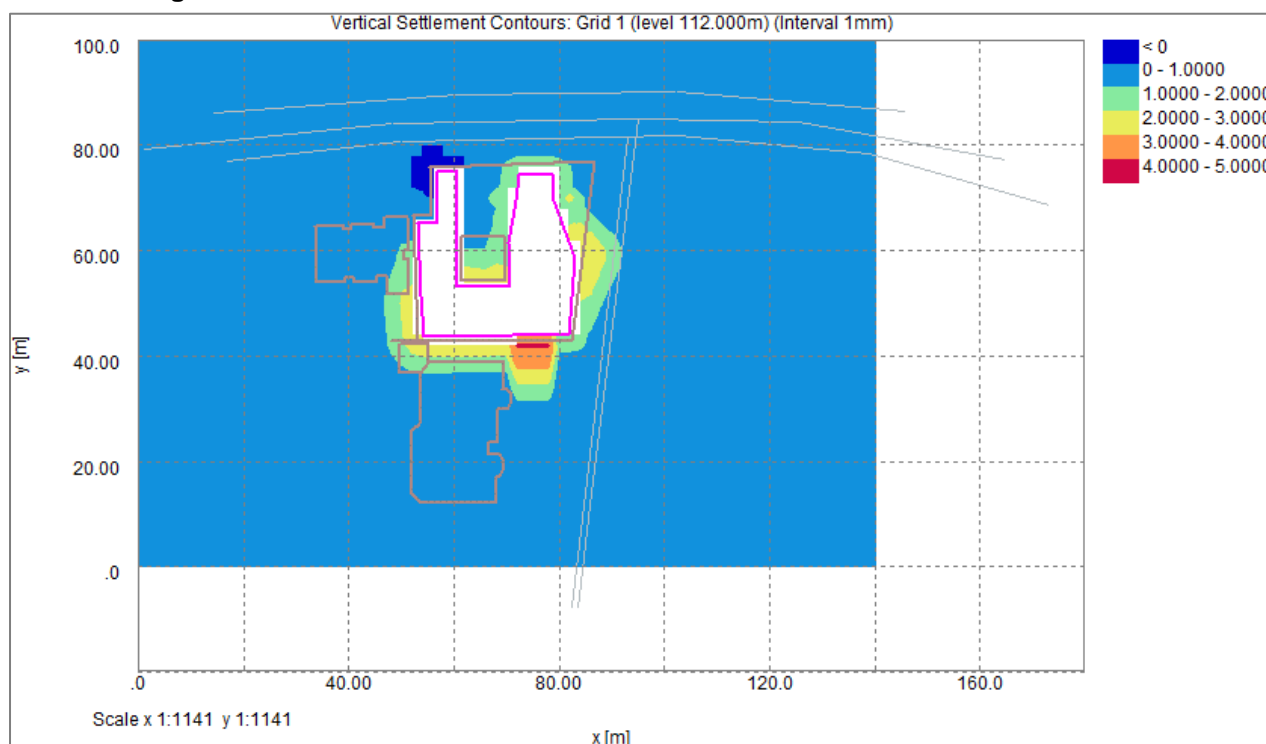
Figure 16.13: Vertical Movement – Method 2 CIRIA Excavation and Installation

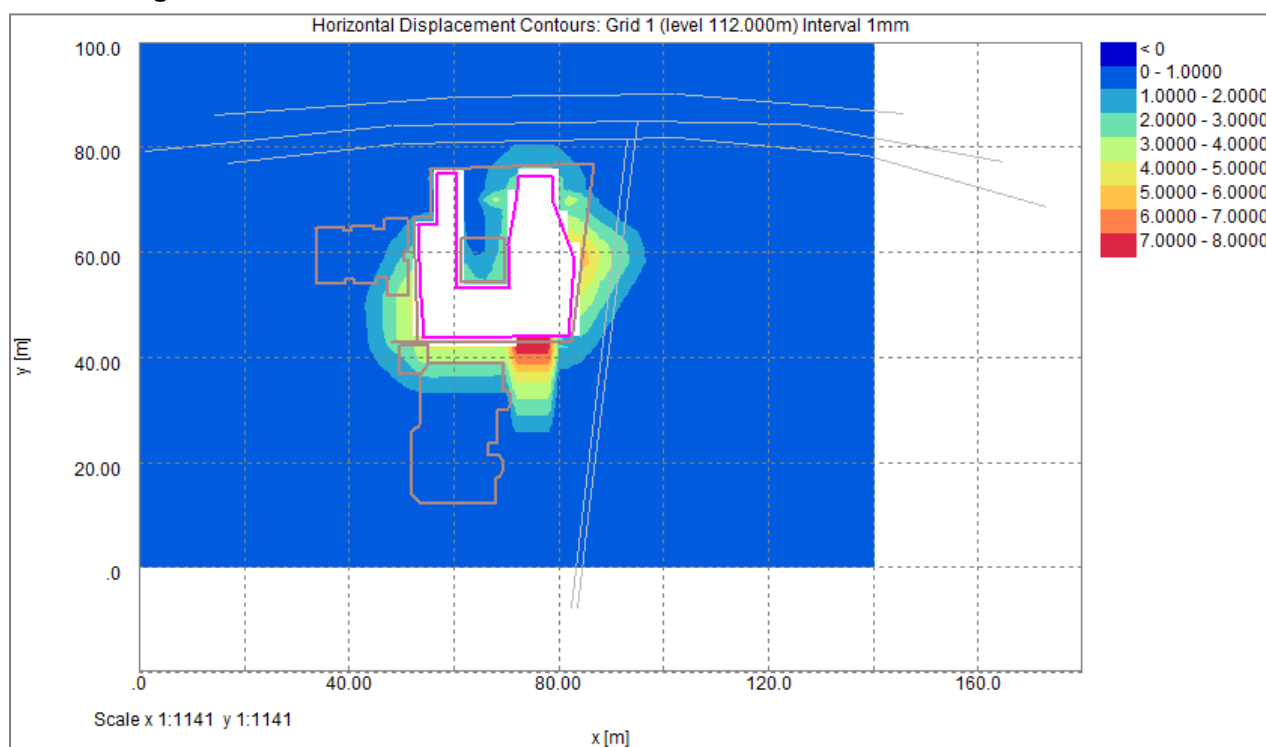
Figure 16.14: Horizontal Movement – Method 2 CIRIA Excavation and Installation

- 16.8.4 The horizontal movements at this stage are the same as the previous stage (Figure 16.14) since the movements of the PDISP long-term movements are only vertical movements (settlement). The figure below shows the cumulative vertical movements of XDISP using CIRIA curves and the PDISP Long-term loading.

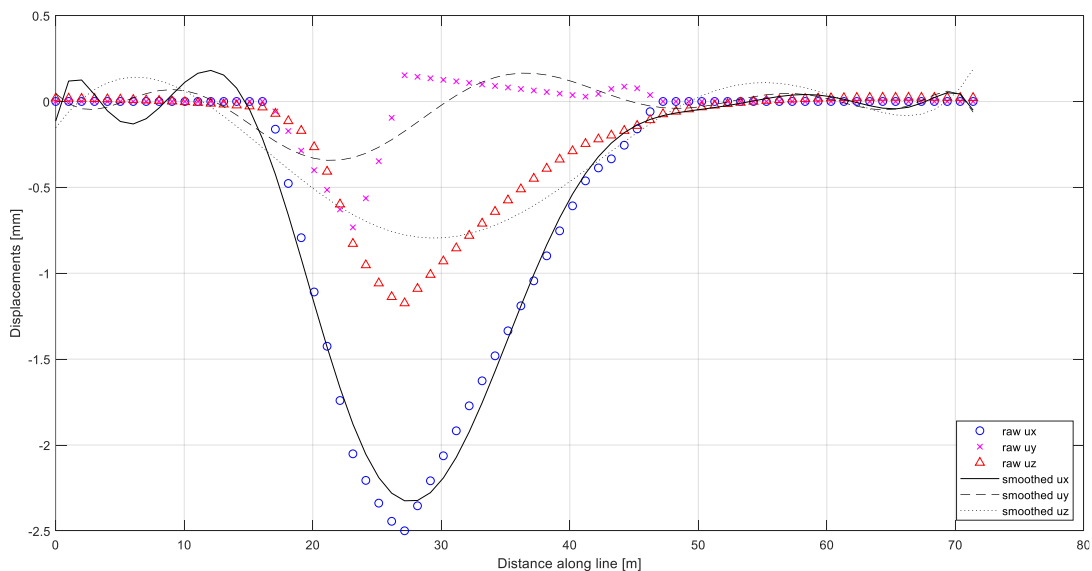
Figure 16.15: Raw and smoothed deflection profiles of Sewer S2 – Method 2 CIRIA Excavation and Installation

- 16.8.2 Sewer S2 that runs below Templewood Avenue has recorded spikes in the data which exceed the tensile strain limit value. These spikes also occur in the compression strain profile due to flexural strain, related to bending of the asset. These spikes result from the modelling simplifications described previously in this report and are attributed to the displacement discontinuities.
- 16.8.3 In light of the above, a smoothing exercise has been undertaken to evaluate more realistic deflections. This was undertaken by adjusting polynomial curves to the raw deflection data shown in Figure 16.15. The resulting smoothed deflection profiles were imported in XDISP and the strains were re-calculated. The strain plots resulting by the raw and smoothed deflection profiles are depicted in Figure 16.16 and Figure 16.17, respectively.

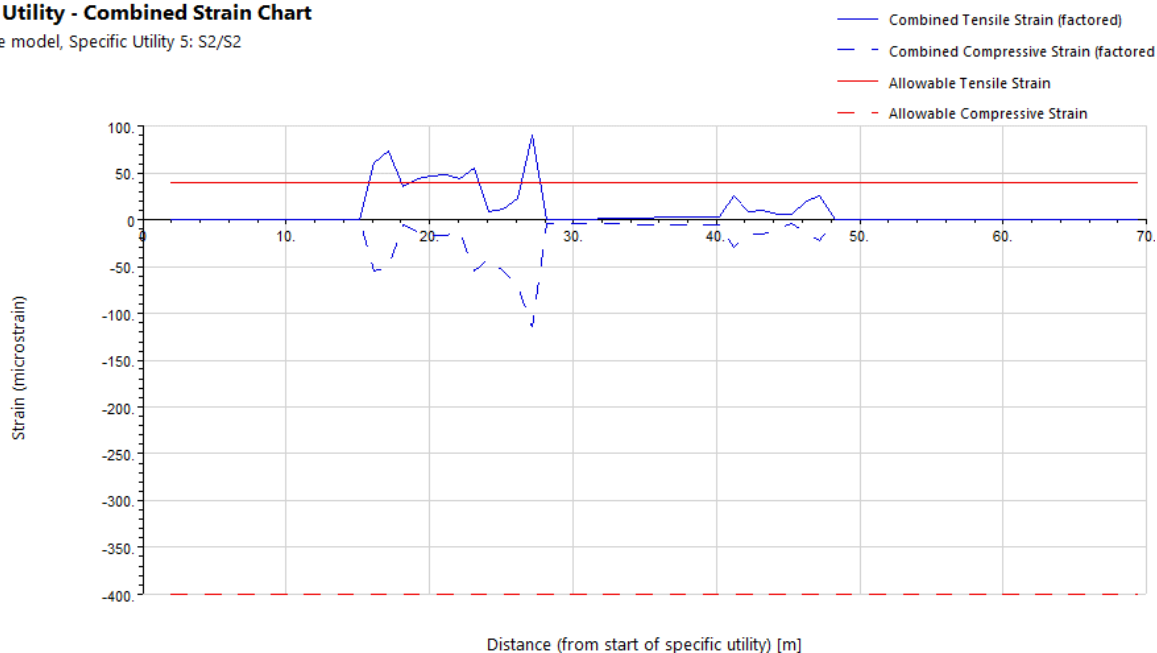
Figure 16.16: Combined strain profile of Sewer S2 – Method 2 CIRIA Excavation and Installation - based on raw deflection profile

Stage: Base model, Specific Utility 5: S2/S2

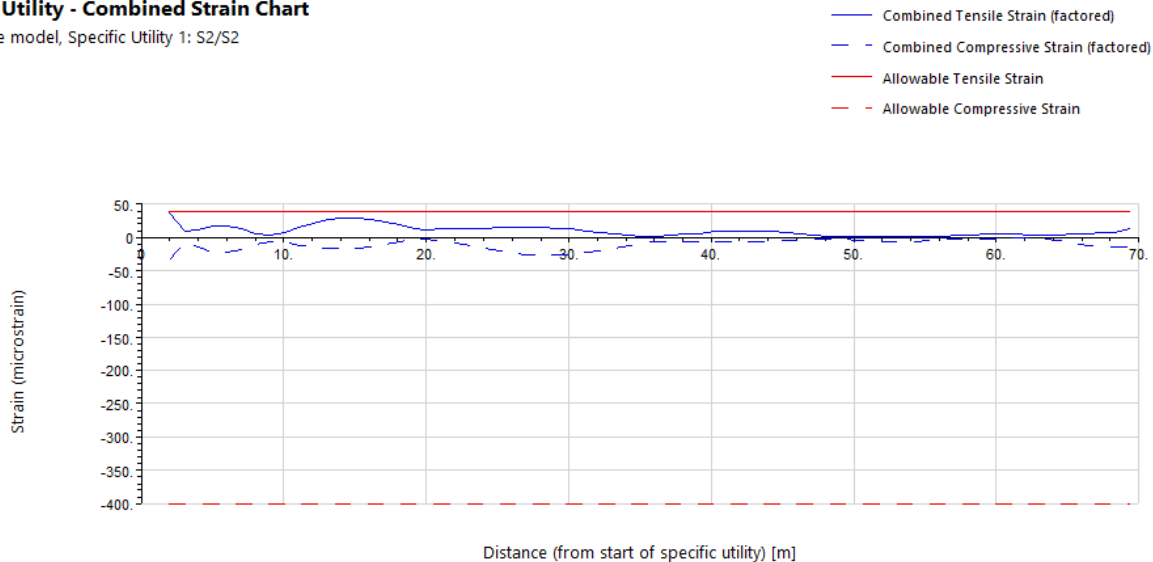
Figure 16.17: Combined strain profile of Sewer S2 – Method 2 CIRIA Excavation and Installation - based on smoothed deflection profile

Stage: Base model, Specific Utility 1: S2/S2

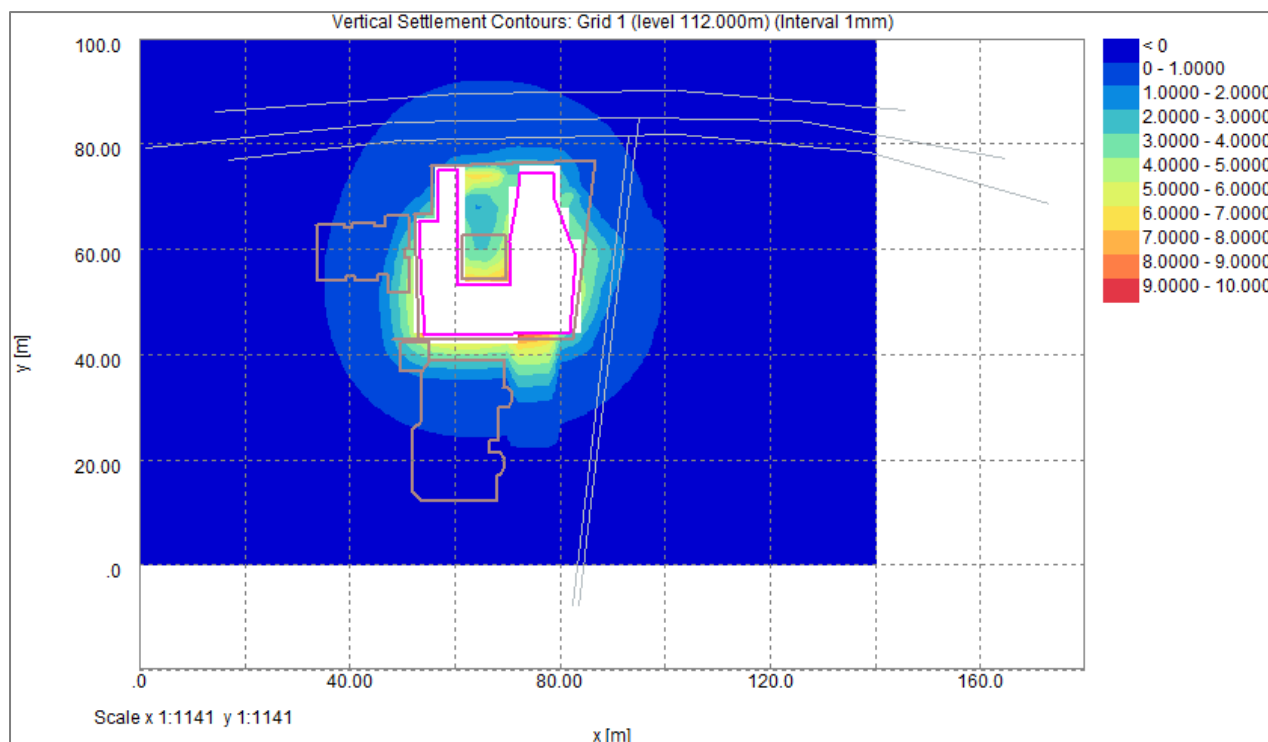
Figure 16.18: Vertical Movement – Method 2 – CIRIA curves + Long-term loading

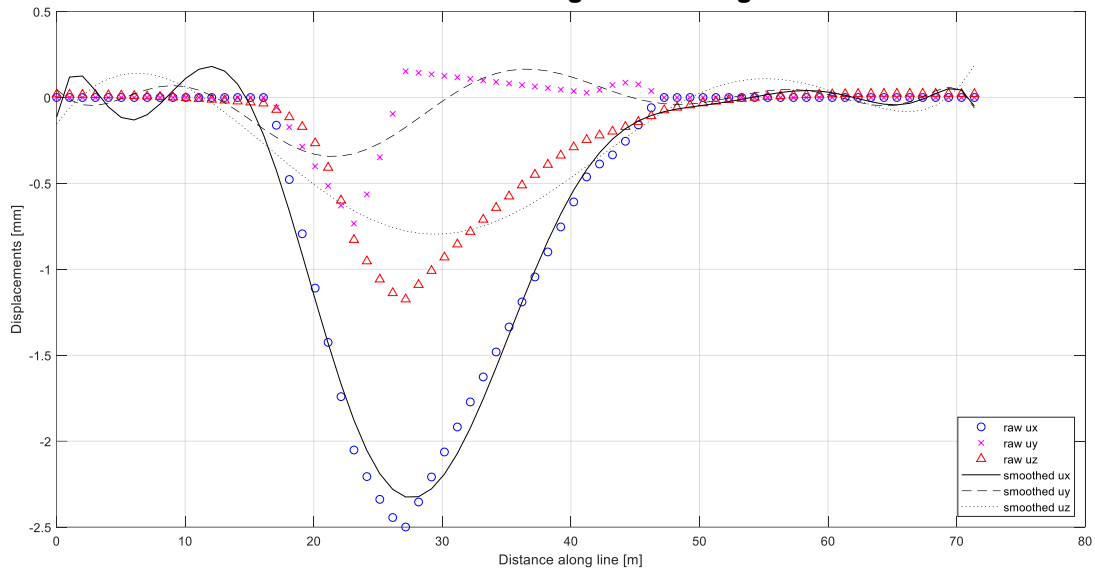
Figure 16.19: Raw and smoothed deflection profiles of Sewer S2 – Method 2 CIRIA Excavation and Installation + Long-term loading

deflection profiles are shown Figure 16.19. The combined strains of Sewer S2 resulting from both raw and smoothed deflection profiles are presented in Figure 16.20 and Figure 16.21.
