Client
Kings Keeley Limited C/o Clearbell Capital LLP
Project
65 Kingsway - Base Scheme

Title
Type 3 Replacement Window Details

Drawing No.
1914-BG-01-00-DR-A-33.613

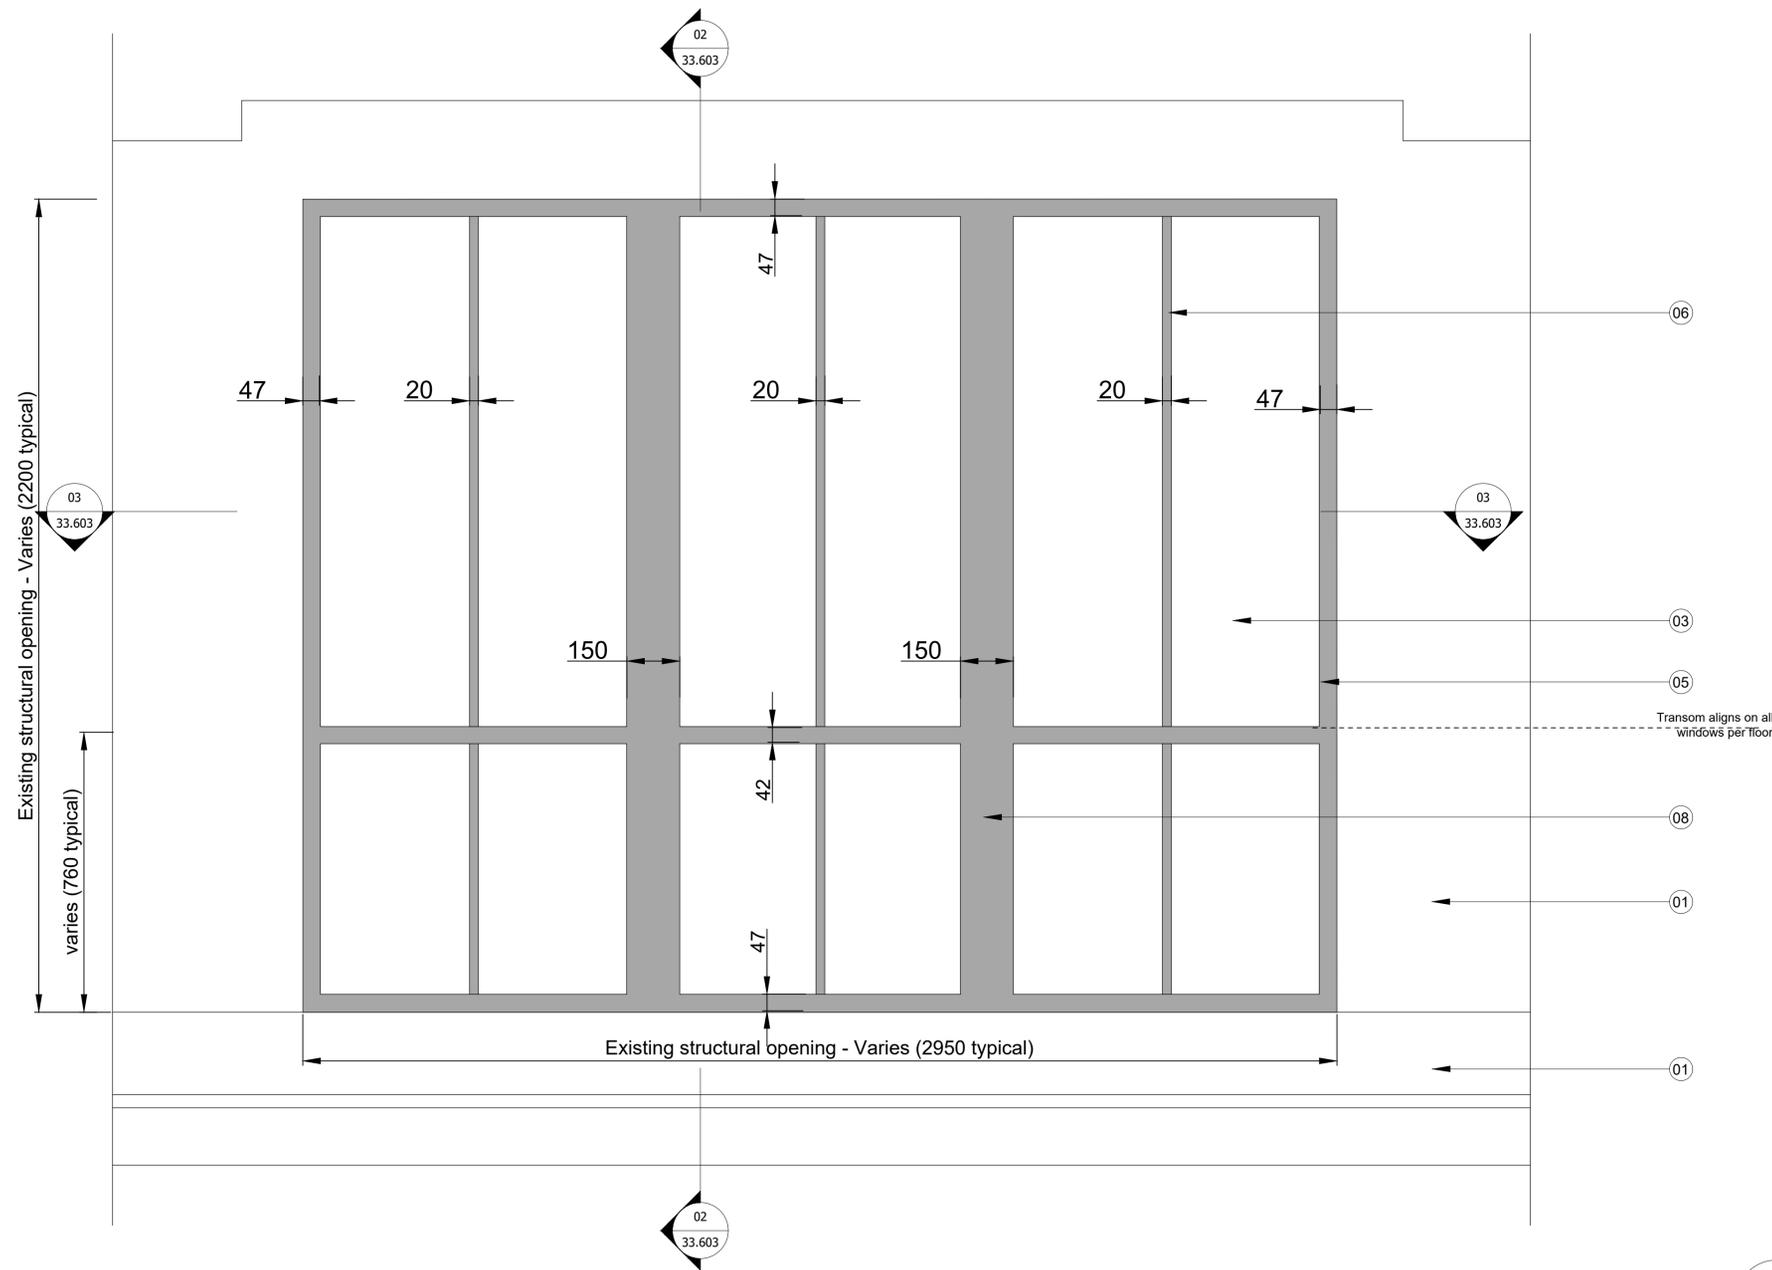
01 Type 3 Replacement Window - Elevation
20.271 1:10@A1, 1:20@A3

- Note:
1. Existing Portland stone cill cleaned and repaired.
 2. -
 3. Window Type 3 - Fixed thermal break steel window with historic mullion detail. Dual colour: bronze outside, black inside.
 4. New aluminum cill pressing, bronze colour
 5. PPC Steel outer frame, mullions and transom. Dual colour: bronze outside, black inside. Outer profile 47mm, transom 42mm to match original windows
 6. 20mm applied divider (Aluminium) with spacer between glass. Bronze colour
 7. Internal hardwood painted cill, white paint finish
 8. Bespoke 150mm mullion profile required to match original windows. Dual colour: bronze outside, black inside
 9. New insulated plasterboard lining, white paint finish

Note: Window Type 3 requires dual colour finish: bronze colour outside, black colour inside.

Unit to achieve barrier loading as detailed in BS 6180
