DEV	DATE	DECODURTION	DEV	DATE	DEGODIDITION		DECODUDITION		CLIENT:	DDO IFOT	
REV.	DATE	DESCRIPTION	REV.	DATE	DESCRIPTION	REV. DATE	DESCRIPTION	NOTE:	GLIENT:	PROJECT:	
								FOR THE PURPOSE OF PLANNING <u>ONLY</u> DRAWINGS CAN BE SCALED OFF.	ELIZABETH and ALASDAIR NISBET	ROOF REPAIRS LISTED BUILDING PLANNING APPLICATION	
								ALL DIMENSIONS ARE IN MILLIMETERS. INCONSISTENCIES ARE TO BE REPORTED TO	SITE:	DRAWING TITLE:	info@
								COPYRIGHT IS HELD BY SIMON MILLER	14 GLOUCESTER CRESCENT CAMDEN TOWN - LONDON NW1 7DS	EXISTING ROOF PLAN - PHOTOGRAPHS - 9 VIEWS

SIMON MILLER	DATE:	JUNE 2020	
ARCHITECTS	DRAWN BY:	RC	
T+44 (U)20 52U1 9373	SCALE:	NTS	
esimonmillerarchitects.com simonmillerarchitects	DRAWING NO .:		REVISION:
11 Portsdown Mews Temple Fortune London NW11 7HD	494 PL02		-

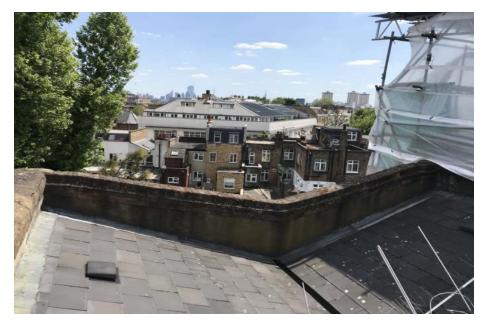
- Butterfly roof has Eternit (artifical type) slate. Rear parapet wall has brick on edge coping with sand cement finish to wall.

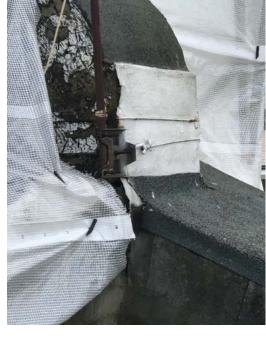
View 6: front parapet pediment crown showing aerial fixing

- Front parapet and pediment feature is covered in felt. Walls are a sand cement render
- Front pediment crown feature is covered with roofing

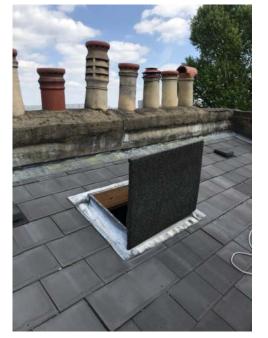
View 7: roof hatch and parapet wall with No. 15

Roof hatch cover is felt flushing on zinc
