Construction Phase – Arboricultural Method Statement

39 Fitzjohns Avenue, London, NW3 5JY

Drawing Title: Tree Protection Plan Construction Phase

Drawing No: CPTPP/39FAL/010 B2
Client: Godfrey London Ltd
Scale: 1:250 @ A1
Drawn By: drc
Date: June 2020

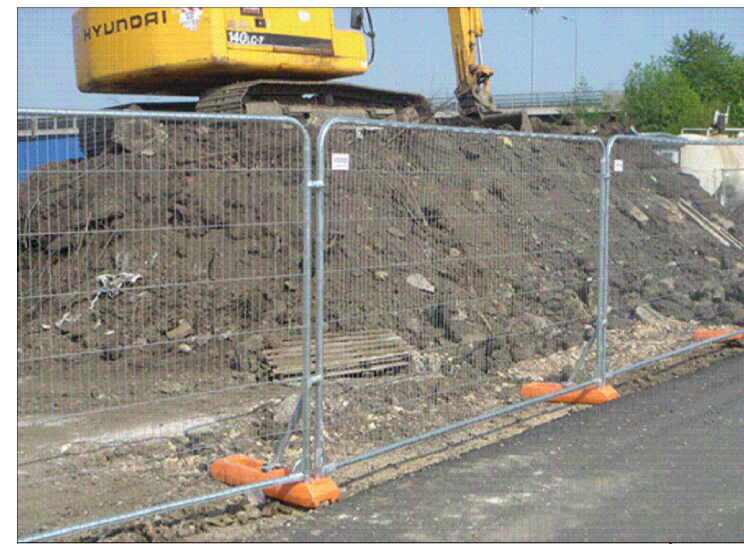
Heras Fencing

Within the main body of the site, 2.0 m high metal mesh panels. Examples would include Heras fencing (See Photograph). The panels will be joined together using a minimum of two anti-tamper couplers to prevent access except for maintenance operations. The distance between the fence couplers will be at least 1.0 m and they will be uniform throughout the fence. Where space does not allow for a full panel to be erected then panels may overlap each other to fill a gap. The panels should be supported on the inner side by stabilizer struts, which should normally be attached to the rubber blocks. Where required the site the panels will be staked and secured in place so that they do not move during the development process. Dust netting will be fixed to the fencing to prevent airborne material generated during the site development from coating the leaves of trunks of trees.

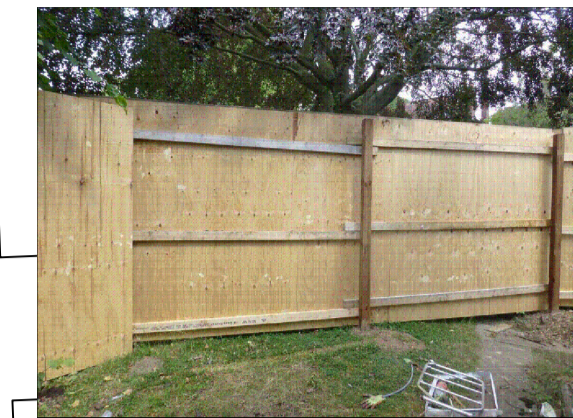
Hoarding to Site Boundary

2.4 m high Timber hoarding fixed to timber posts set at 2.0–3.0 m centres (See Photograph). Where applicable post holes for the timber hoarding will be hand dug using hand held tools and avoiding severance of significant roots of adjacent trees.
