76 Lawn Road London NW3

Structural Methodology Statement

R11438-MS1 Revision B

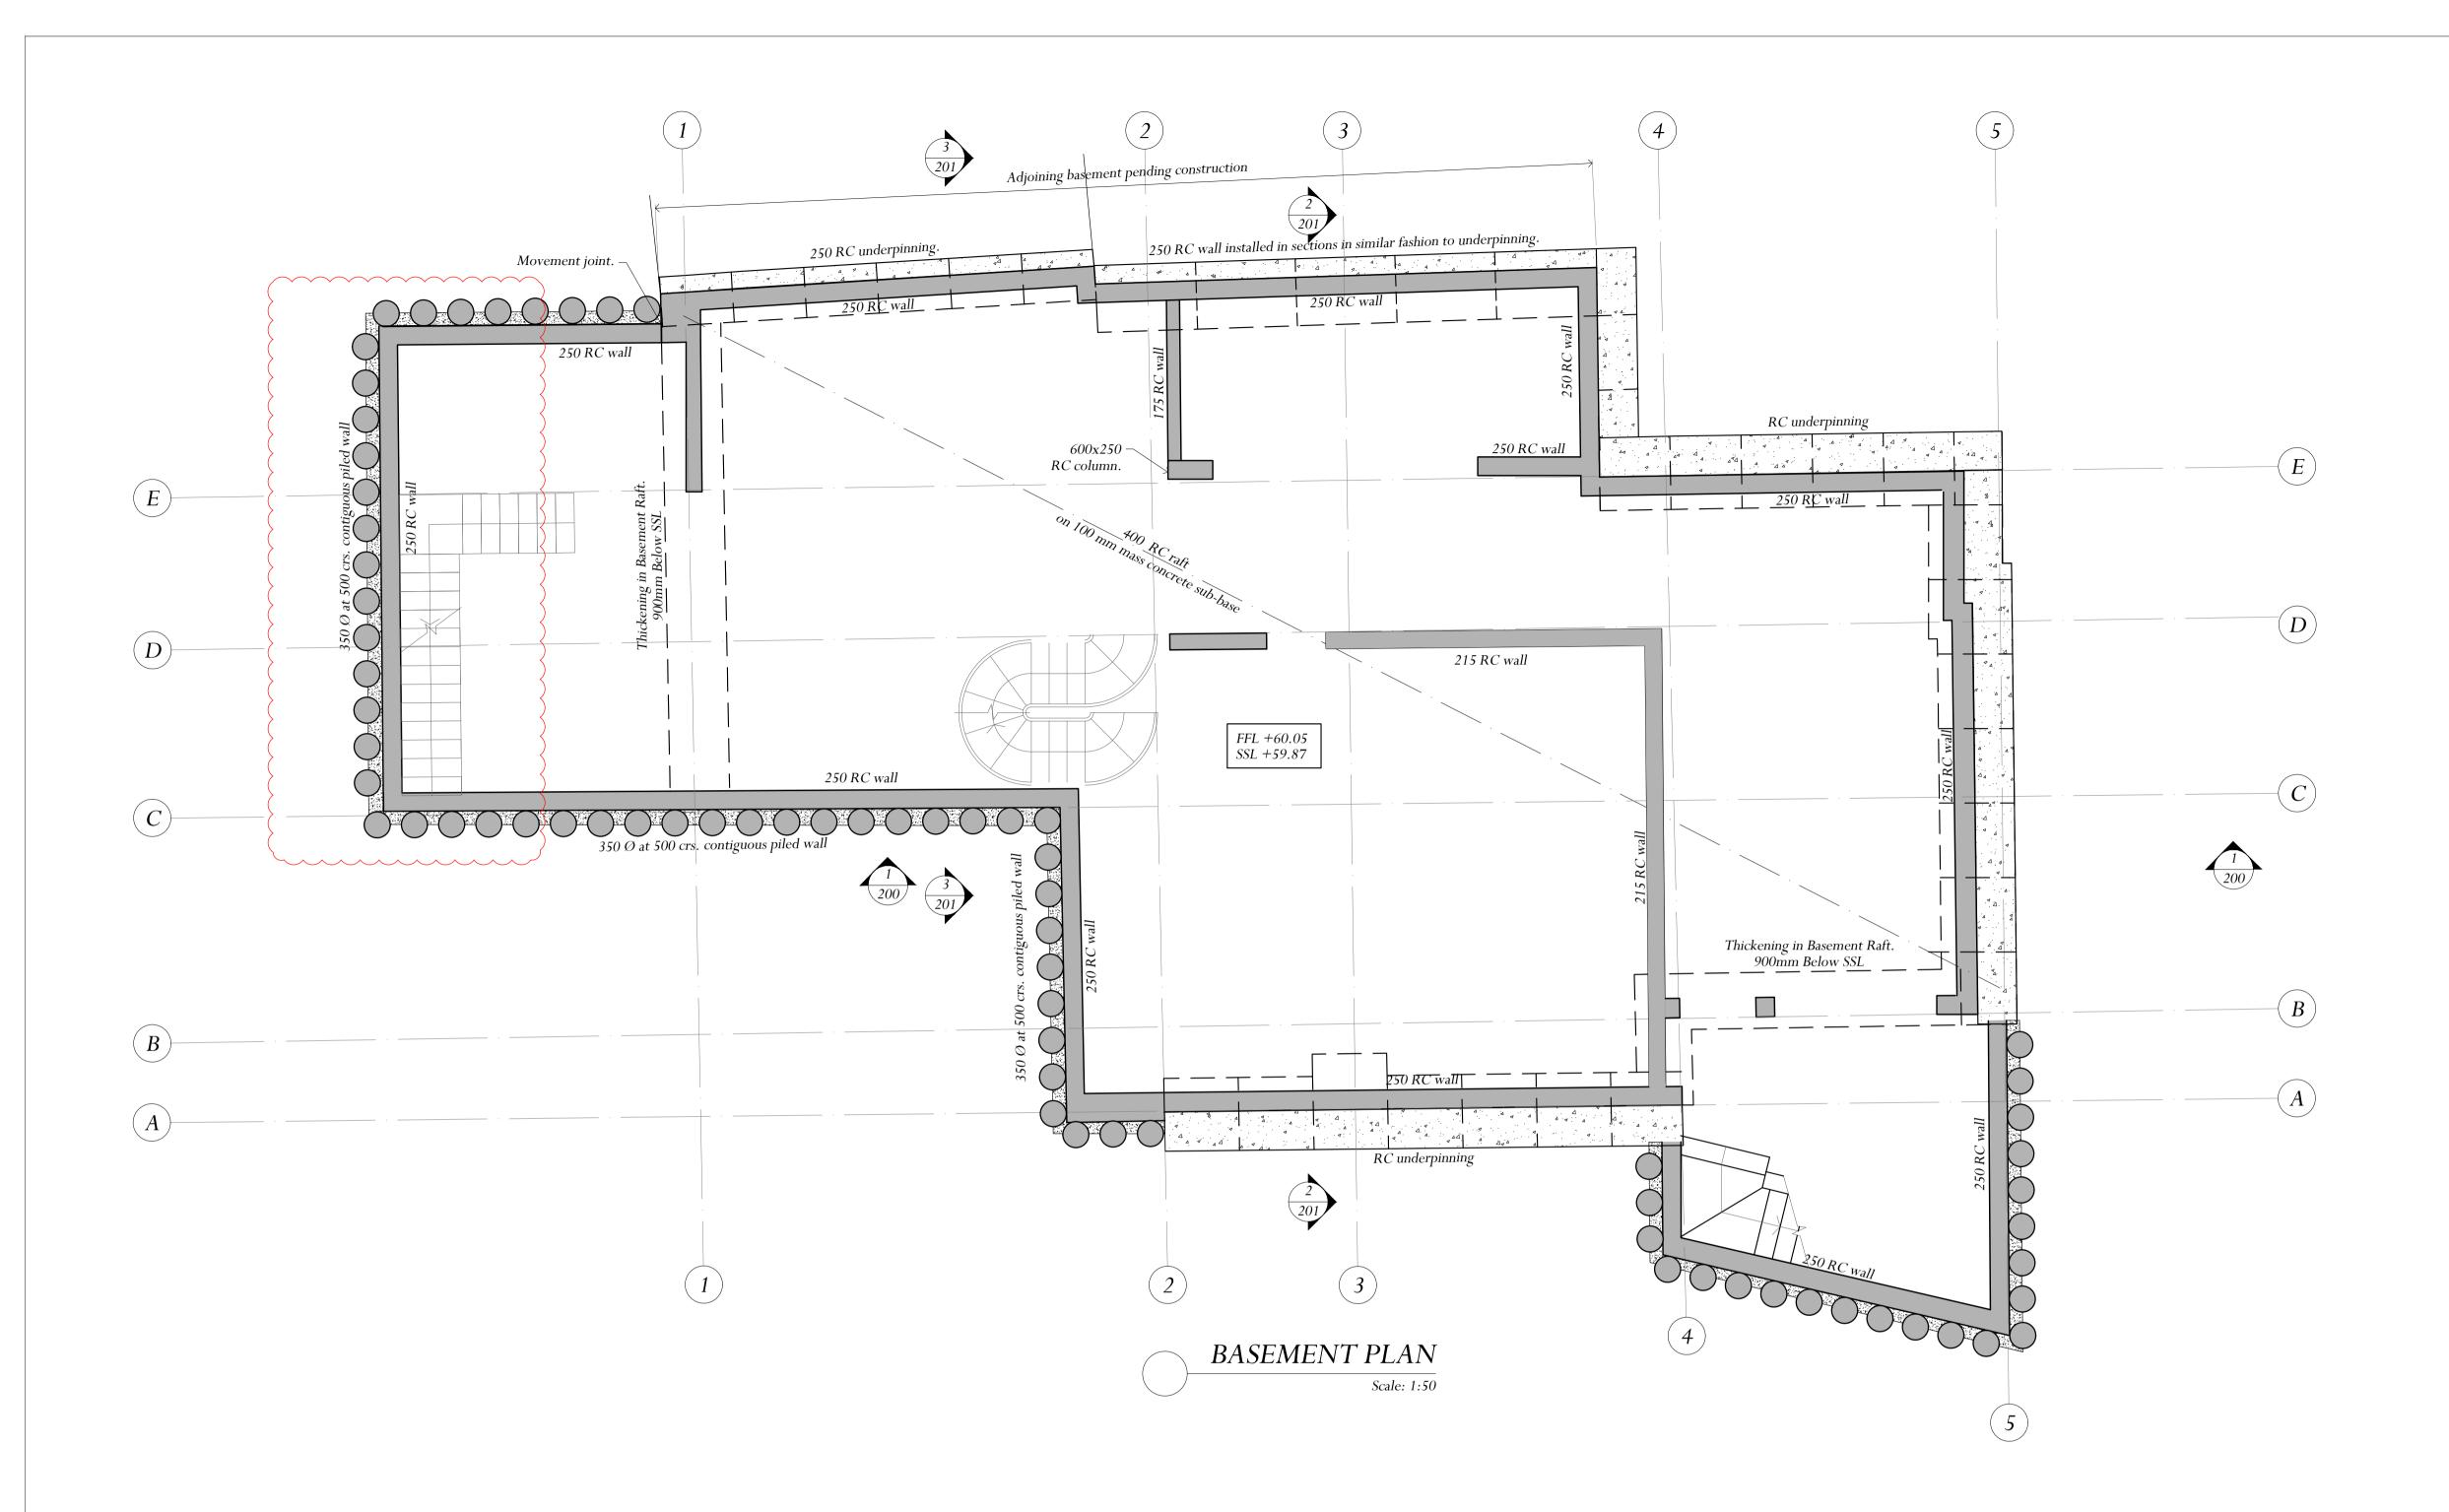
GENERAL ARRANGEMENT BASEMENT

The building is to be supported on a ground bearing reinforced concrete raft designed to support the building above, to provide secure lateral support and fixity to the perimeter earth retaining structures and to resist potential upwards pressures due to ground heave and ground water. The front retaining wall would also be installed in underpinning fashion in view of the tree in the front garden.

Temporary support of the excavation at the side and rear of the building, where there is no underpinning, is to be provided by a 350mm diameter contiguous piled wall.

R11438/101C General Arrangement Basement R11438/102C General Arrangement Ground Floor R11438/103B General Arrangement First Floor R11438/104A General Arrangement Second Floor R11438/105A General Arrangement Roof R11438/200A Section & Details Sheet 1 R11438/201A Section & Details Sheet 2

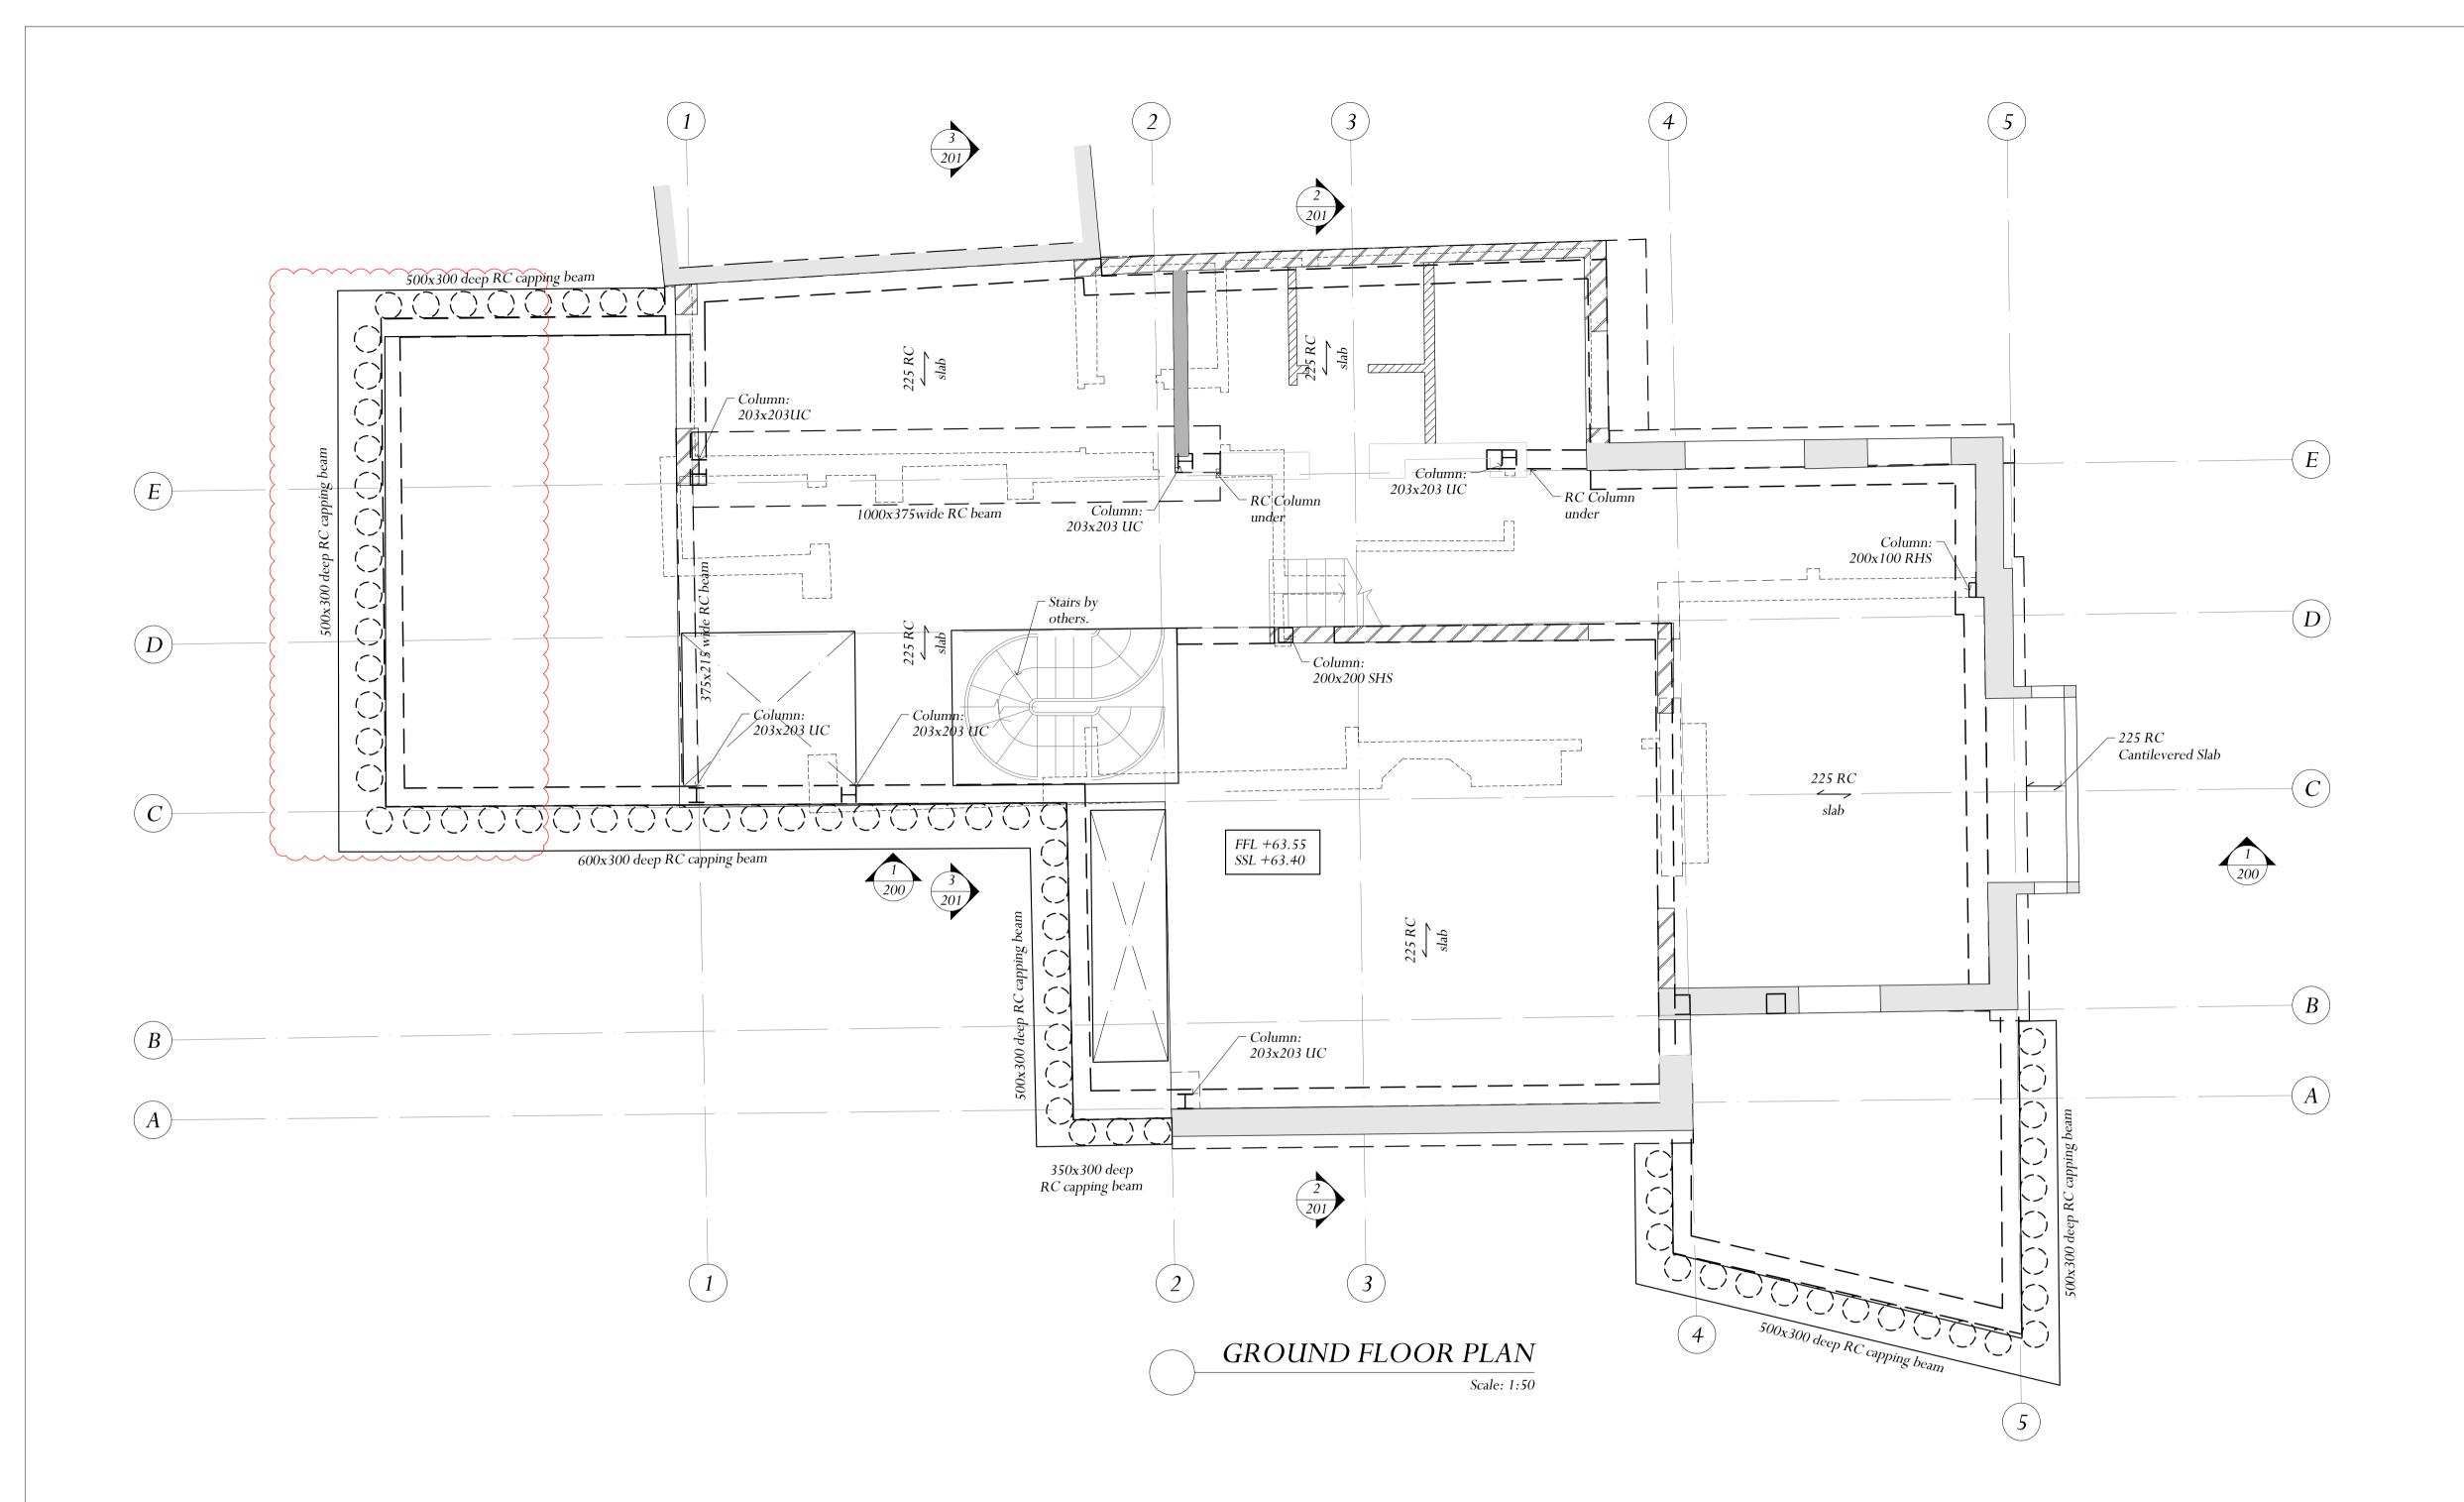
GENERAL ARRANGEMENT GROUND FLOOR

Underpinning of the retained walls is to be undertaken in traditional hit and miss fashion in accordance with the specification and would be reinforced to support the ground pressures during construction; in the permanent state the underpinning is to be buttressed by a reinforced concrete wall that would be propped at the top by the ground floor slab.
