Job No. 16.749	Drawn DE	Client 4 Handel Street Ltd	david narro associates Consulting Structural & Civil Engineers
Drg No. SK04	Checked	Job Title Staircase at 4 Handel Street, London WC1	
Date Aug 2016	Scale NTS	Sheet Title Stair Repairs

Step 3 - Further removal of finishes

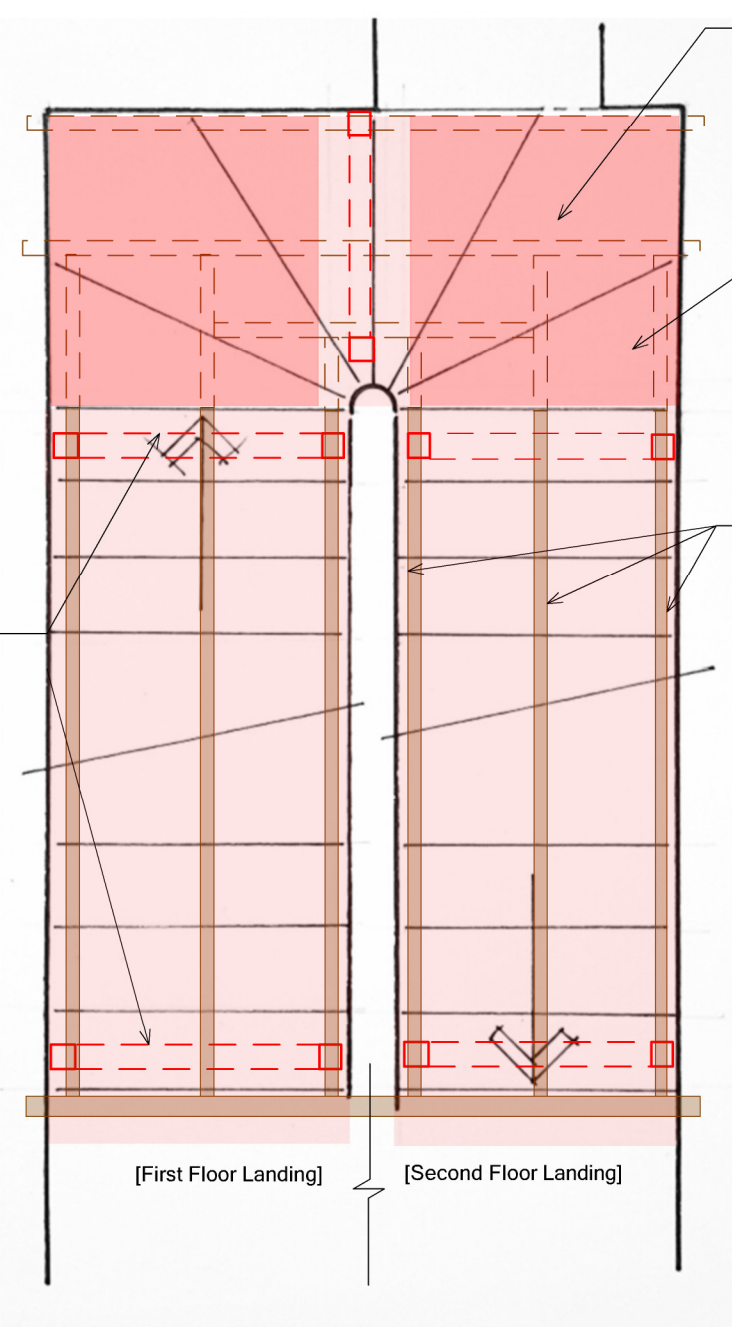
Plan of stair between first floor to second floor landings
(not to scale)

Indicates areas of lath & plaster finishes to underside of stait to be stripped at this stage

Areas of lath & plaster finishes previous stripped

Existing timber carriage beams

Timber frame propping all three carriage beams

Once arrangement of carriage timber in winder section of stair known, strip finishes over full underside of stair.

Take up any remaining carpet, underlay and other finishes on top of stair at this stage
