PROJECT
**Car Park Site,
2 Lidlington Place,
Morningson Crescent**

TITLE
Tree Constraint Plan (TCP)

Job	02992R	Scale	1:100 @ A3	DRG NO		Revision	
Date	26/11/2018	Type	a	02992P_TCP_01		-

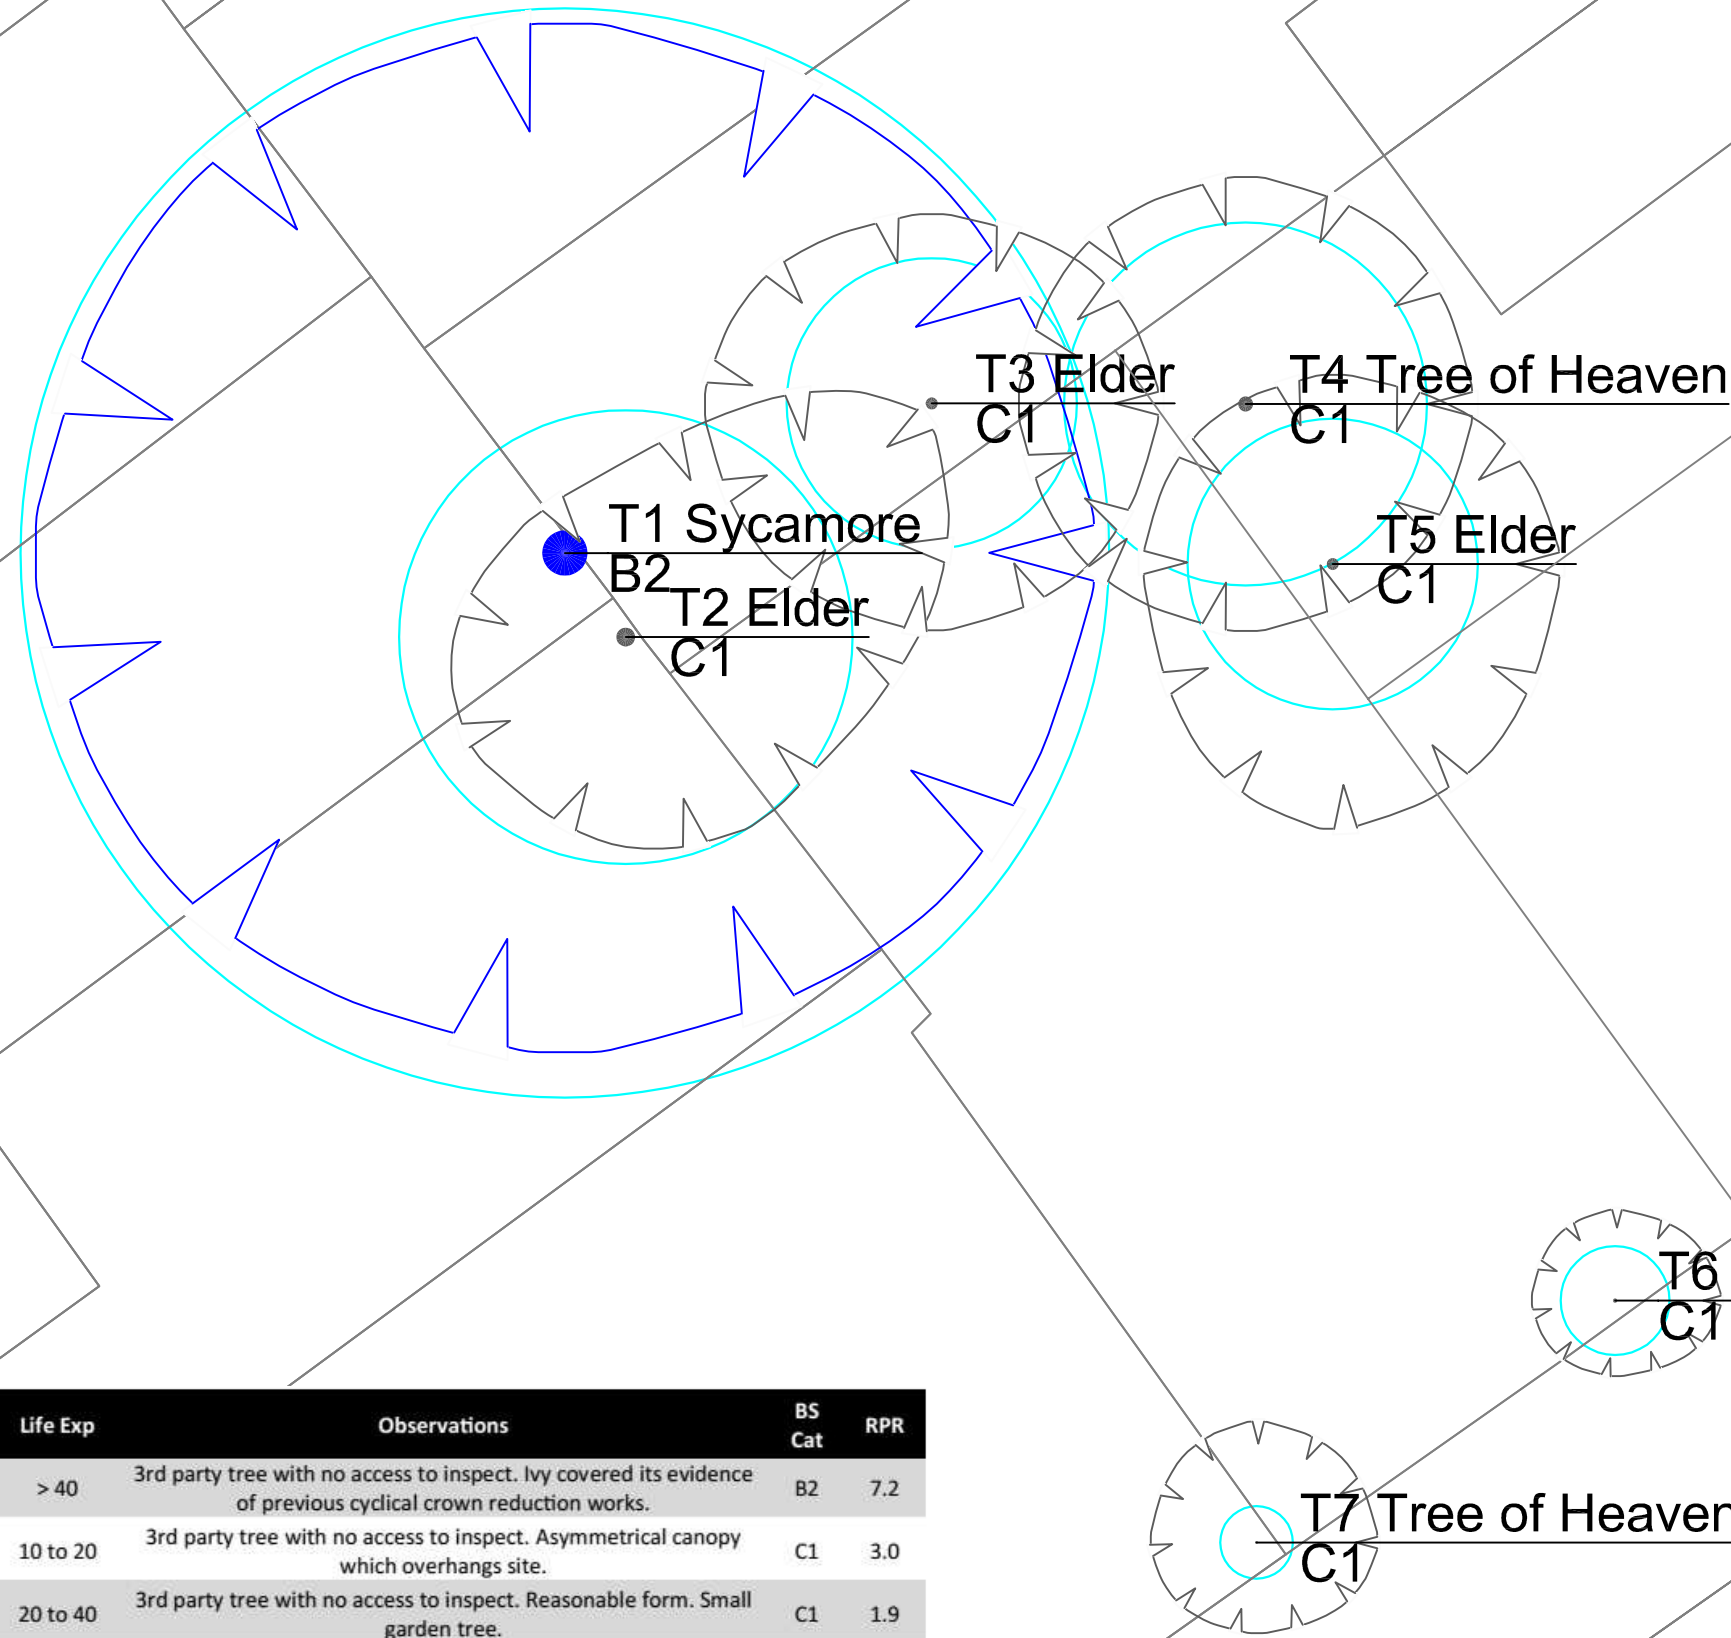
- Category A - Trees of high quality
- Category B - moderate quality
- Category C - low quality
- Category U - Dead, Dying or Defect trees with <10 years retention value

NOTE Tree positions indicatively mapped due to lack of detailed topographical plan

Tree No	Species	DBH	Height	Age Class	Life Exp	Observations	BS Cat	RPR
T1	Sycamore	0.6	19	Mature	> 40	3rd party tree with no access to inspect. Ivy covered its evidence of previous cyclical crown reduction works.	B2	7.2
T2	Elder	0.25	4.3	Mature	10 to 20	3rd party tree with no access to inspect. Asymmetrical canopy which overhangs site.	C1	3.0
T3	Elder	0.16	4.2	Early-mature	20 to 40	3rd party tree with no access to inspect. Reasonable form. Small garden tree.	C1	1.9
T4	Tree of Heaven	0.2	8	Early-mature	> 40	3rd party tree with no access to inspect. Establishing fast growing ornamental with high growth potential.	C1	2.4
T5	Elder	0.16	4.2	Early-mature	20 to 40	3rd party tree with no access to inspect. Small garden tree.	C1	1.9
T6	Fig	0.06	4	Young	<10	Self-set tree growing through concrete. Below BS size threshold.	C1	0.7
T7	Tree of Heaven	0.04	4.5	Young	10 to 20	3rd party tree with no access to inspect. Below BS size threshold. Poor form.	C1	0.5
