ARBORICULTURAL IMPACT ASSESSMENT REPORT FOR:

Adam Hollis
MSc ARB MICFor FArbor A MRICS C Env

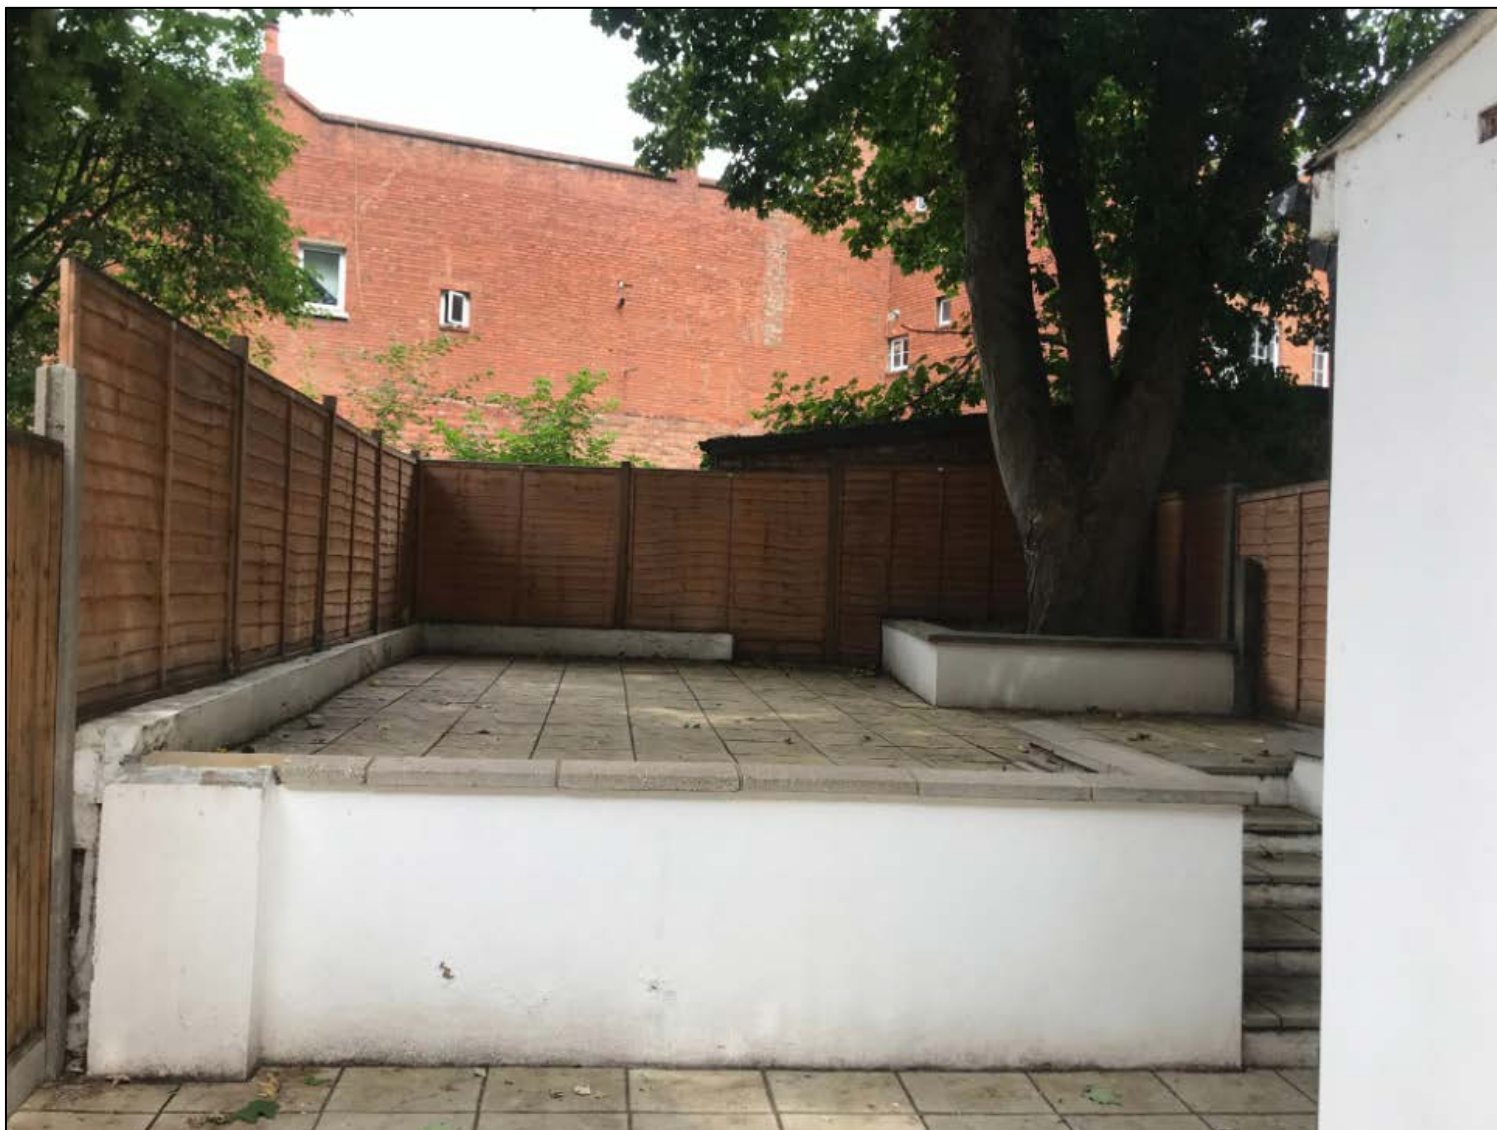
| 3.1.2 | The site is relatively flat throughout although there are a number of existing level changes in line with the built form. |

Photograph 2: Level changes within rear garden of application site

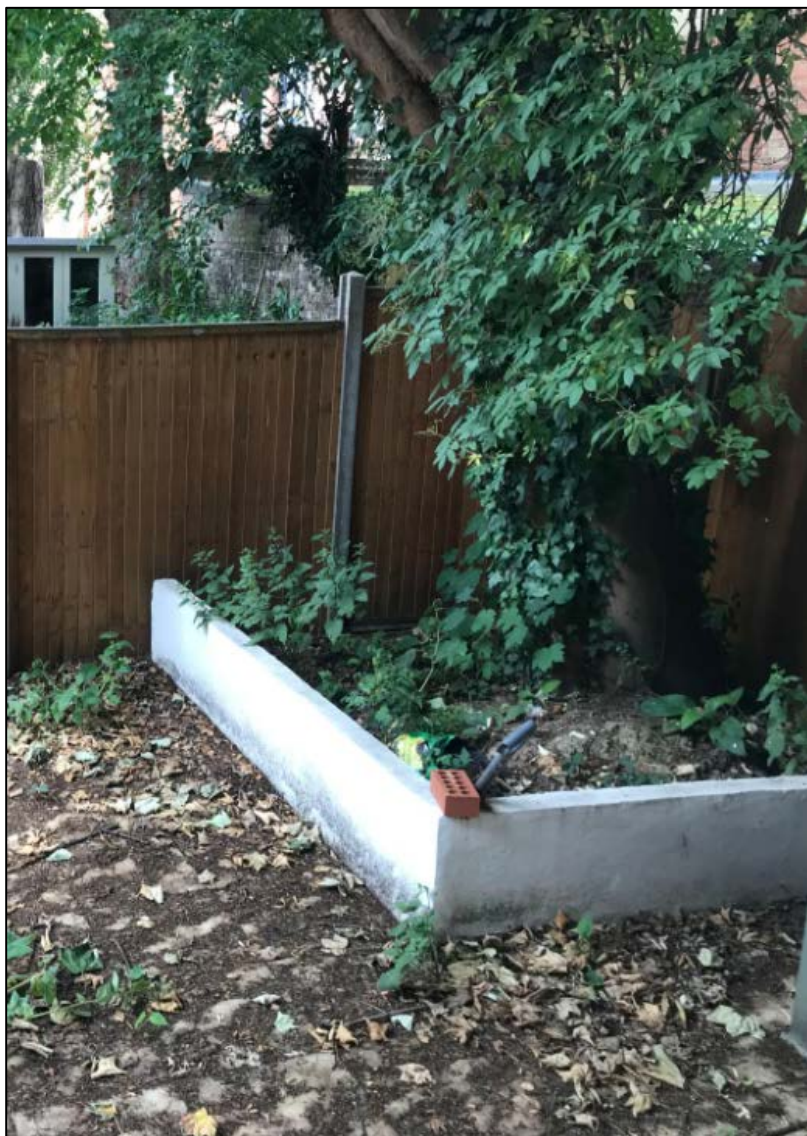
- 3.3.1 Three trees were surveyed on and adjacent to the site, a mature, moderate quality sycamore standing in a small raised bed within the rear garden of the application site, a mature, low quality sycamore standing in the rear garden of the neighbouring property to the west and a mature, low quality pollarded Portuguese laurel that stands in the pavement in front of No. 8 Inglewood Road.

Photograph 3: T2 also growing in small raised bed

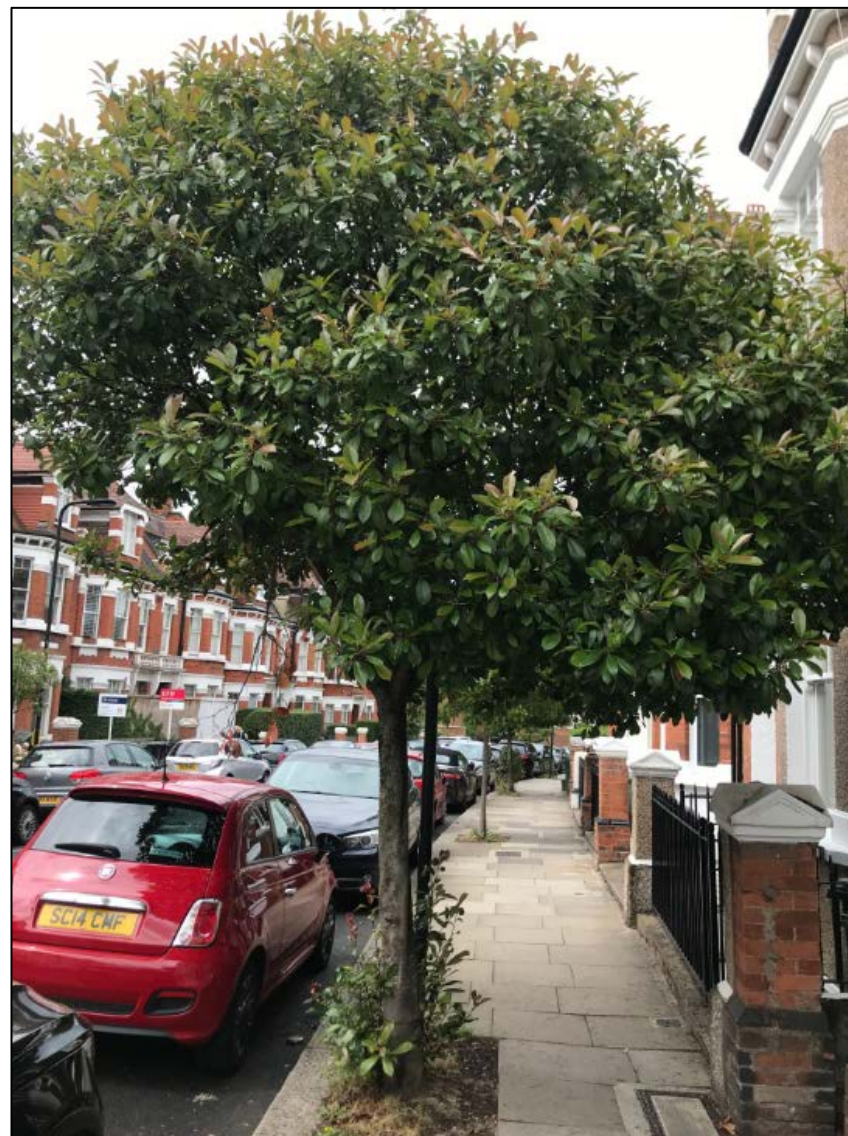
Photograph 4: Street tree T3

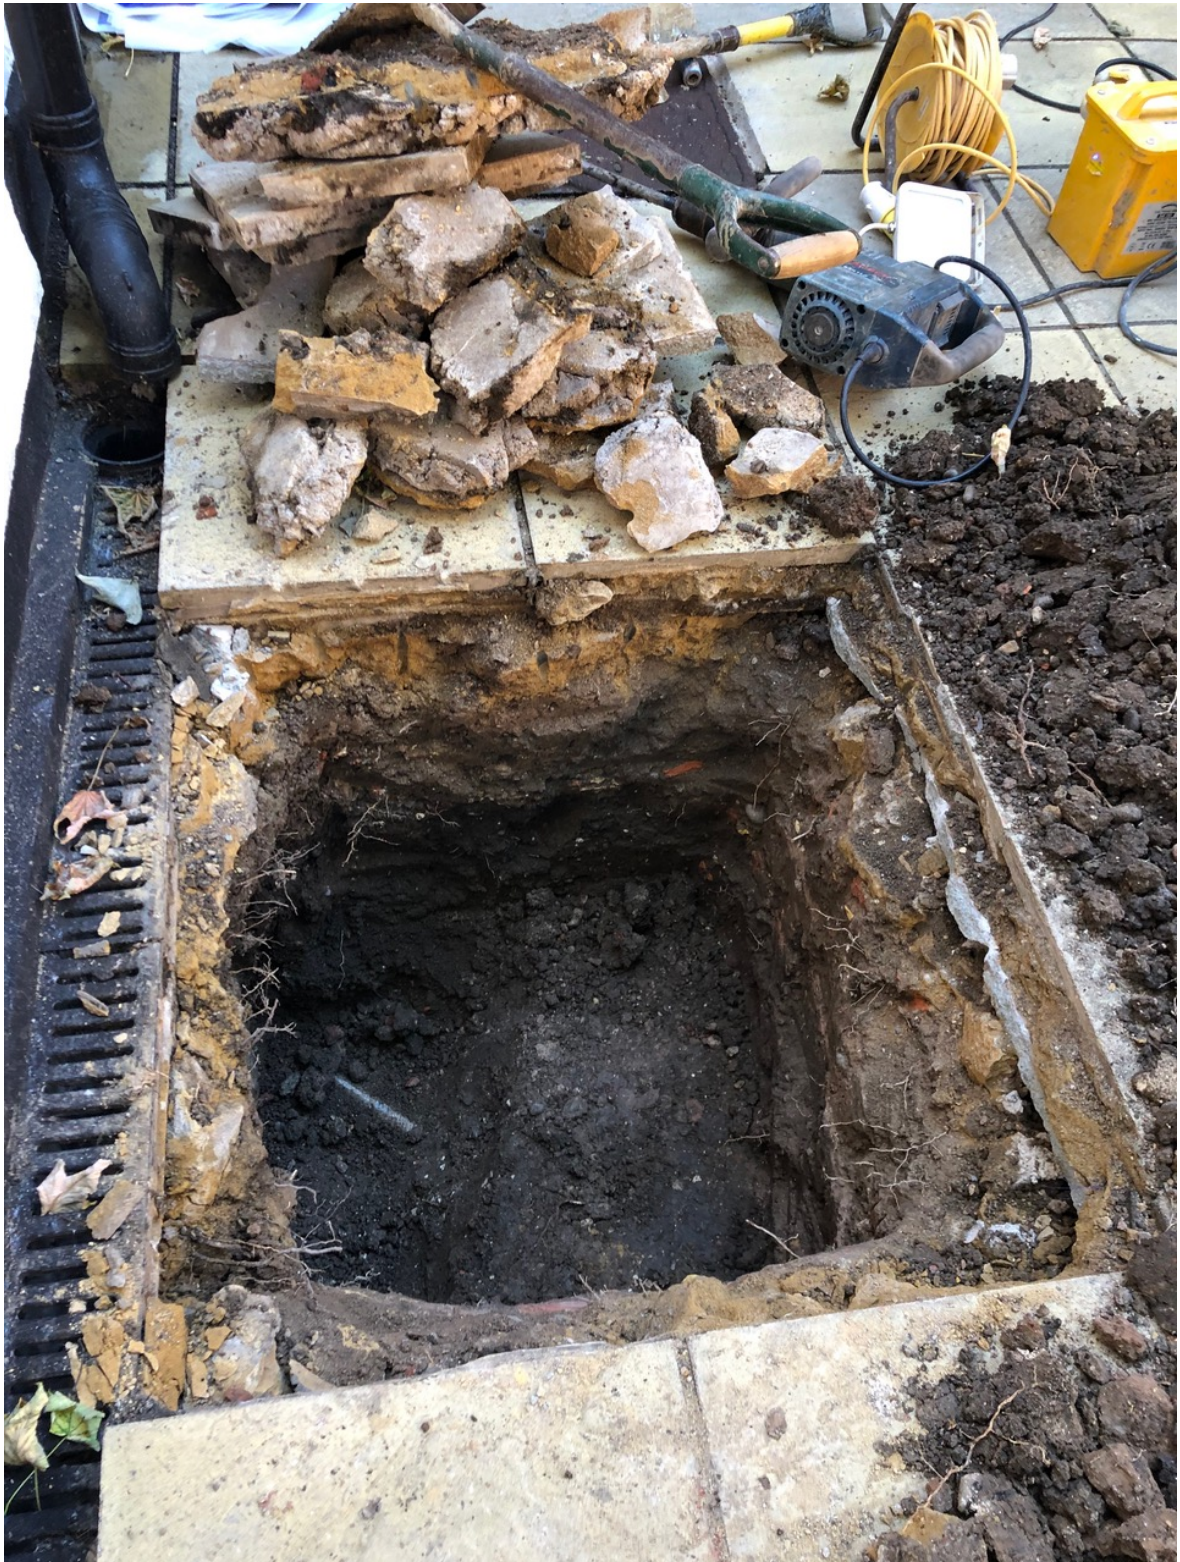
- 6.1.1 Whilst the proposed basement footprint is outside the conventional circular RPA of T1, it is unclear how accurate a depiction of the likely priority area to protect that represents. Accordingly, a trial pit was excavated in the location detailed in Appendix 2. This trial pit found only minor rooting of sub-10mm diameter and we therefore conclude that the proposed development footprint does not comprise a priority area to protect.

Photograph A2.1: No significant rooting in trial pit

- 6.3.1 The outer line of the basement foundations closest to T1 will be manually excavated to 750mm depth under arboricultural supervision; any roots encountered within the trenches / pits will be cleanly pruned back to an appropriate junction with a sharp pruning saw or secateurs back to a junction. Roots larger than 25mm diameter may only be cut in consultation with an arboriculturalist.

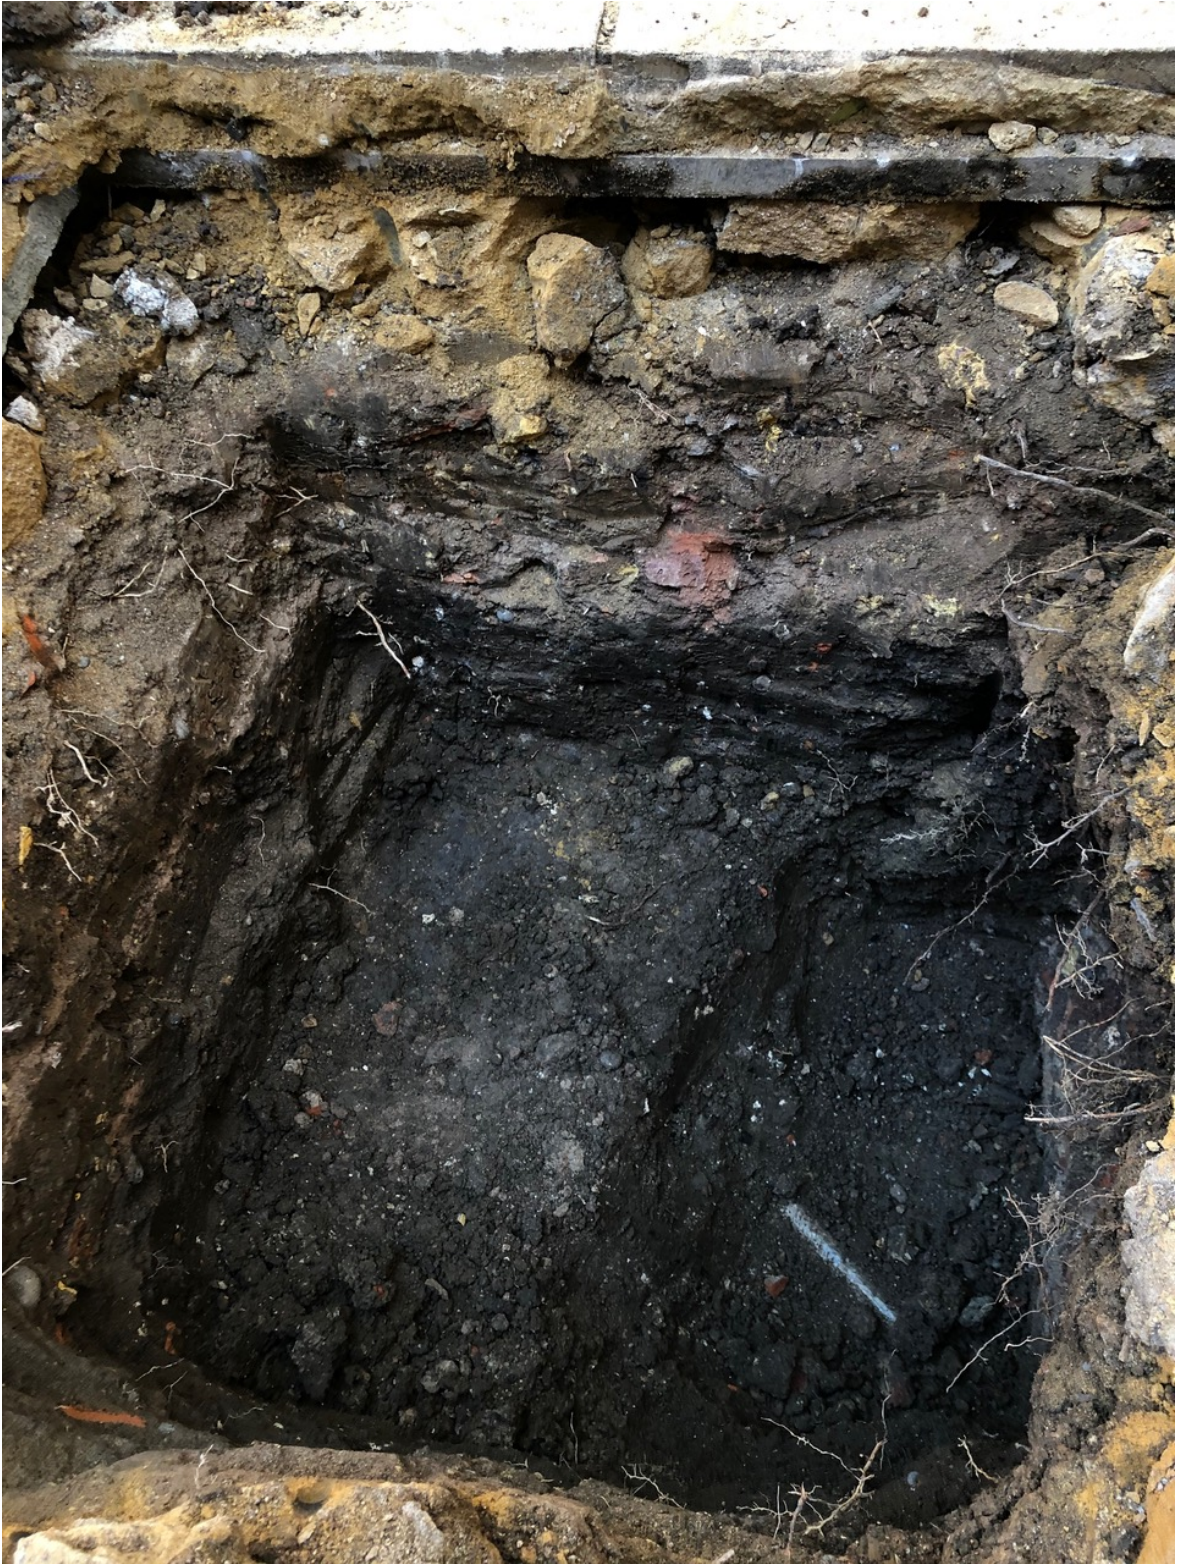
Photograph A2.2: Closer view of trial pit
