Client:				
Sarah Bard Sassoon				
Project Title:				
24 Heath Drive, London, NW3 7SB				
Drawing Title:				
Strip-Out				
Section B				
Scale:	Date:	Drawn:	Checked:	
1:50@A1	JAN 18	ST	HV	
)

Project No.:	Drawing No.:	Revision:
508-16	1701	F

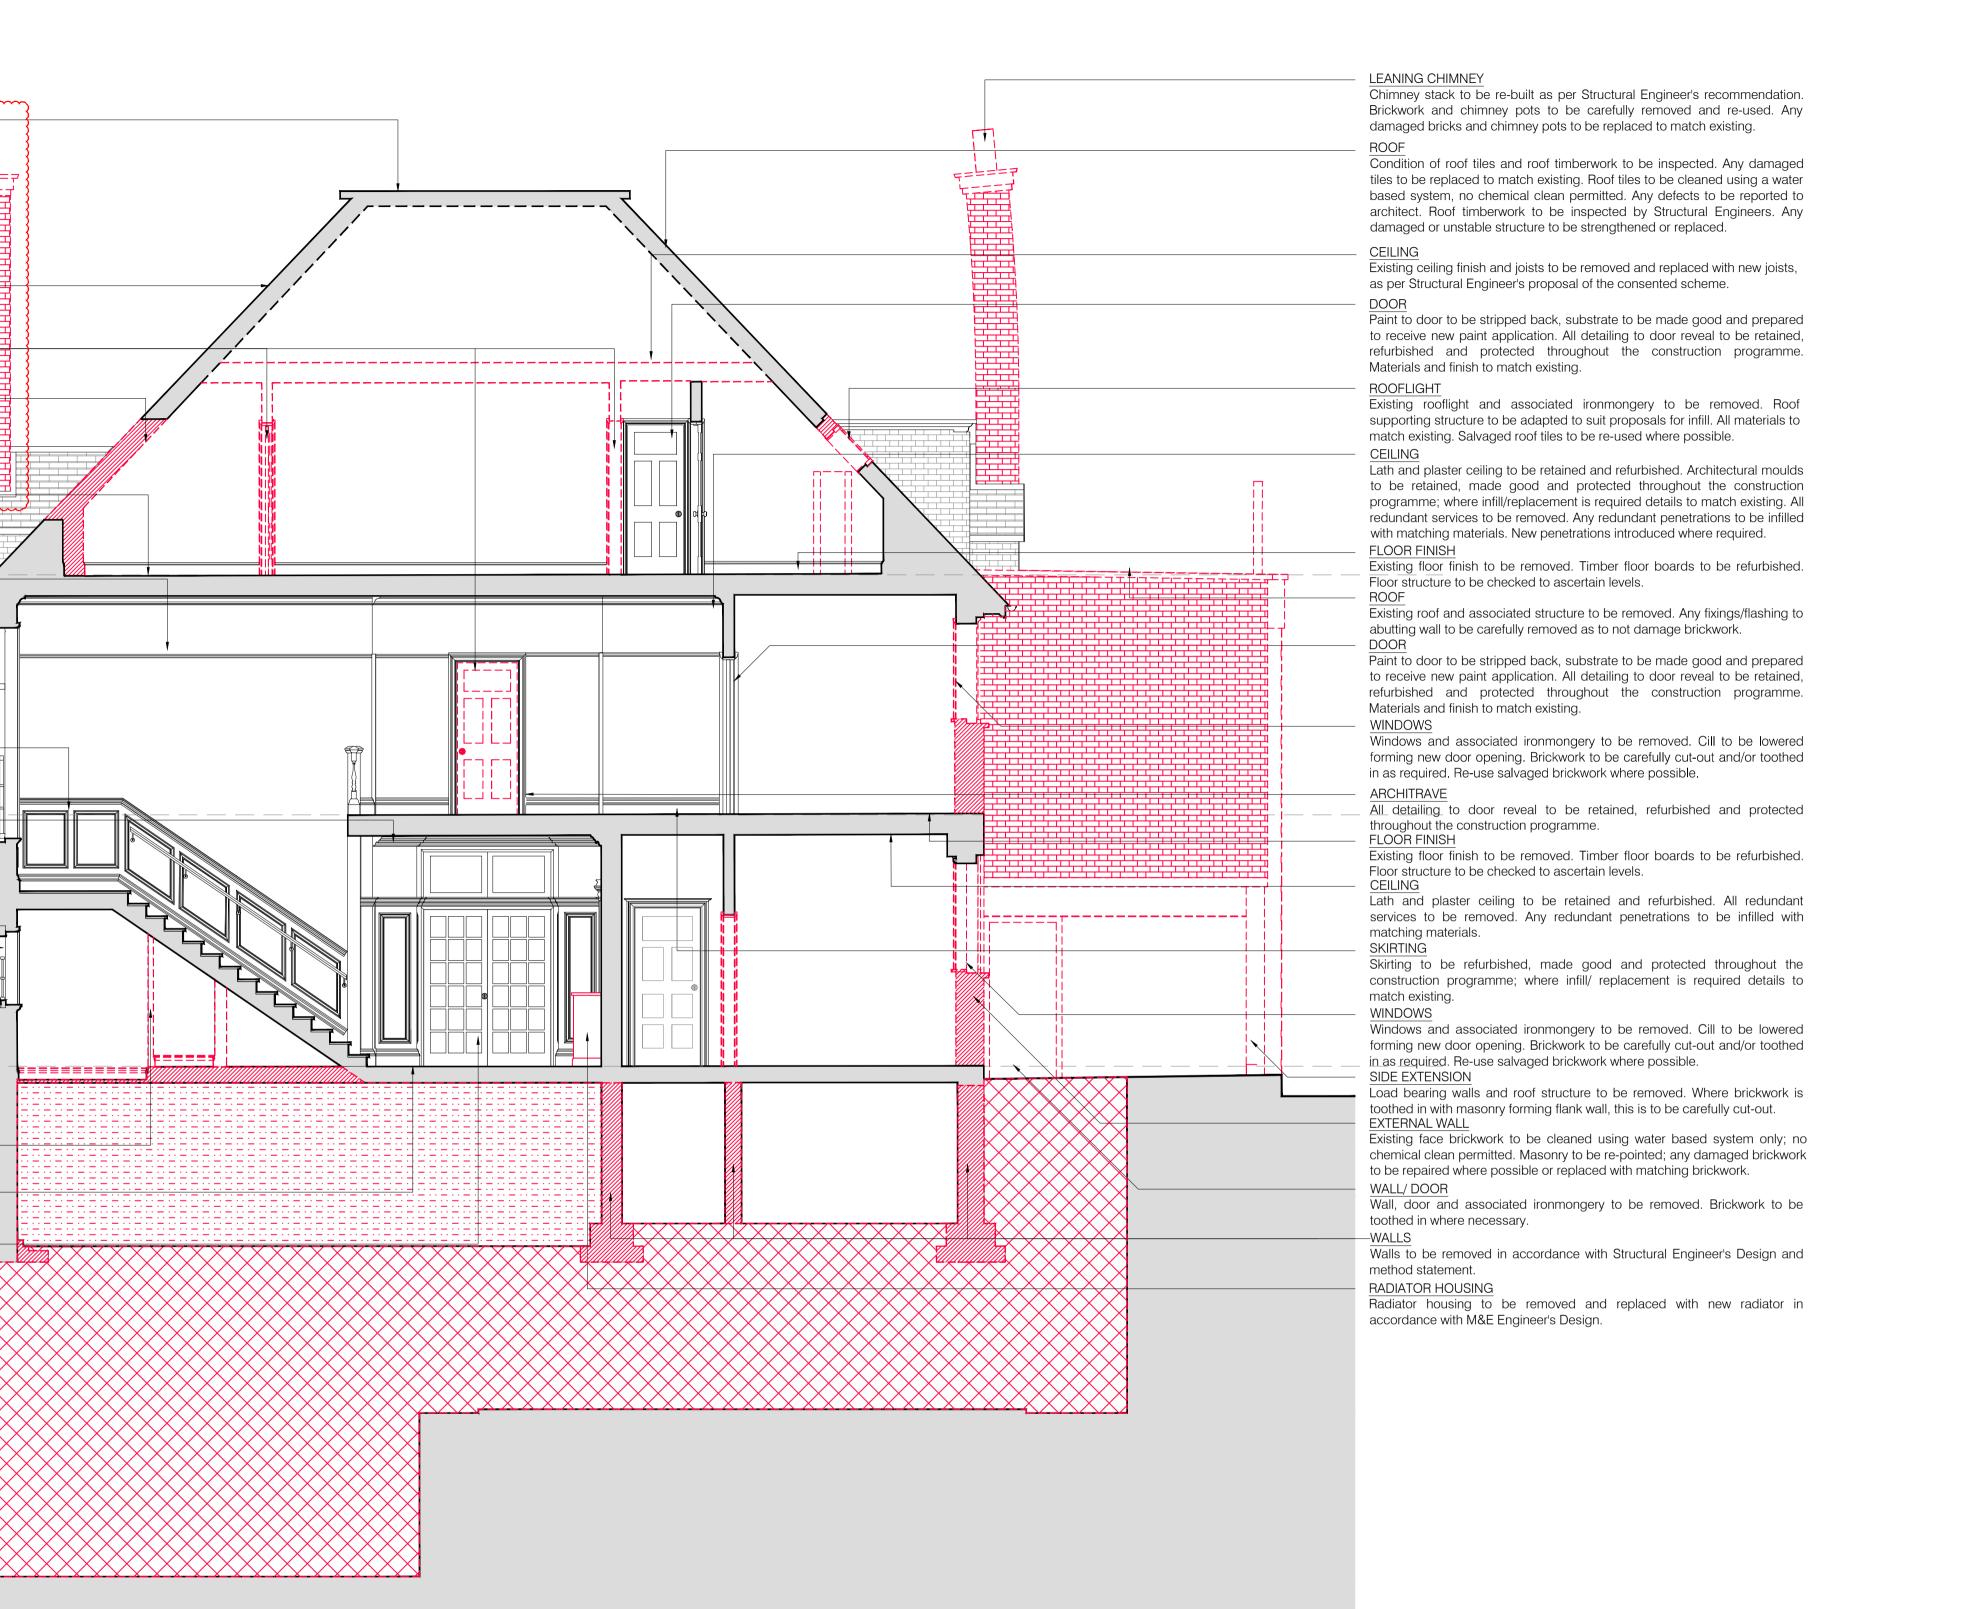
Panelling to be refurbished, made good and protected throughout the construction programme; where infill/ replacement is required details to match existing. First FFL 91.66

Paint to windows to be stripped back, substrate to be made good and

prepared to receive new paint application. All detailing to window reveal to

be retained, refurbished and protected throughout the construction

programme. Materials and finish to match existing.

CEILING Lath and plaster ceiling to be retained and refurbished. Architectural moulds to be retained, made good and protected throughout the construction programme; where infill/replacement is required details to match existing. All redundant services to be removed. Any redundant penetrations to be infilled with matching materials. New penetrations introduced where required.

Paint to windows to be stripped back, substrate to be made good and prepared to receive new paint application. All detailing to window reveal to be retained, refurbished and protected throughout the construction programme. Materials and finish to match existing.

EXTERNAL WALL Existing face brickwork to be cleaned using water based system only; no chemical clean permitted. Masonry to be re-pointed; any damaged brickwork to be repaired where possible or replaced with matching brickwork.

WALLS Walls to be removed. Substrate to wall, ceiling and floor to be made good with all materials to match existing.

PARQUET FLOORING Existing floor finish to be retained, refurbished and protected throughout the construction programme.

Paint to door to be stripped back, substrate to be made good and prepared to receive new paint application. All detailing to door reveal to be retained, refurbished and protected throughout the construction programme. Materials and finish to match existing.
