## HERITAGE AND DESIGN STATEMENT

Proposed En-suite to Master Bedroom 18 Holly Mount, London NW3 6SG

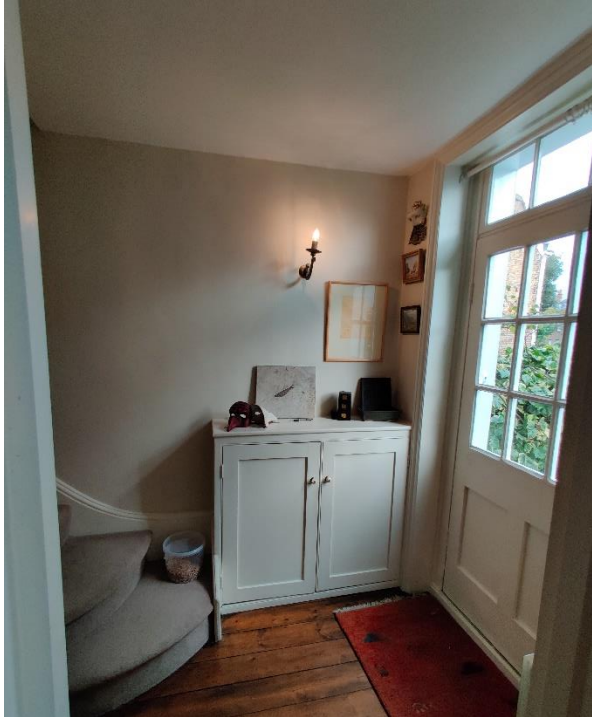
The ground level entrance hall, with C20 built-in cabinet to be replaced

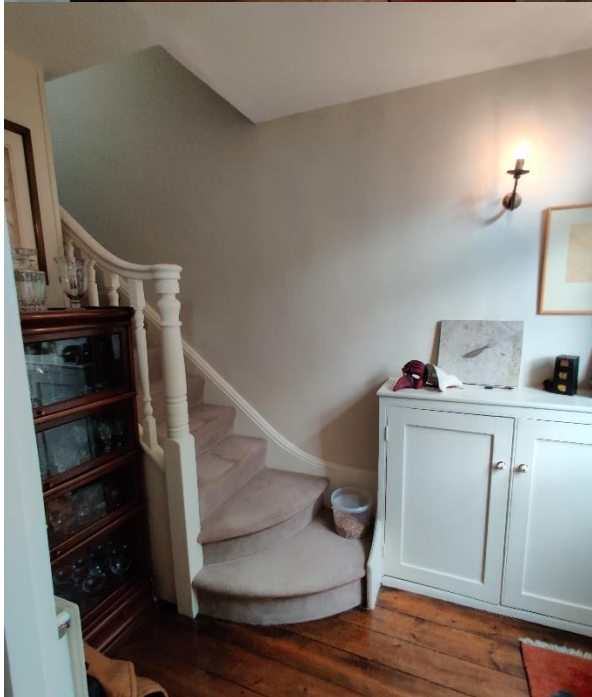
Stairs to first floor and the existing cabinet to be replaced

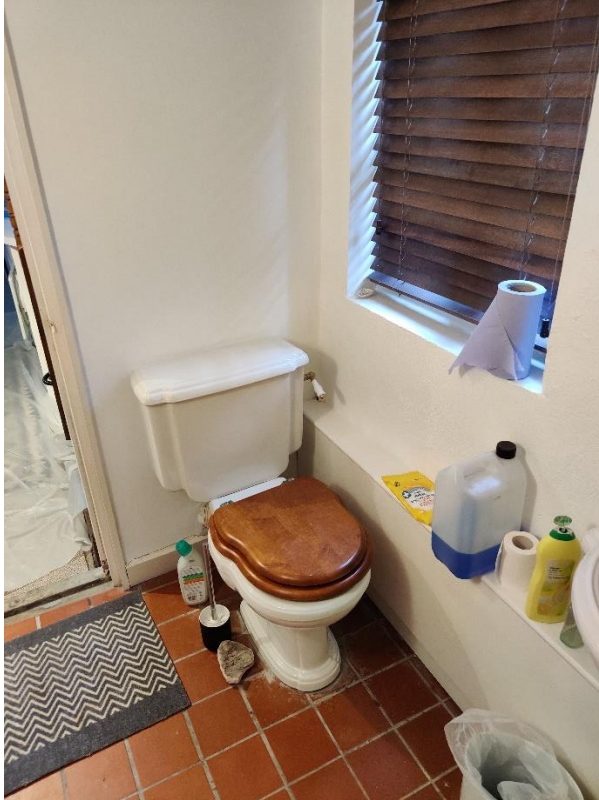
The cellar WC. All finishes and sanitaryware are C20 and by the previous owner. Note the pipework boxing concealing the supply and waste pipework to the sink (right-hand-side, out of shot).

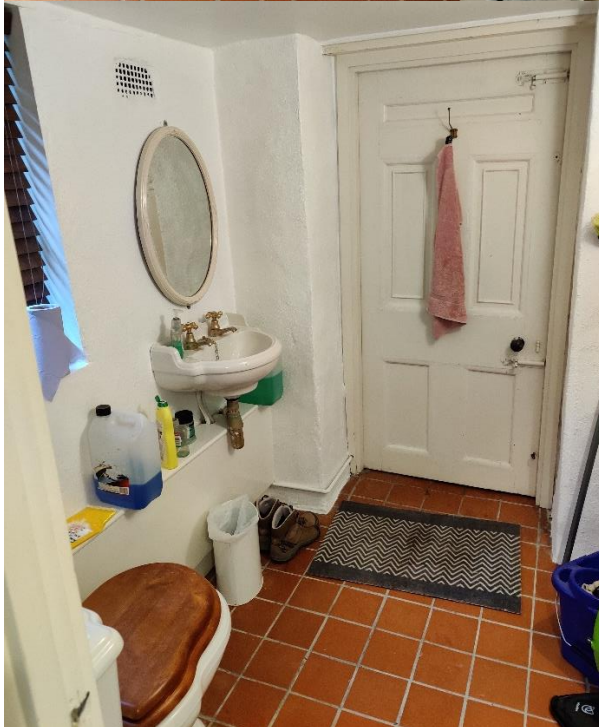
The cellar WC. The new pipework would be inserted in the corner just to the right of the mirror, and would return along the existing pipework run.

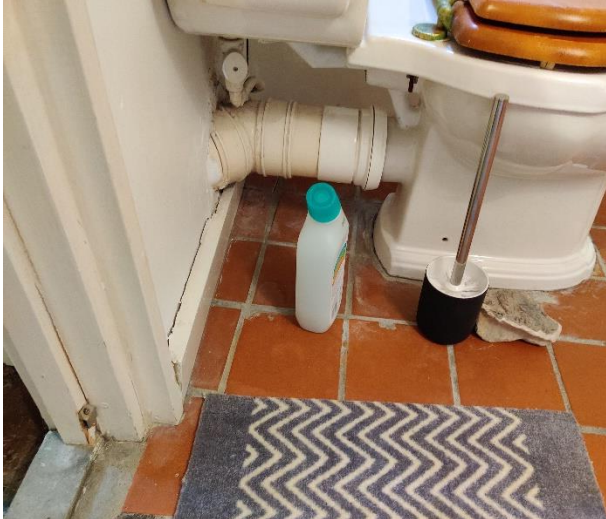
Close-up of above-ground soil pipe. The new connection would be above ground, on the side of the pipe closest the WC window.

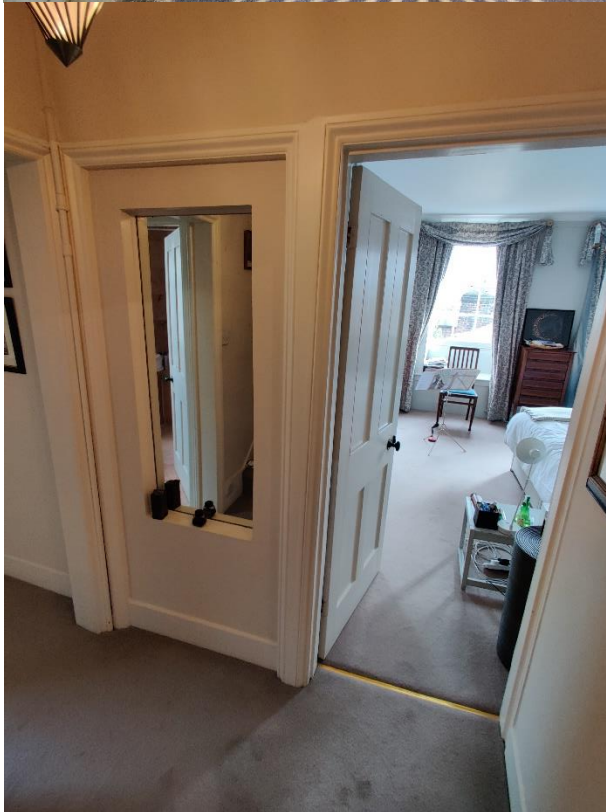
The landing outside the first floor Master Bedroom. Note the infilled doorway on the left, evidence of a previous undetermined room or landing layout.

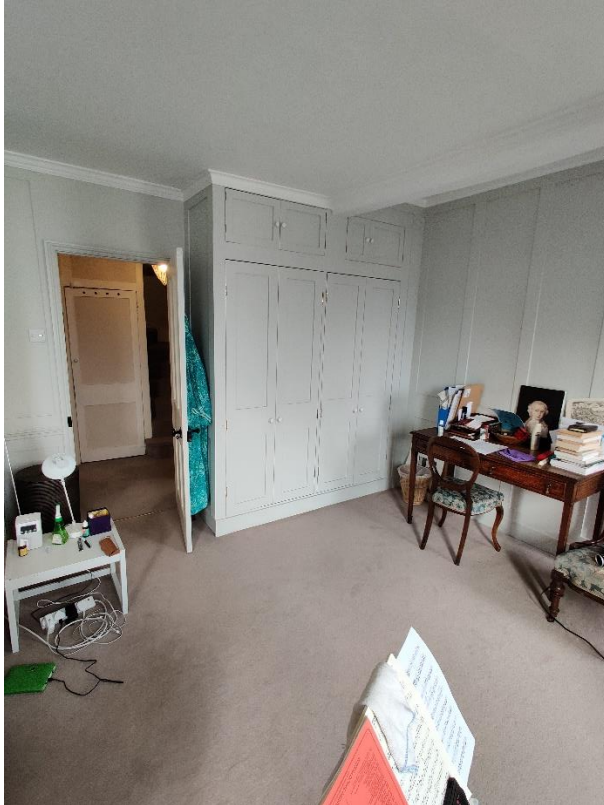
The existing C20 wardrobe in the Master Bedroom. Note the beam intersecting the wardrobe and higher ceiling to the right. These wardrobes would be removed, and panelling behind inserted to match the historic panelling (see images below). Note the absence of a moulded dado detail to the non-historic panelling on the right.

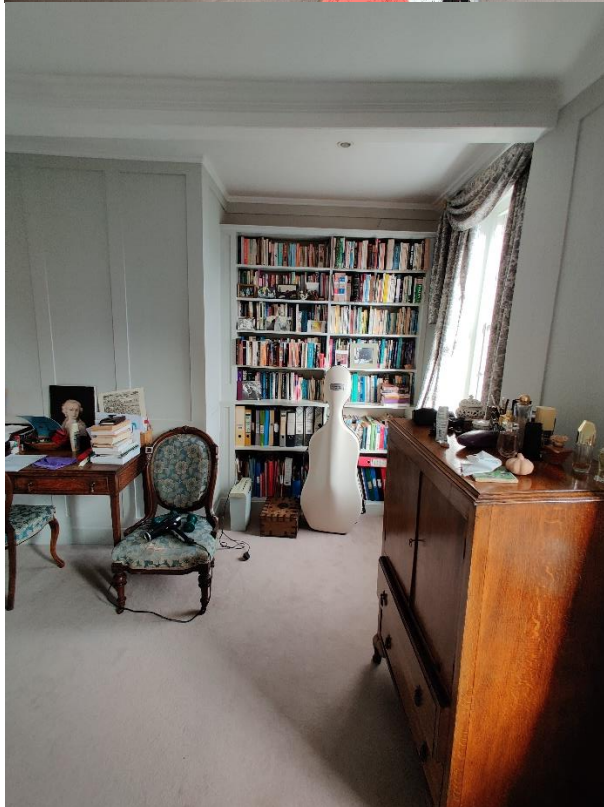
C20 panelling on the left enclosing the staircase, and a C20 bookcase directly above the ground floor entrance hall. The bookcase would be removed and the panelling would be concealed by the new wardrobe and en-suite.

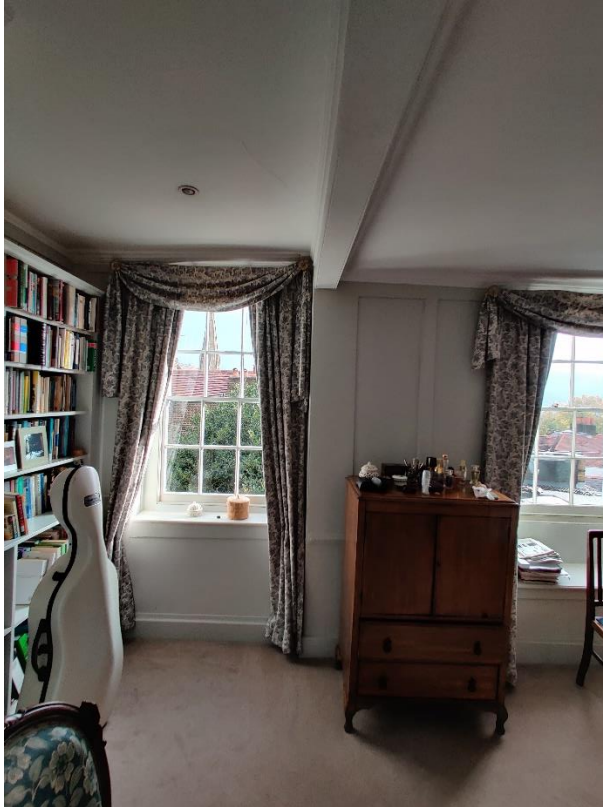
Historic panelling with moulded dado rail detail. Close inspection reveals some repairs to the rail and panelling. It may be not all these elements are original, but they do not look recent and may have come about during a previous change to the floor plan's layout at an unascertained period.

Note the change in ceiling heights. The proposed new wall would align with the downstand beam, dry-jointed against the external wall, the fabric of which is believed to be if not original then at least historic.

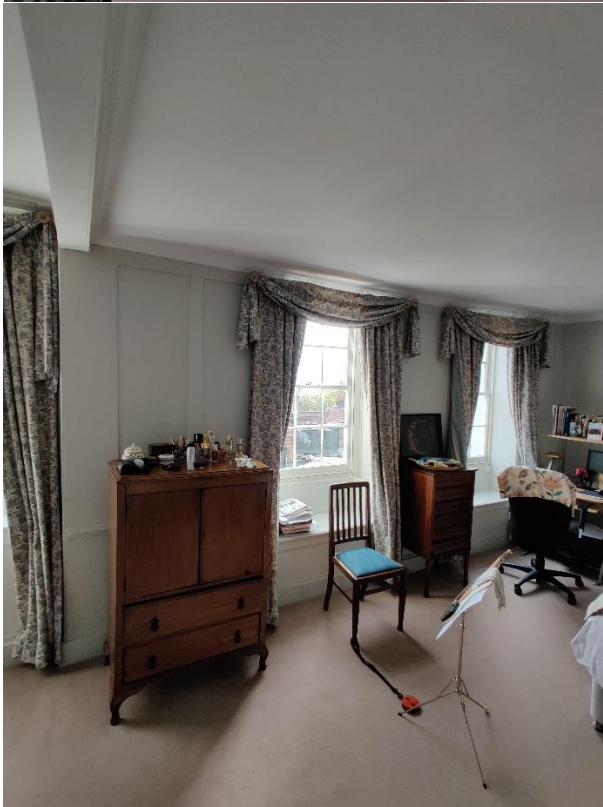
Seemingly original panelling and window recesses along the external wall.

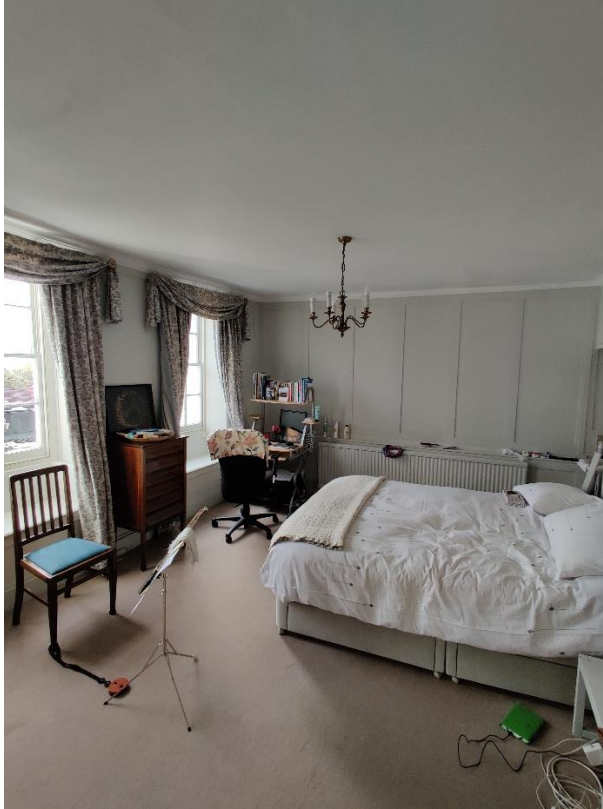
This image shows more panelling which is more adjacent the windows which is similar to that adjacent the stair. The wall behind seems to be hollow. We suspect the original wall behind may have been in poor condition so was covered over with a C20 attempt at a replica. Aside from the crispness of the detailing and lack of paint build-up one would assume from an older building element, note here the ledge above the radiator and absence of a moulded dado rail, which reinforces the conclusion that these are not original features.

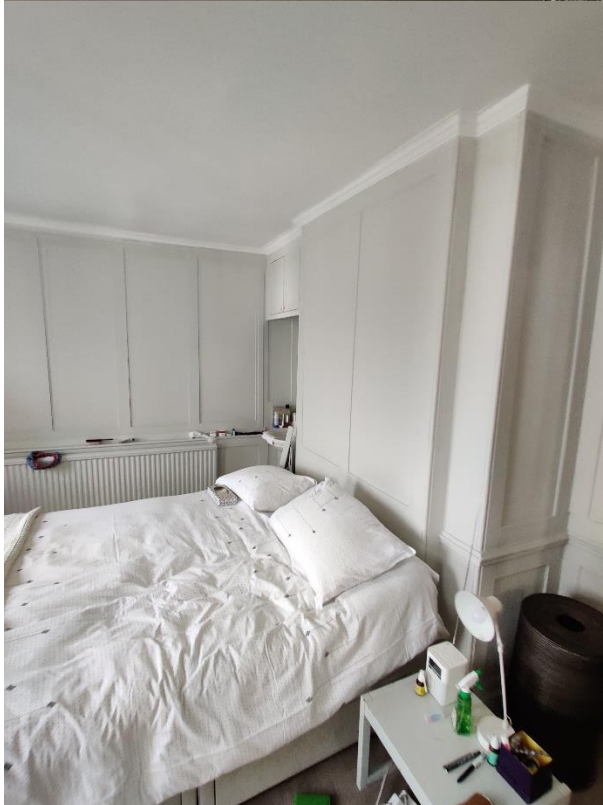
Panelling to what was presumably an open fireplace. Note the presence of a dado rail on the right, but absence on the panelling along the chimney breast. This may have been for decorative reasons, or due to changes taking place over time.
