Existing\_Ground Floor Bathroom

**10 Grand Union Walk**  
 As Existing  
 Ground Floor Bathroom  
 1:20@A3 Oct 2020  
 Drawn: TS Checked: TS  
**GUW10-E141( )**

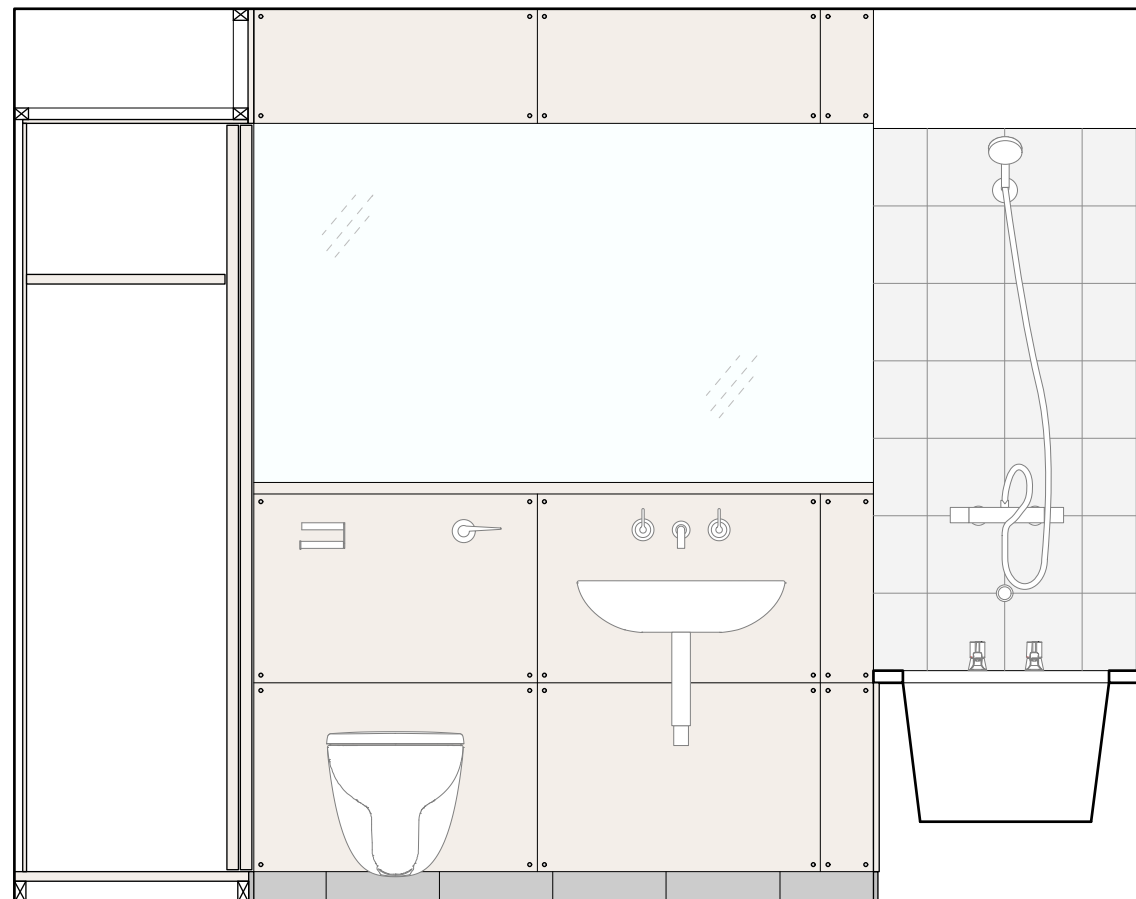
SECTION 1

The existing original and non-original sanitary goods, cupboard, panelling, floor and wall tiles are worn out and partially damaged - please refer to photographs 5 to 8 on drawing GUW10-E150.  
 They are proposed to be removed and to be replaced in a sympathetic style and similar arrangement - please refer to drawing GUW10-P141 for details and specification references and to sample board for finishes.
