Historic Door Report

**42 Bedford Square** *Historic Doors - Condition Survey* February 2018 Rev A 42 Bedford Square, London

## Introduction

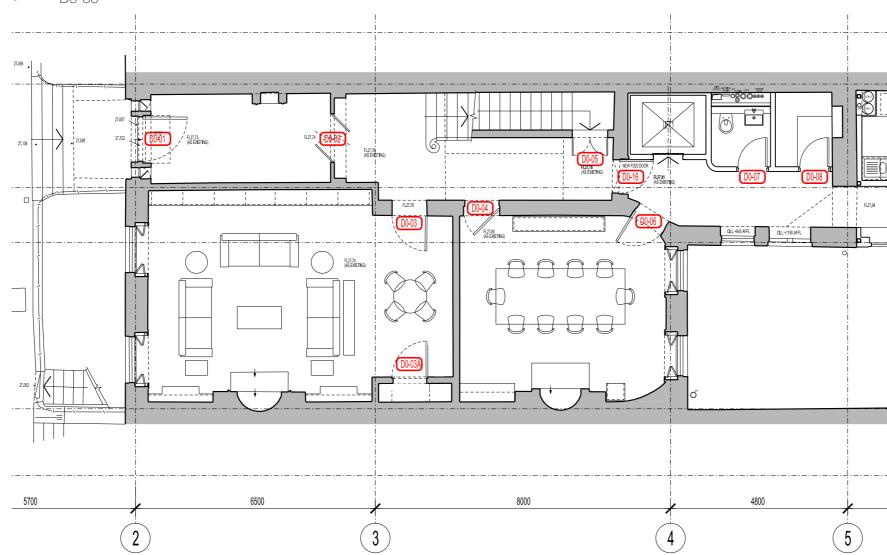
## Ground Floor - Door Location Key Plan (as issued for condition 4b discharge)

Doors to be retained:

- D0-03 •
- D0-03A •
- D0-04 .
- D0-06 •

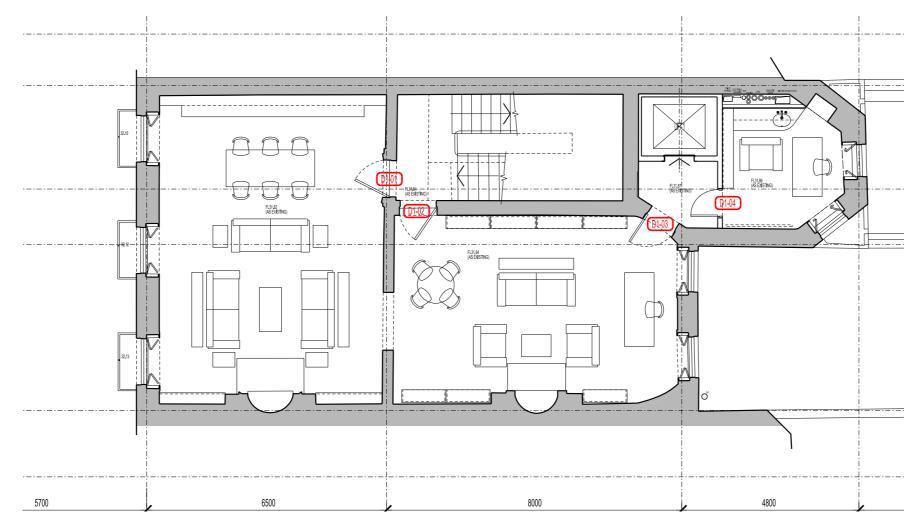
## First Floor - Door Location Key Plan (as issued for condition 4b discharge)

Doors to be retained:

- D1-01 •
- D1-02 •
- D1-03 •

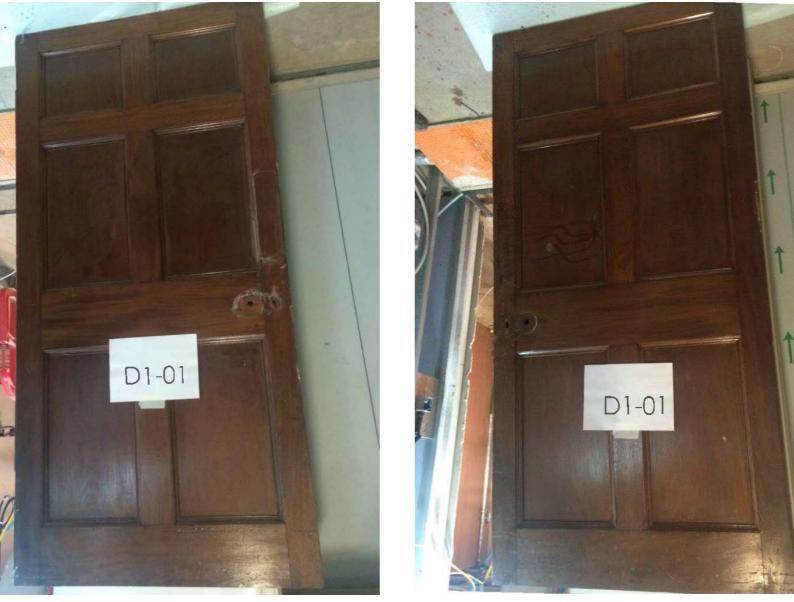
D1-01 Door photographed upside down
