PROJECT TITLE:  
**33 Estelle Road**

DRAWING TITLE:  
**Existing Side Elevation**

PROJECT NO.: **19-104** DRAWING NO.: **027** REVISION: **P5**

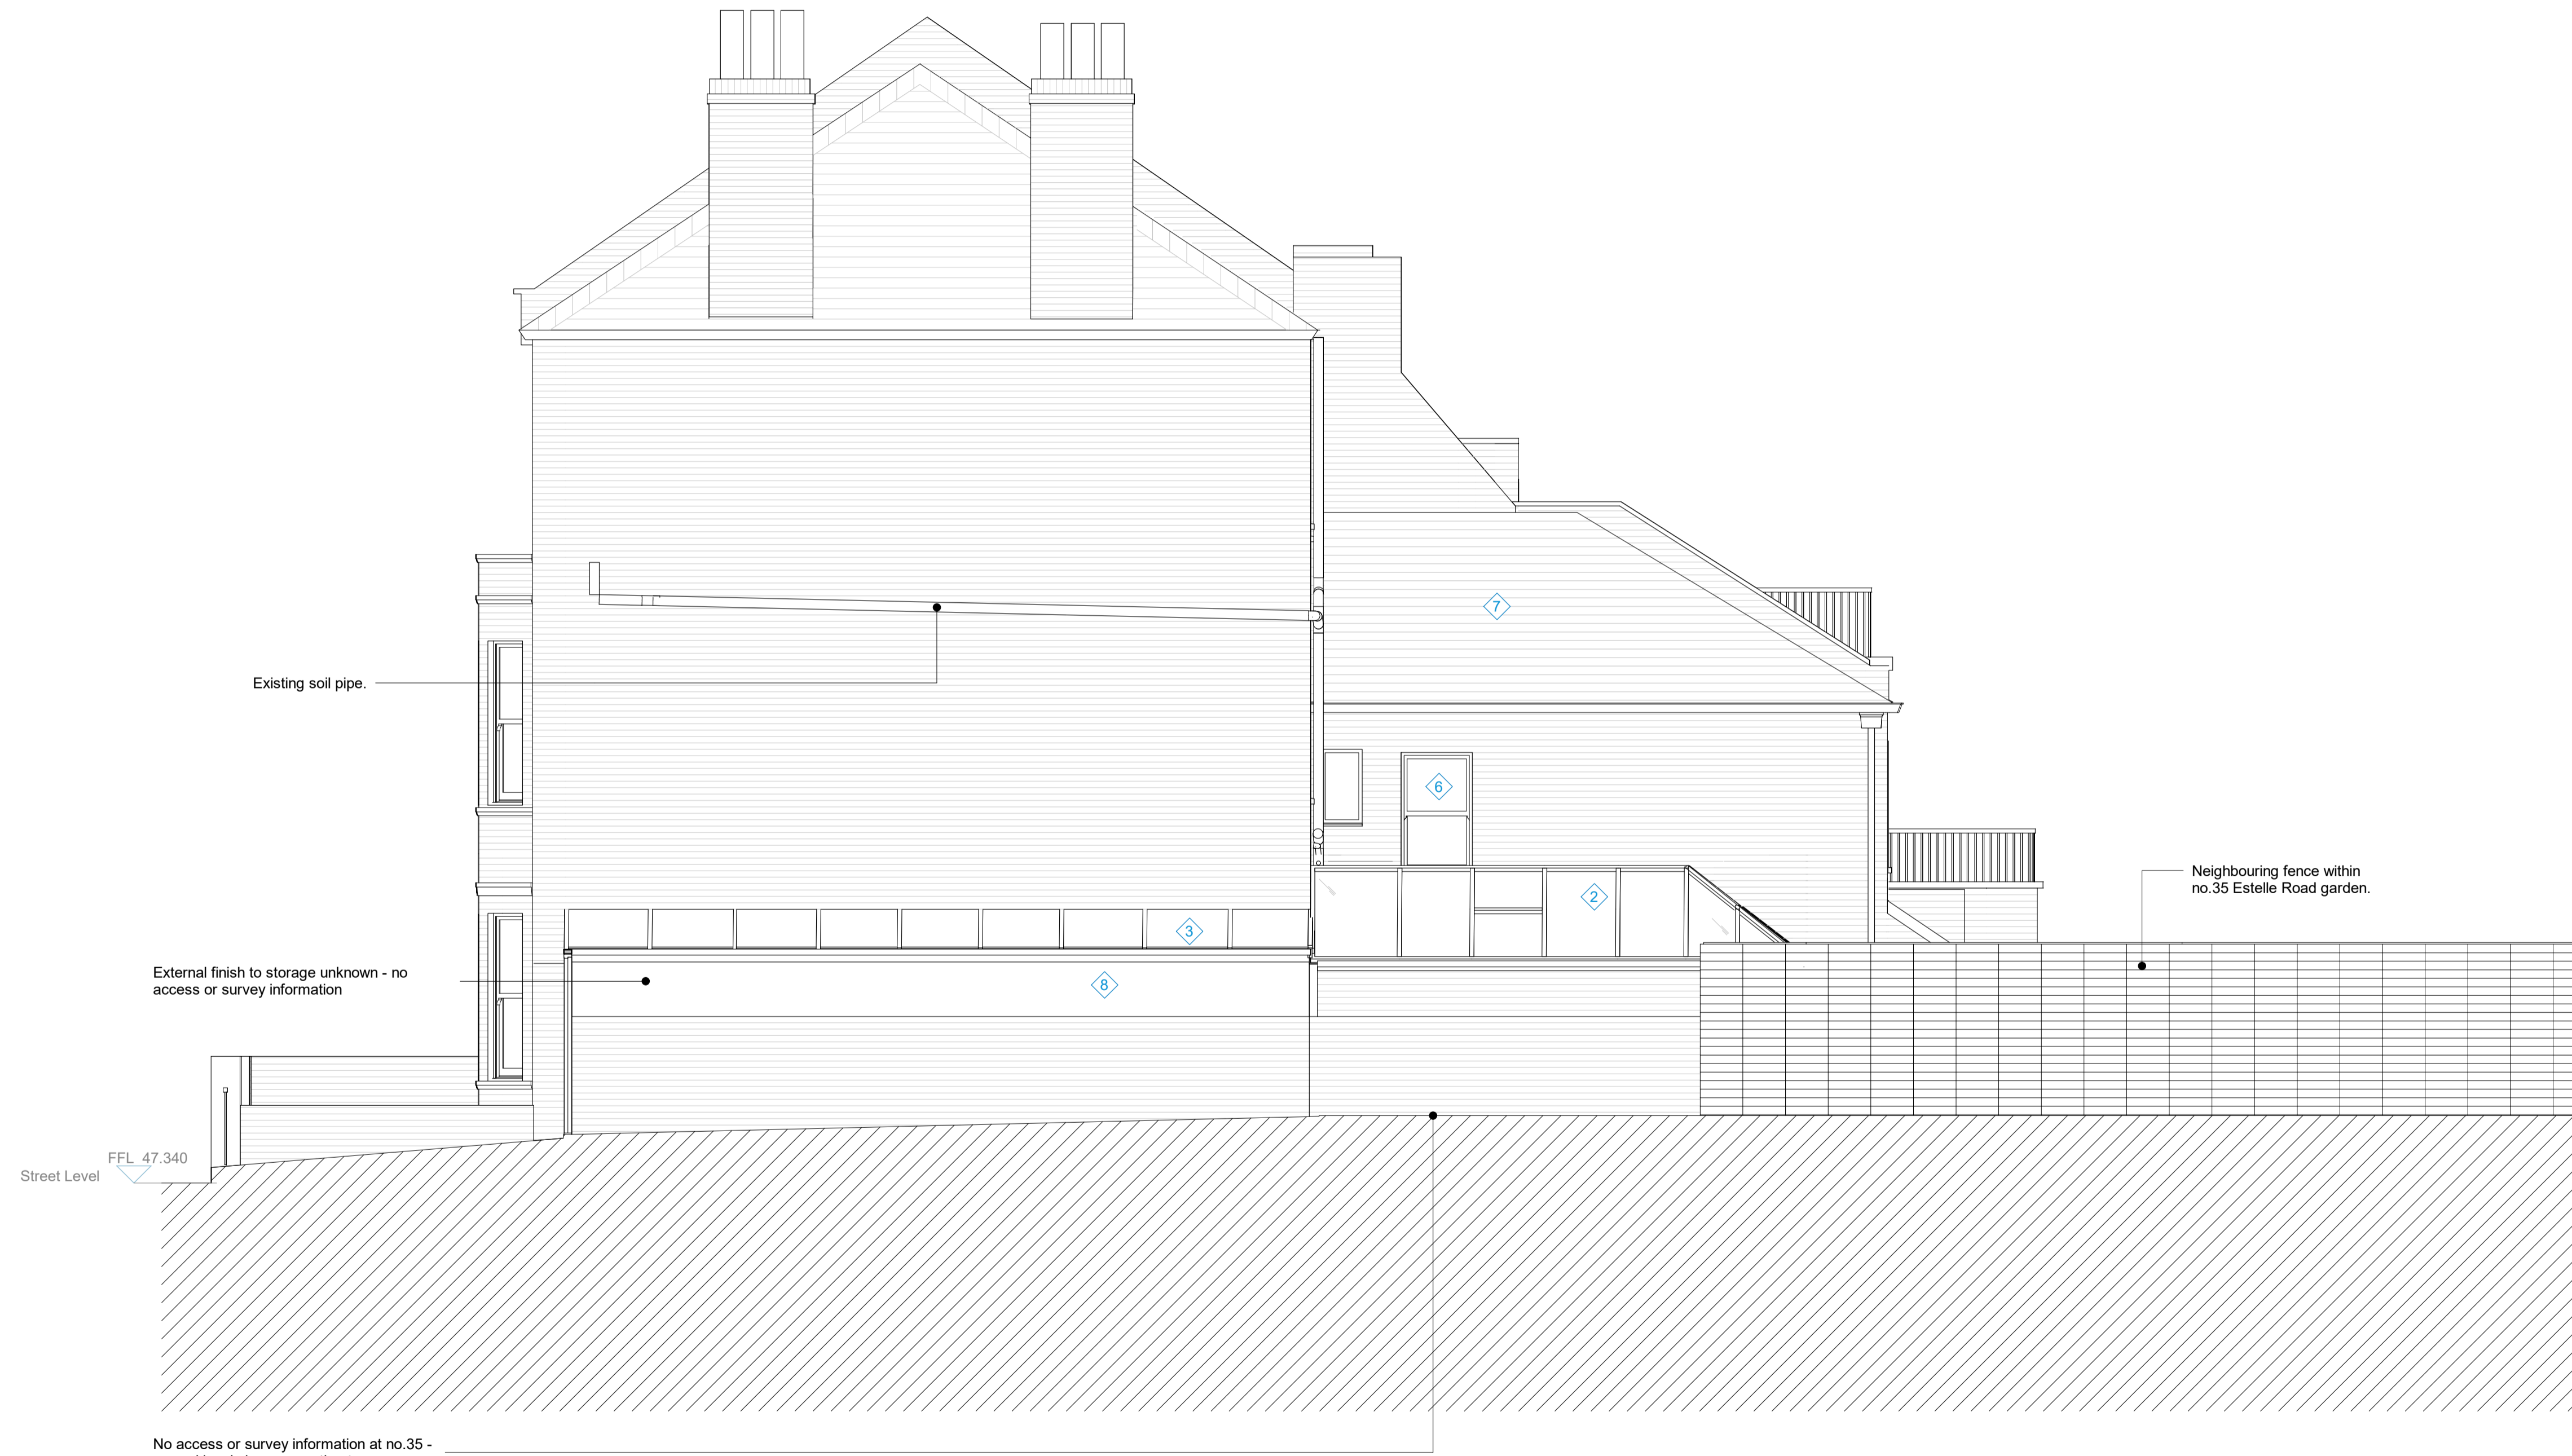
- 1 Existing roof tiles
- 2 Double glazed PVC conservatory roof to be removed
- 3 Polycarbonate roof to be removed
- 4 London stock brickwork
- 5 Painted white timber framed double glazed windows and door to conservatory side extension to be removed
- 6 Painted white timber framed double glazed sash windows to be replaced with new
- 7 Slate tiled roof to be removed
- 8 Painted timber boards
