Report Reference: CGL01-6094152

Overview of Findings

Report Reference: CGL01-6094152 Client Reference: 2841

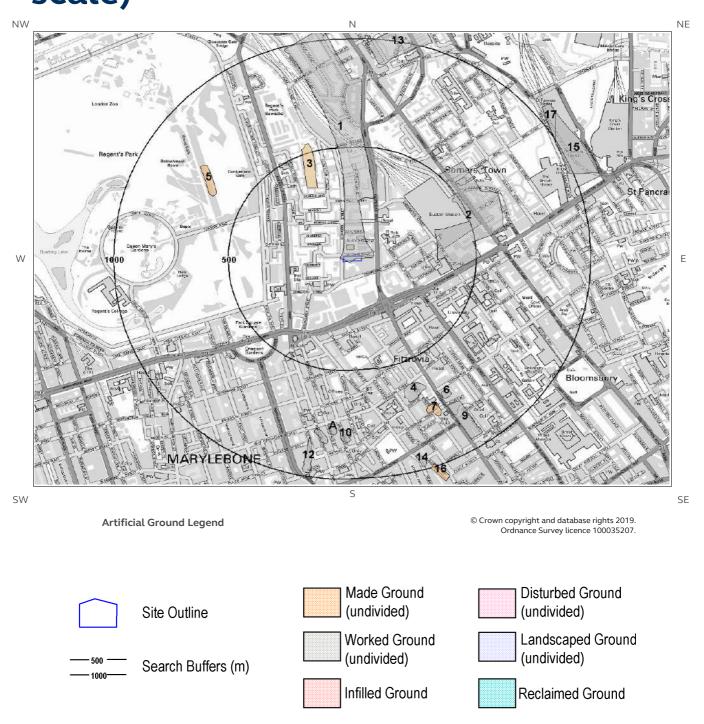
1.1 Artificial Ground map (1:10,000 scale)

ID	Distance	Direction	LEX Code	Description	Rock Description
1	0.0	On Site	WGR-	Worked Ground (Undivided)	Unknown/unclassified Entry
			UKNOWN		
2	330.0	Е	WGR-	Worked Ground (Undivided)	Unknown/unclassified Entry
			UKNOWN		-
3	335.0	N	MGR-	Made Ground (Undivided)	Unknown/unclassified Entry
			UKNOWN		-

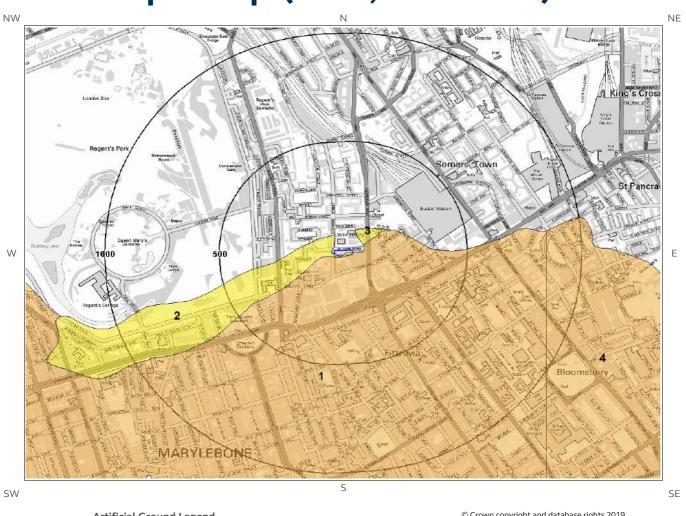
1.2 Superficial Deposits and Landslips map (1:10,000 scale)

ID	Distance (m)	Direction	LEX Code	Description	Rock Description
1	0.0	On Site	LHGR-XSV	Lynch Hill Gravel Member - Sand And Gravel	Sand And Gravel
2	0.0	On Site	LASI-CZ	Langley Silt Member - Silty Clay	Clay, Silty
3	53.0	NE	LASI-CZ	Langley Silt Member - Silty Clay	Clay, Silty

This Geology shows the main components as discrete layers, these are: Artificial / Made Ground, Superficial / Drift Geology and Landslips. These are all displayed with the BGS Lexicon code for the rock unit and BGS sheet number. Not all of the main geological components have nationwide coverage.

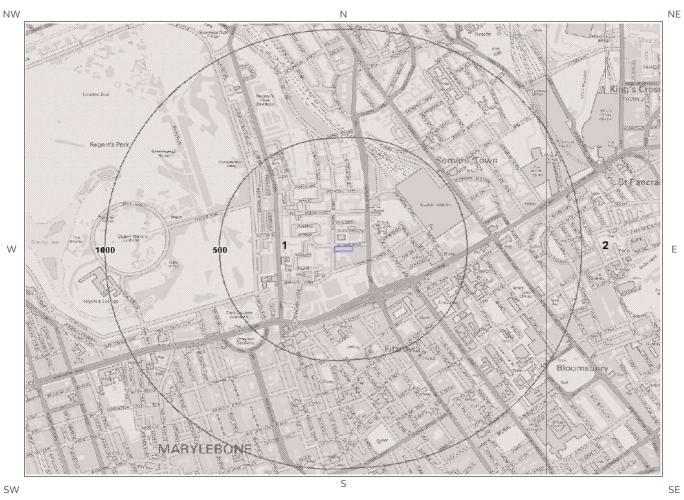
1.3 Bedrock and linear features map (1:10,000 scale)

ID	Distance (m)	Direction	LEX Code	Description	Rock Age
1	0.0	On Site	LC-CLAY	London Clay Formation - Clay	Eocene Epoch

This Geology shows the main components as discrete layers, these are: Bedrock/ Solid Geology and linear features such as faults. These are all displayed with the BGS Lexicon code for the rock unit and BGS sheet number. Not all of the main geological components have nationwide coverage.

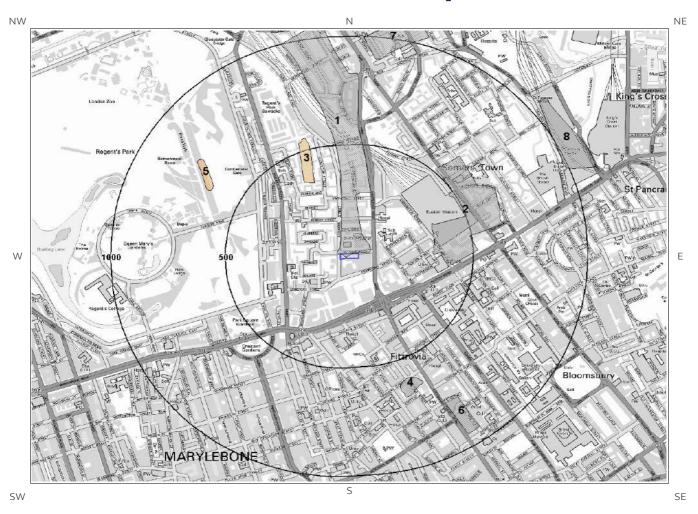
2 Geology 1:50,000 Scale2.1 Artificial Ground map

ID	Distance (m)	Direction	LEX Code	Description	Rock Description
1	0.0	On Site	WGR-VOID	WORKED GROUND (UNDIVIDED)	VOID
2	329.0	E	WGR-VOID	WORKED GROUND (UNDIVIDED)	VOID
3	347.0	N	MGR-ARTDP	MADE GROUND (UNDIVIDED)	ARTIFICIAL DEPOSIT

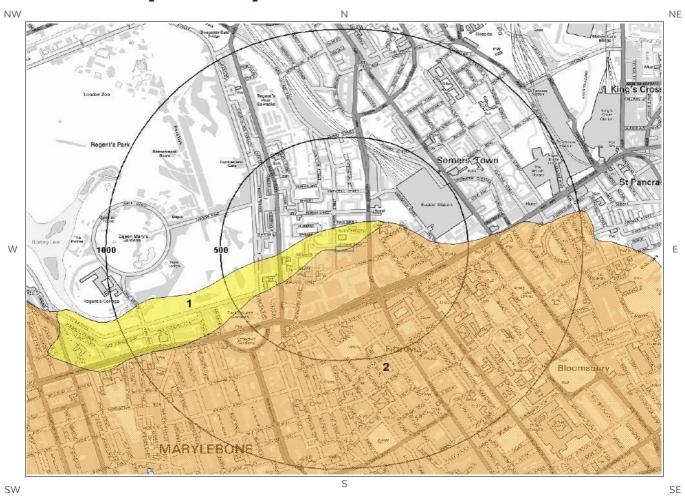
2.2 Superficial Deposits and Landslips map (1:50,000 scale)

ID	Distance	Direction	LEX Code	Description	Rock Description
1	0.0	On Site	LASI-XCZ	LANGLEY SILT MEMBER	CLAY AND SILT
2	0.0	On Site	LHGR-XSV	LYNCH HILL GRAVEL MEMBER	SAND AND GRAVEL

Distance (m)	Direction	Flow Type	Maximum Permeability	Minimum Permeability
0.0	On Site	Intergranular	Very High	High
0.0	On Site	Mixed	Low	Very Low

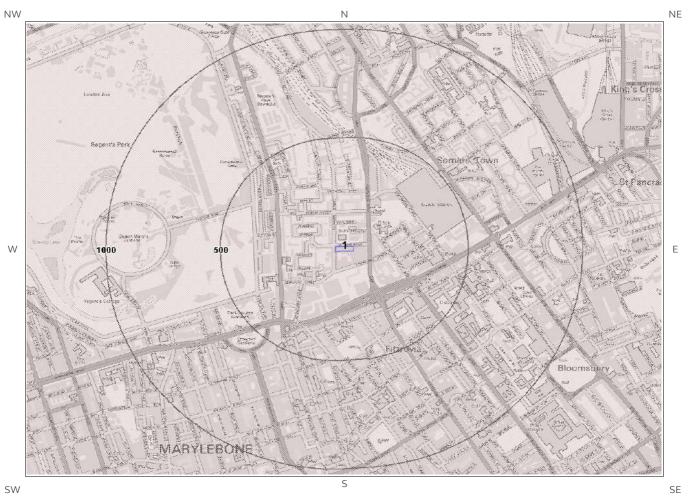
2.3 Bedrock and linear features map (1:50,000 scale)

ID	Distance	Direction	LEX Code	Rock Description	Rock Age
1	0.0	On Site	LC-XCZS	LONDON CLAY FORMATION - CLAY, SILT AND SAND	YPRESIAN

Distanc e	Direction	Flow Type	Maximum Permeability	Minimum Permeability
0.0	On Site	Mixed	Moderate	Very Low

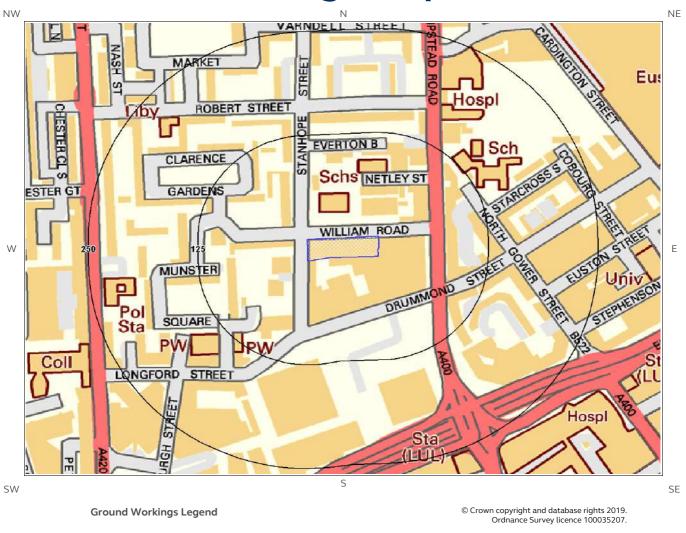
4 Ground Workings map

ID	Distance (m)	Direction	NGR	Use	Date
Not shown	976.0	NE	529982 183101	Tunnel	1894

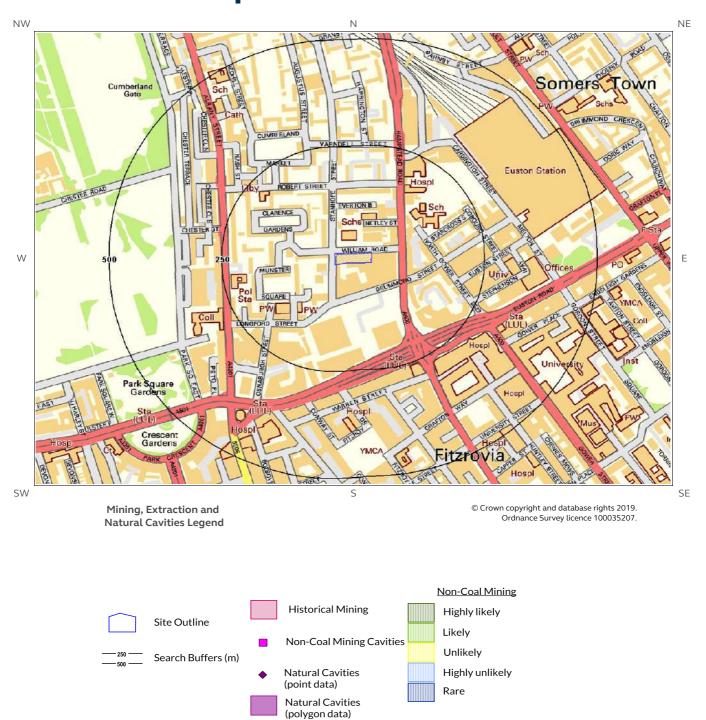
5 Mining, Extraction & Natural Cavities map

This dataset provides information based on the Peter Brett Associates natural cavities database. The dataset is made up of points and polygons. Where polygons are used these represent an area in which it is expected the cavities could be found. It does not indicate that cavities are present everywhere within the polygon, and caution should be used in the interpretation of this data.

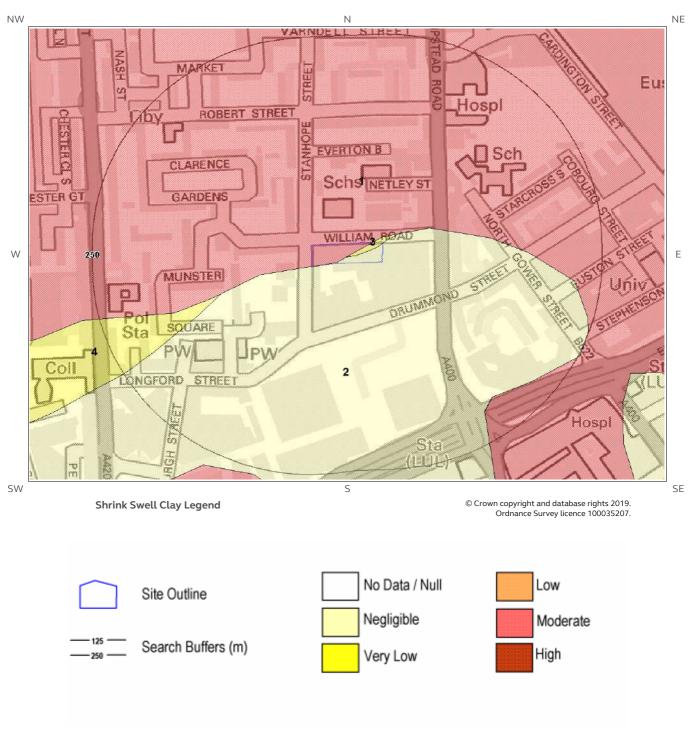
6 Natural Ground Subsidence6.1 Shrink-Swell Clay map

ID	Distance (m)	Direction	Hazard Rating	Details
1	0.0	On Site	Moderate	Ground conditions predominantly high plasticity. Do not plant or remove trees or shrubs near to buildings without expert advice about their effect and management. For new build, consideration should be given to advice published by the National House Building Council (NHBC) and the Building Research Establishment (BRE). There is a probable increase in construction cost to reduce potential shrink-swell problems. For existing property, there is a probable increase in insurance risk during droughts or where vegetation with high moisture demands is present.
2	0.0	On Site	Negligible	Ground conditions predominantly non-plastic. No special actions required to avoid problems due to shrink-swell clays. No special ground investigation required, and increased construction costs or increased financial risks are unlikely likely due to potential problems with shrink-swell clays.

3	0.0	On Site	Very Low	Ground conditions predominantly low plasticity. No special actions required to avoid problems due to shrink-swell clays. No special ground investigation required, and increased construction costs or increased financial risks are unlikely due to potential problems with shrink-swell clays.

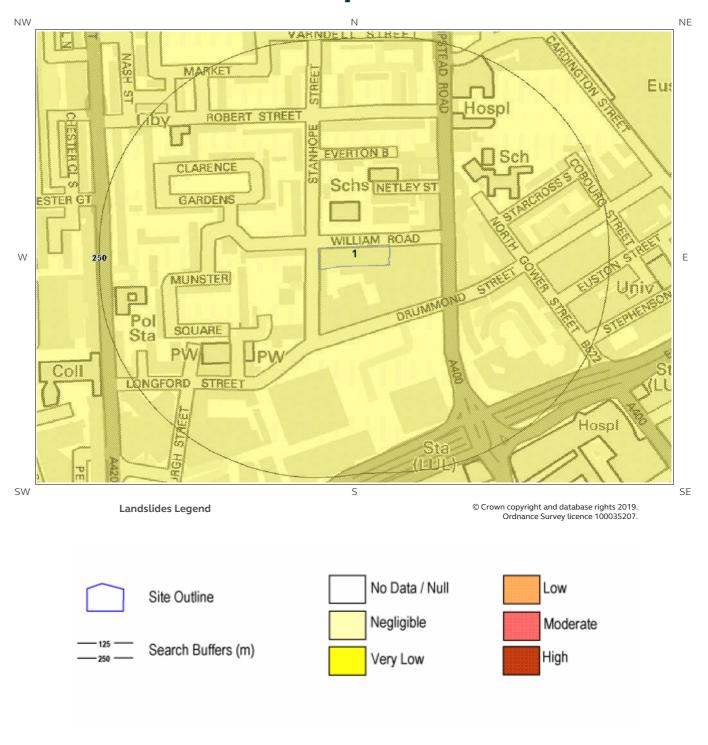
6.2 Landslides map

ID	Distance (m)	Direction	Hazard Rating	Details
1	0.0	On Site	Very Low	Slope instability problems are unlikely to be present. No special actions required to avoid problems due to landslides. No special ground investigation required, and increased construction costs or increased financial risks are unlikely due to potential problems with landslides.

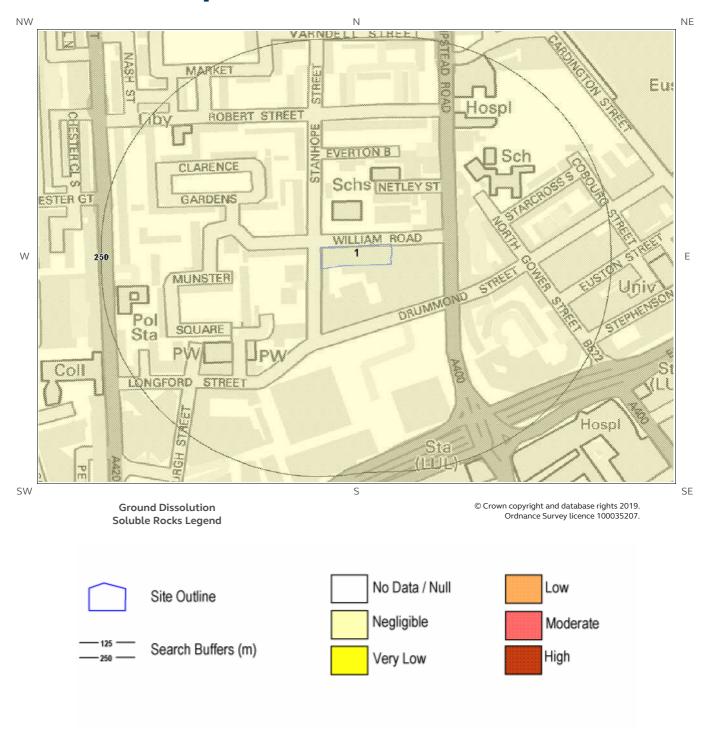
6.3 Ground Dissolution of Soluble Rocks map

ID	Distance (m)	Direction	Hazard Rating	Details
1	0.0	On Site	Negligible	Soluble rocks are present, but unlikely to cause problems except under exceptional conditions. No special actions required to avoid problems due to soluble rocks. No special ground investigation required, and increased construction costs or increased financial risks are unlikely due to potential problems with soluble rocks.

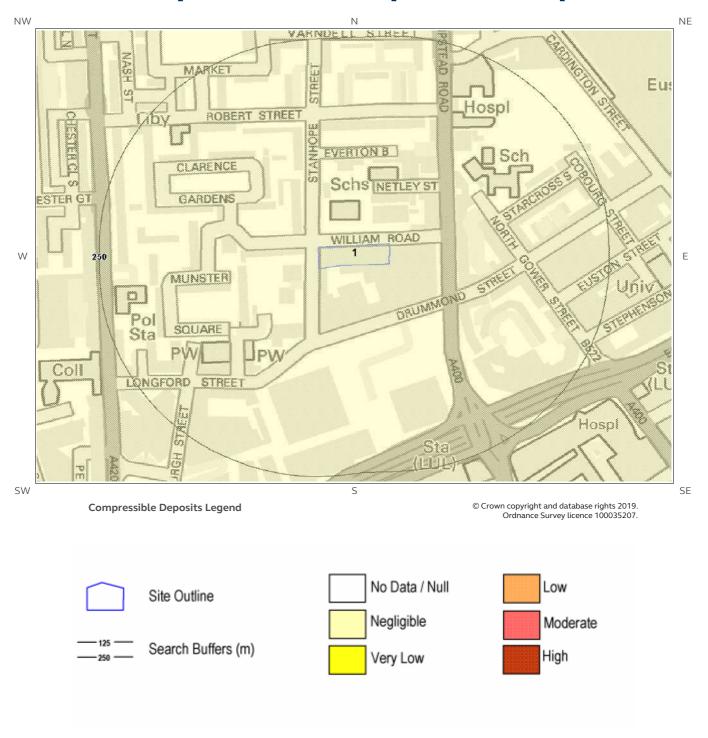
6.4 Compressible Deposits map

ID	Distance (m)	Direction	Hazard Rating	Details
1	0.0	On Site	Negligible	No indicators for compressible deposits identified. No special actions required to avoid problems due to compressible deposits. No special ground investigation required, and increased construction costs or increased financial risks are unlikely due to potential problems with compressible deposits.

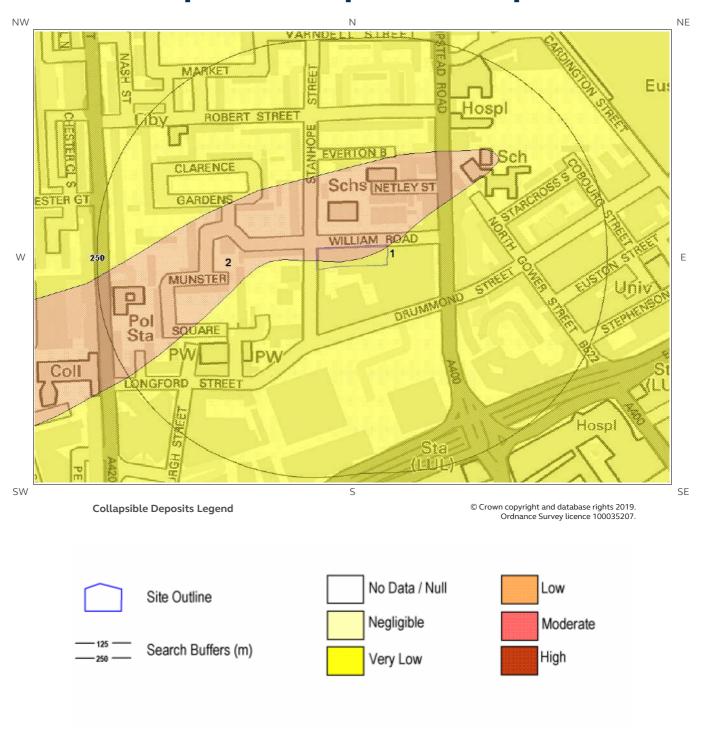
6.5 Collapsible Deposits map

ID	Distance (m)	e Direction	Hazard Rating	Details
1	0.0	On Site	Very Low	Deposits with potential to collapse when loaded and saturated are unlikely to be present. No special ground investigation required or increased construction costs or increased financial risk due to potential problems with collapsible deposits.
2	0.0	On Site	Low	Slight possibility for collapsible deposit problems after major changes in loading or groundwater conditions. Normal maintenance to avoid large amounts of water entering the ground through pipe leakage or soak-aways should reduce the likelihood of problems due to collapsible deposits. For new build, assess the possibility of collapsible (loessic) deposits in ground investigation. For existing property, no significant increase in insurance risk from collapsible deposits is likely.

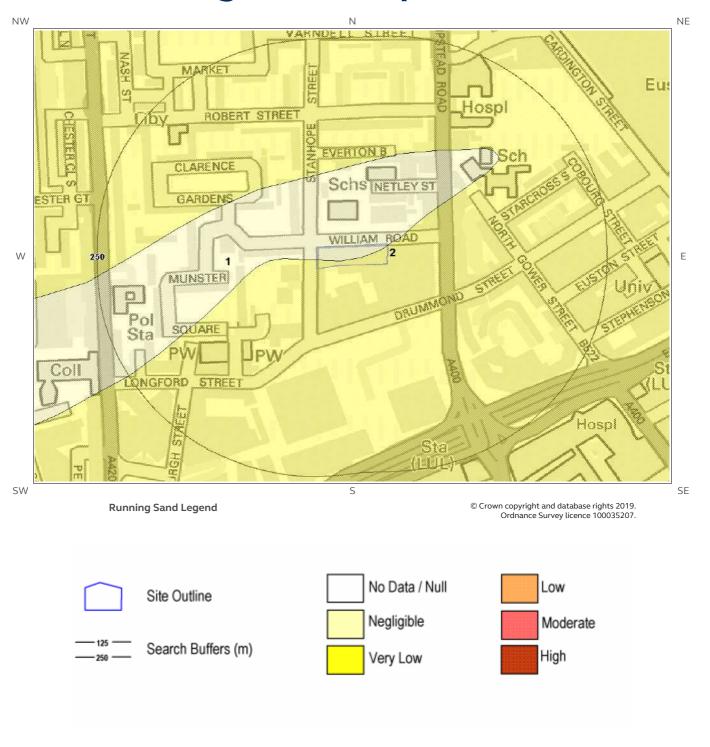
6.6 Running Sand map

ID	Distance (m)	Direction	Hazard Rating	Details
1	0.0	On Site	Negligible	No indicators for running sand identified. No special actions required to avoid problems due to running sand. No special ground investigation required, and increased construction costs or increased financial risks are unlikely due to potential problems with running sand.
2	0.0	On Site	Very Low	Very low potential for running sand problems if water table rises or if sandy strata are exposed to water. No special actions required, to avoid problems due to running sand. No special ground investigation required, and increased construction costs or increased financial risks are unlikely due to potential problems with running sand.

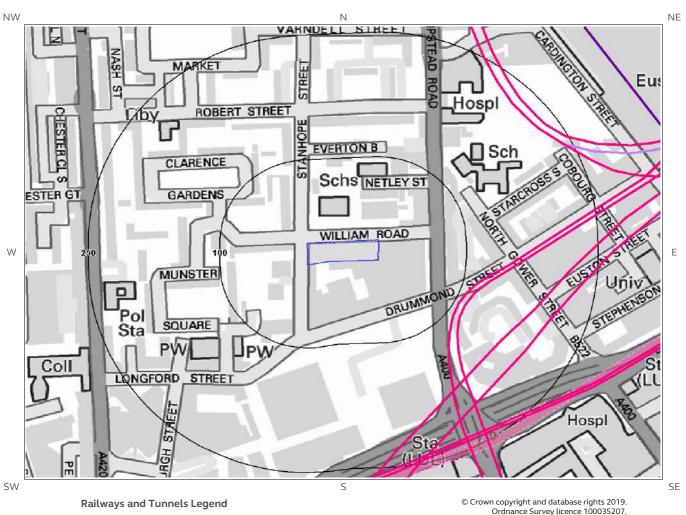
9 Railways and Tunnels map

This data is derived from OpenStreetMap and provides information on the possible locations of underground railway systems in the UK - the London Underground, the Tyne & Wear Metro and the Glasgow Subway.
