Project:
7b Belsize Park Gardens

Drawing Title:
Existing Flank Elevation

Project No. 2004	Drawing No: 311	Revision: PP1
---------------------	--------------------	------------------

Status:
Planning

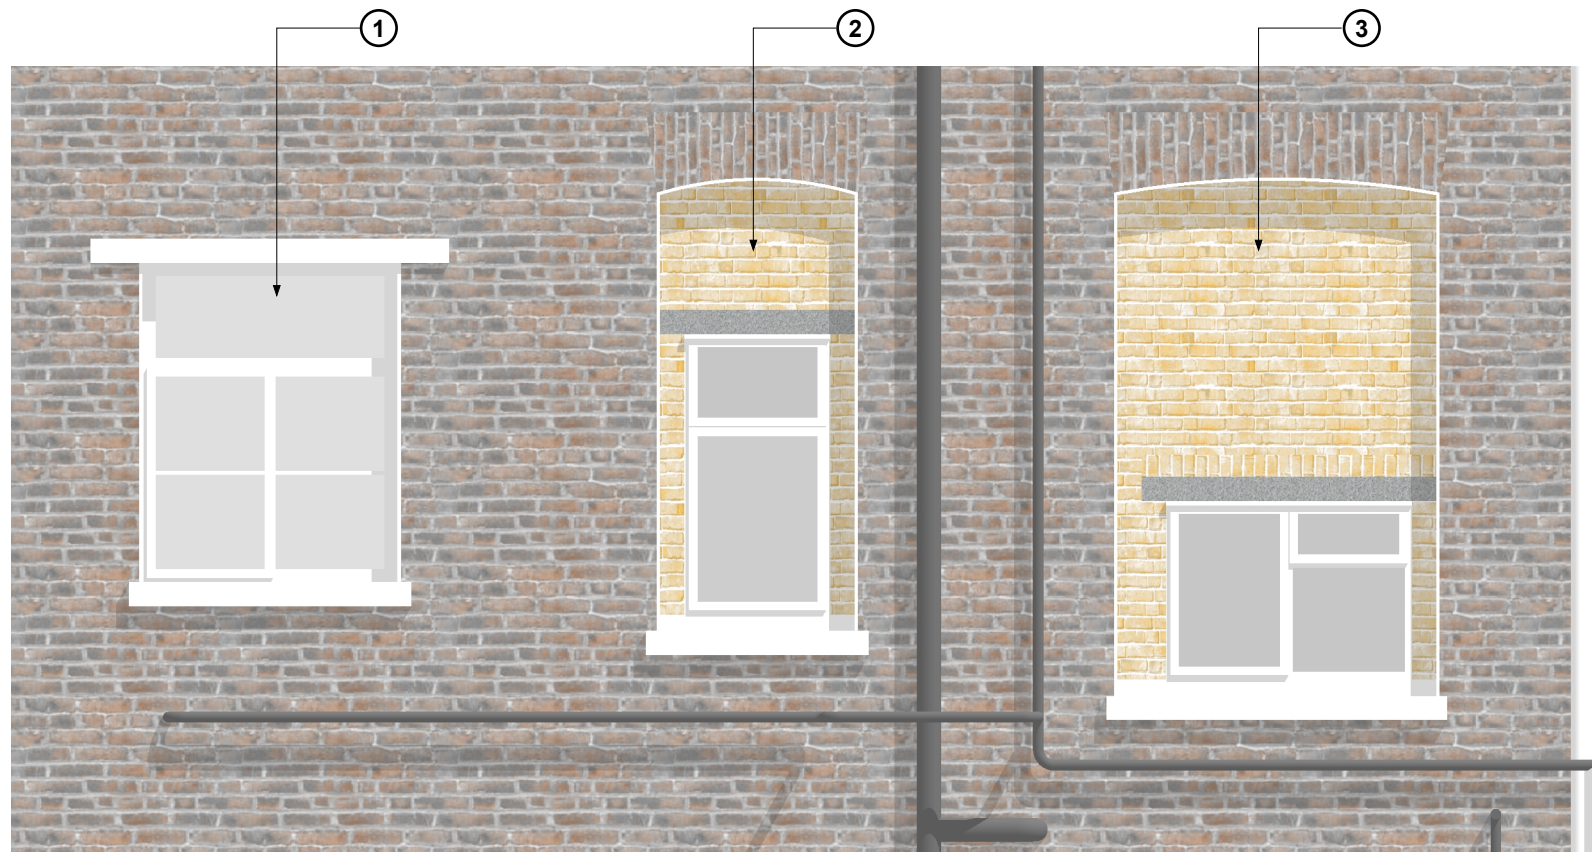
2 Existing Flank Windows

- ① Existing timber casement window
- ② Existing timber casement window with visible concrete lintel over. Window is significantly smaller than existing structural opening, with mismatched brickwork infill. Additionally, high level kitchen units run across this window, blocking potential amenity gained to the flat.
- ③ Existing timber casement window with visible concrete lintel over. Window is significantly smaller than existing structural opening, with mismatched brickwork infill.
