Pre-construction & Construction Dust Monitoring

Project: 20-23 GREVILLE STREET, LONDON

Report reference: CM01-20443

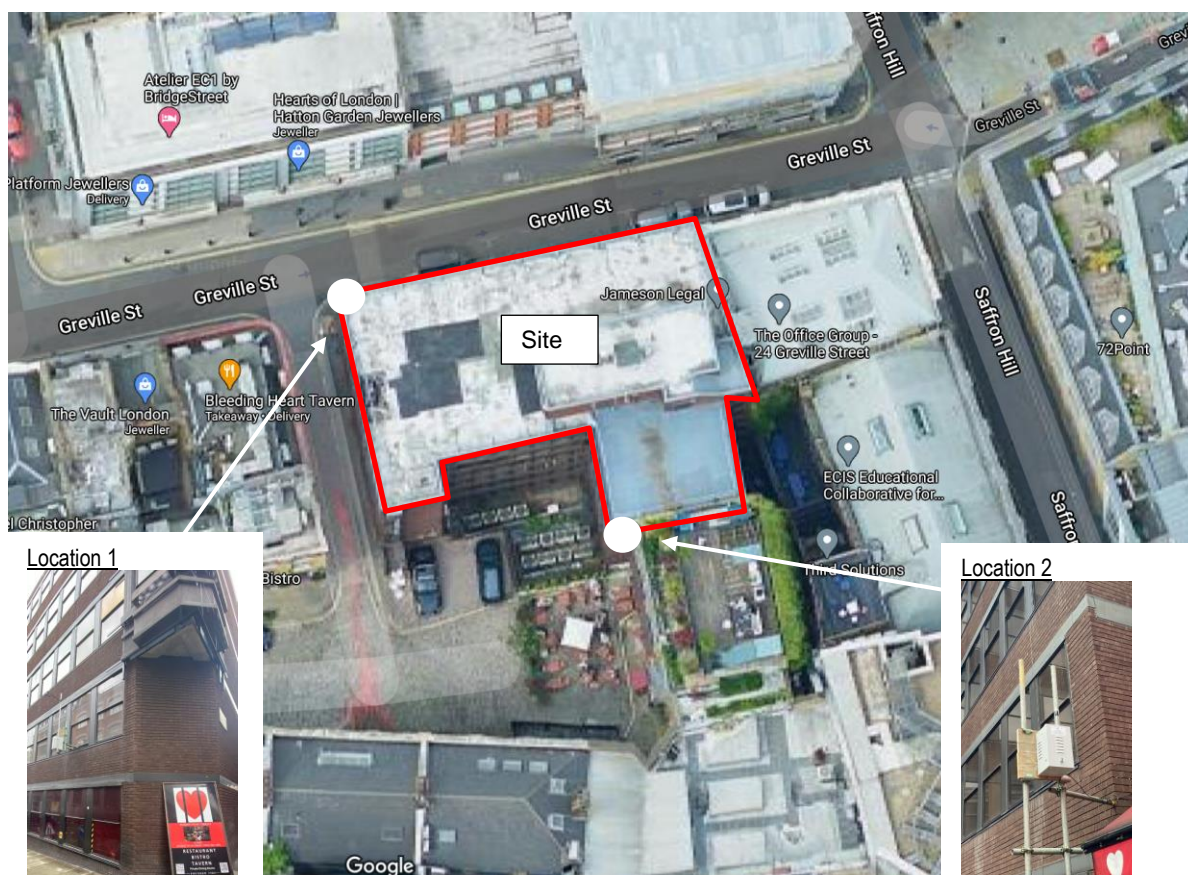
Figure 1 Construction Monitoring Locations

2.1 Two MCERTS [dust monitoring systems](#) are installed along the north-west and south-east site boundaries, as per the requirements of the project air quality monitoring plan prepared by Hilson Moran (report reference 28477-RP-SU-001 dated 3 June 2020). Camden Council expressed concerns regarding the siting of these monitoring units and this is discussed in further detailed in our letter report LR01-20443 dated 6 October 2020, included within Appendix 3 of this report. The monitoring positions were relocated on 30th September and the current positions are shown in Figure 1 below.

- The dust monitoring units are fixed to temporary scaffolding at least 0.5m in front of the facade of the building at approximately first floor level (4m above local ground level) to minimise obstructions affecting the airflow in the vicinity of the sampler and to prevent any risk of it being tampered with at street level below.

- An anemometer has been installed on the dust monitoring unit at Location 1. This will collect local wind speed and direct data impacting the site and its surroundings. An anemometer will also be installed at Location 2 w/c 16th November 2020 once the permanent monitor for Location 1 is returned from the manufacturer.

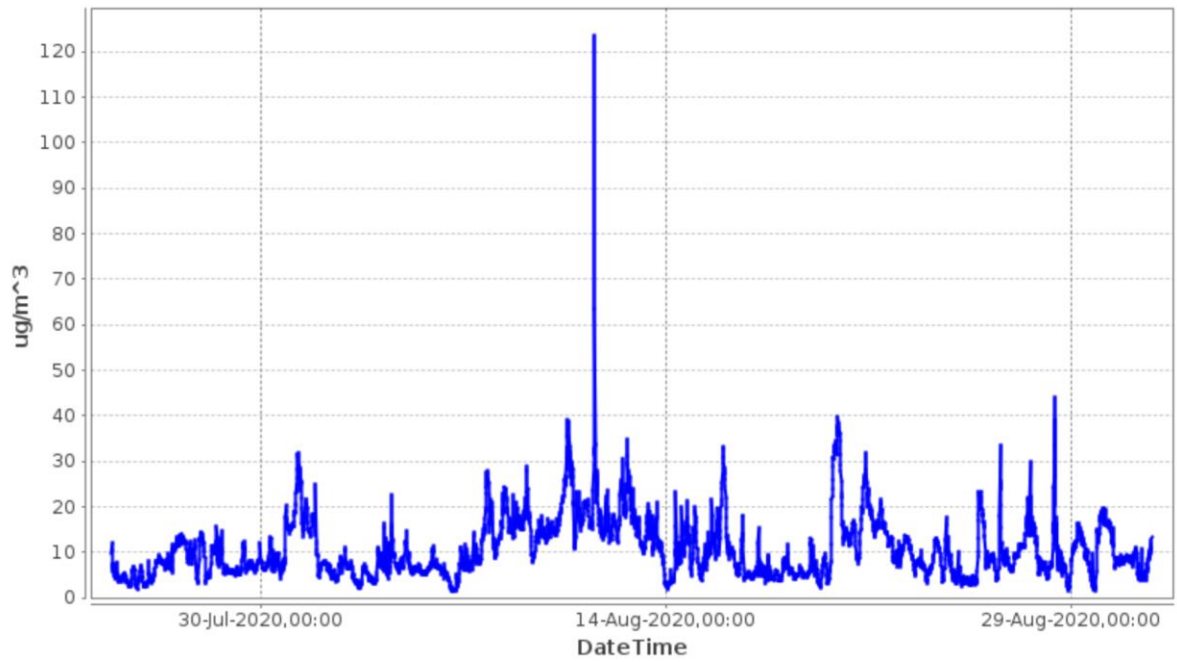
Location 2 – South-east corner of site

- Dust trigger level, 150 $\mu\text{g m}^{-3}$ 15-minute mean for PM10 concentrations
- Dust action level, 250 $\mu\text{g m}^{-3}$ 15-minute mean for PM10 concentrations
- Dust level, $\mu\text{g m}^{-3}$ 15-minute mean for PM10 concentrations

Average PM10 level during monitoring period – 11 $\mu\text{g/m}^3$

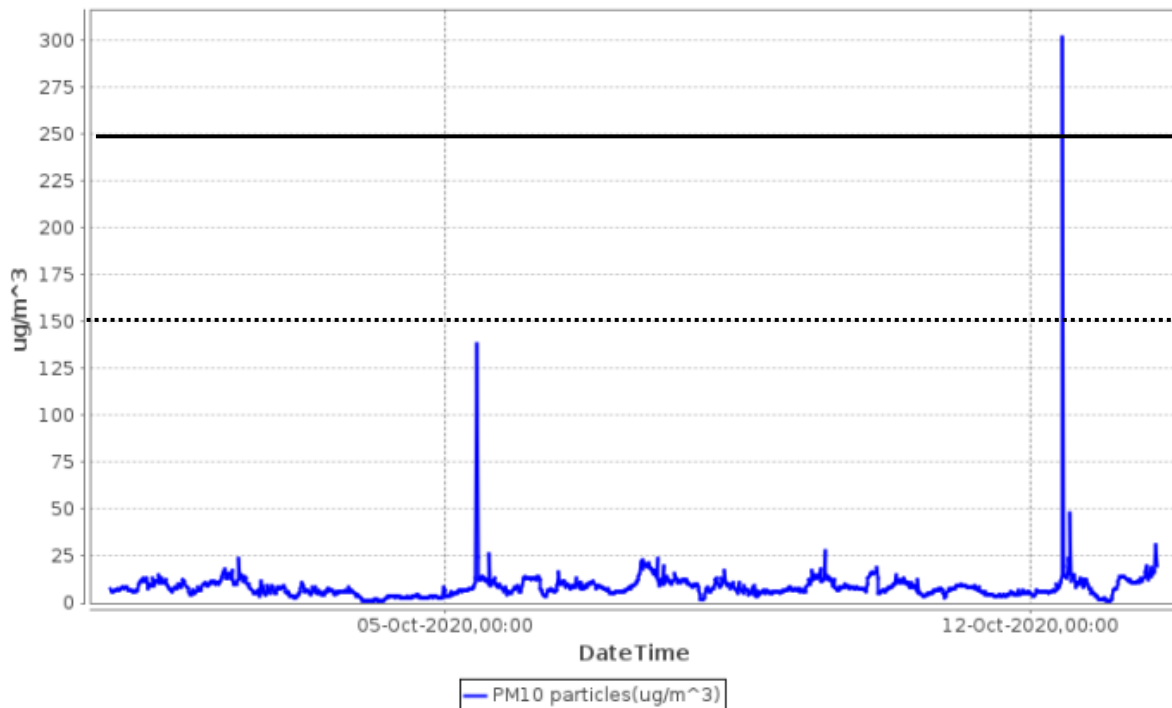
Location 1 – North-west corner of site

- Dust trigger level, $150 \mu\text{g m}^{-3}$ 15-minute mean for PM10 concentrations
- Dust action level, $250 \mu\text{g m}^{-3}$ 15-minute mean for PM10 concentrations
- PM10 particles($\mu\text{g m}^{-3}$)

Average PM10 level during monitoring period (1st October to 13th October) – $9 \mu\text{g m}^{-3}$

Unfortunately, the monitor stopped working on 13th October unexpectedly and no data was recorded between midday on the 13th October until 11:15 hours on 27th October when a temporary replacement unit was installed whilst the permanent monitor is fixed by the equipment manufacturer.

It is understood that the replacement monitor will be shipped from the manufacturer w/c 9th November until the clients dust monitor is repaired under warranty.

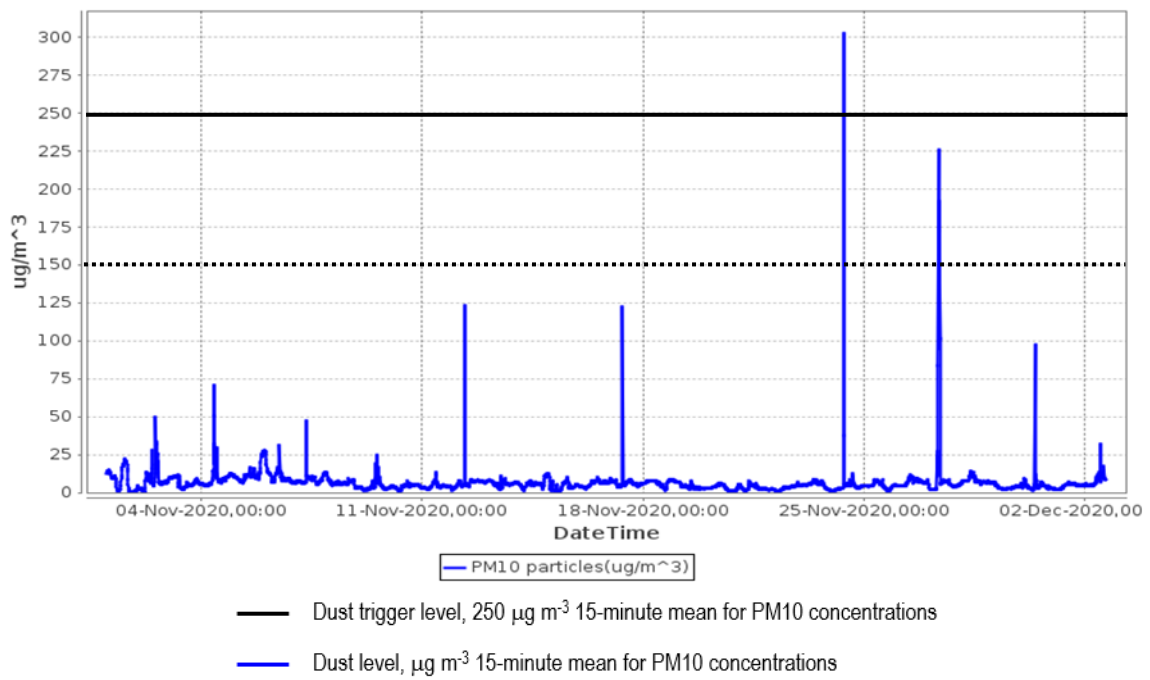
Location 1 – North-west corner of site

Average PM10 level during monitoring period – 7 $\mu\text{g/m}^3$

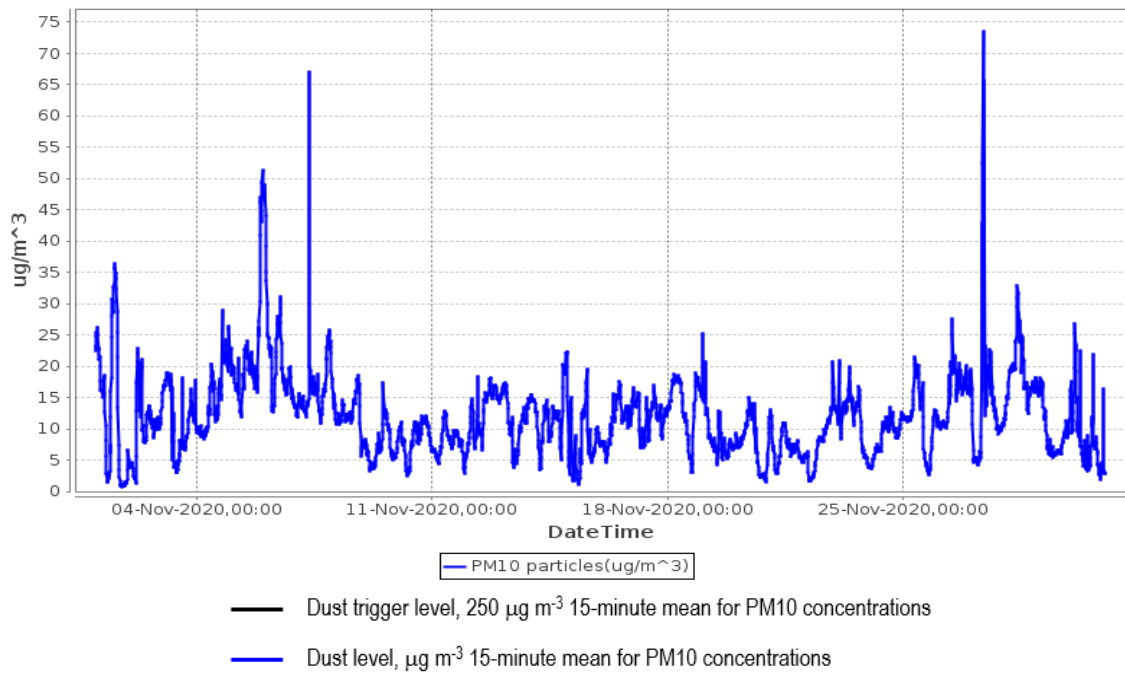
Location 2 – South-east corner of site

Average PM10 level during monitoring period – 12 $\mu\text{g/m}^3$
