PM₁₀ Monitoring Report
(April 2020)

115 – 119 Camden High Street

May 2020

Project no.	Project
9571.S	115 – 119 Camden High Street

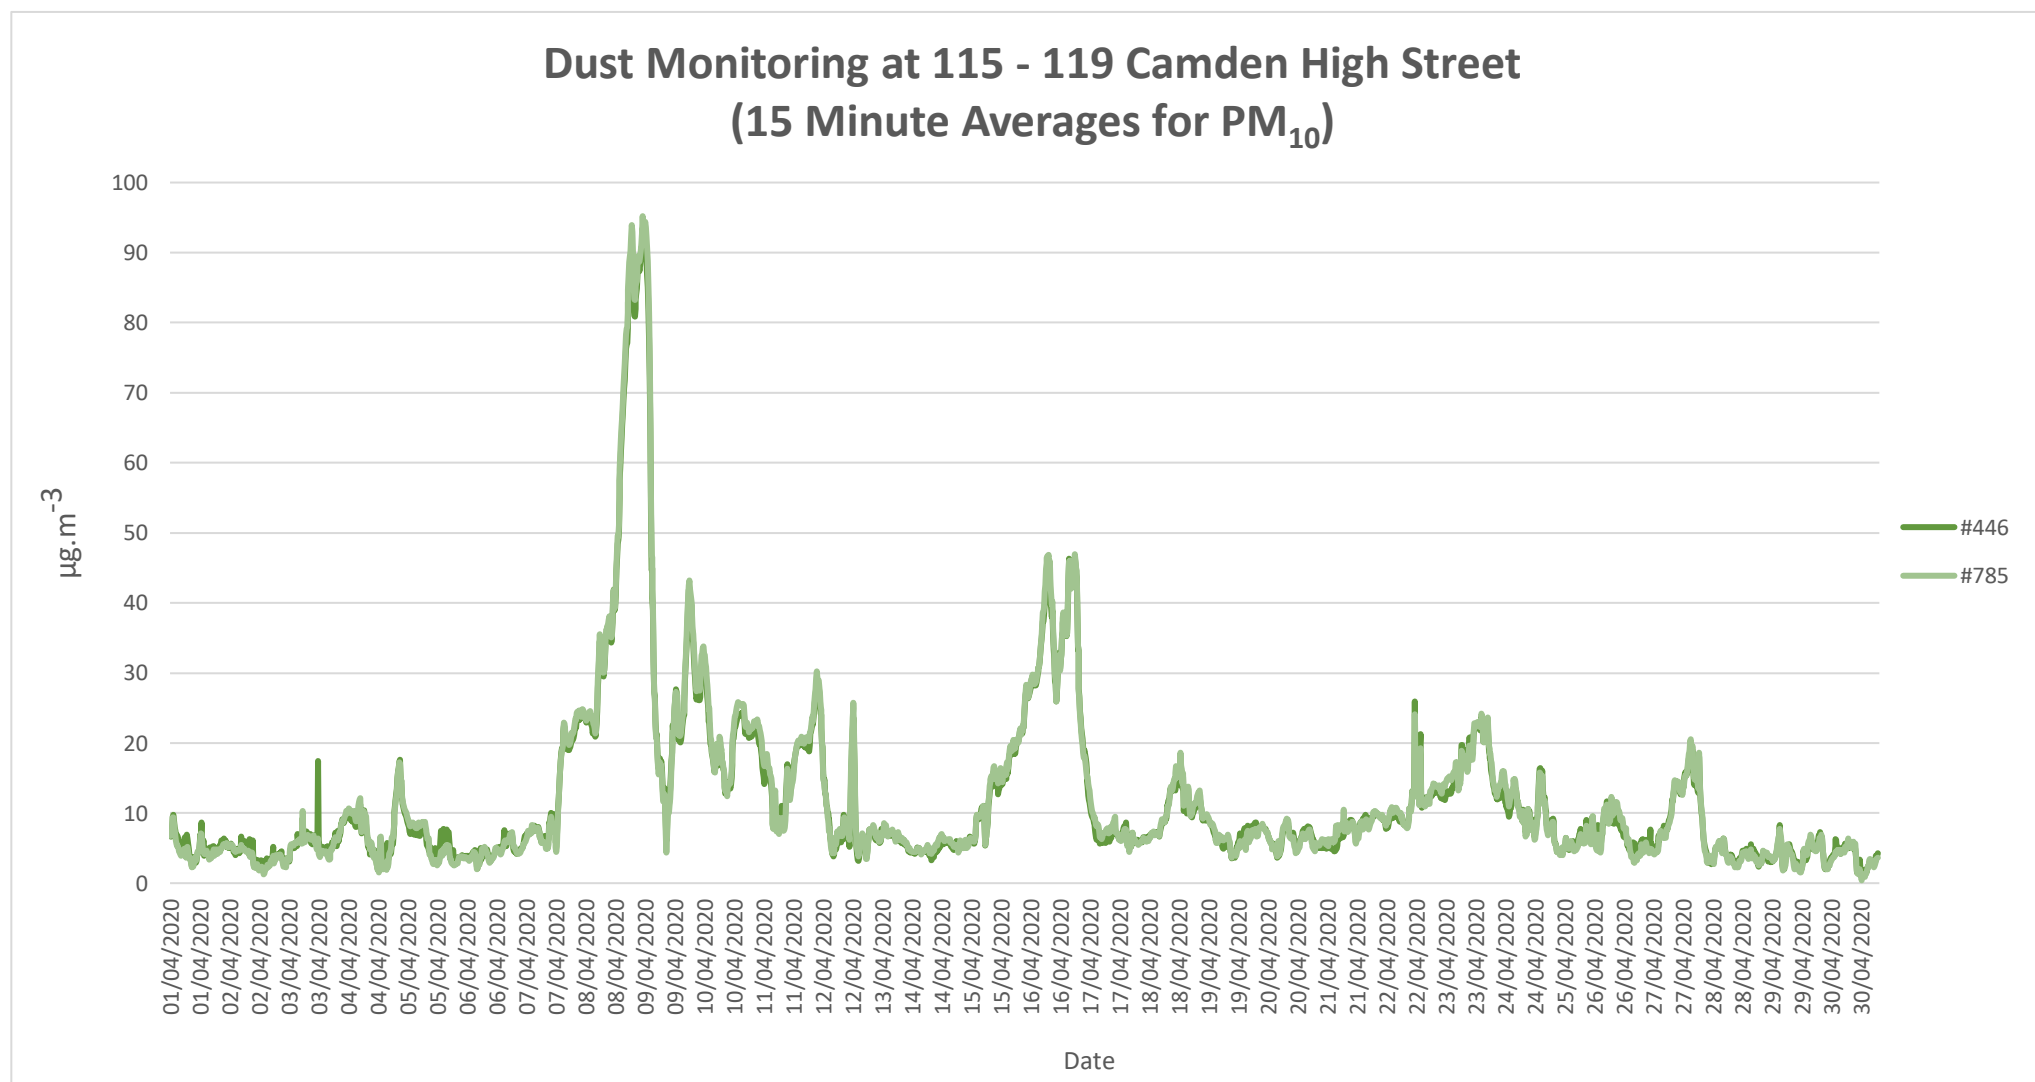
Graph 1: 15-minute mean time-series

- 3.5 Graph 1 toward the end of this report provides the 15-minute average PM₁₀ time-series for the monitoring period. It shows that there are no exceedances of either the 'Warning' or 'Action' trigger levels and there is good agreement in the trendline for both monitors which suggests there are no significant localised dust sources in close proximity to either monitor.
- 3.6 Graph 2 toward the end of this report provides the 1-hour average PM₁₀ time-series for the monitoring period. Again, it shows that there are no exceedances of the 'Action' trigger level and there is good agreement in the trendline for both monitors.
