**CONDITION LBC 4 - Council Chamber access and nosings ref: 2019/6283/L**

ISSUE	DATE	DRAWN	CHECKED	DESCRIPTION
<b>DRAWING TITLE</b>	GA PLAN PROPOSED BASEMENT LEVEL PLAN			
<b>DRAWING NO.</b>	CTH-PUR-MP-B0-DR-A-92000 NMA REV			
<b>REVISION</b>	P00			
<b>SIZE &amp; SCALE</b>	A1L 1:200 @A1			
<b>DRAWING STATUS</b>	S0 - Work In Progress

<b>PROJECT</b>	Camden Town Hall	
<b>JOB NUMBER</b>	238664

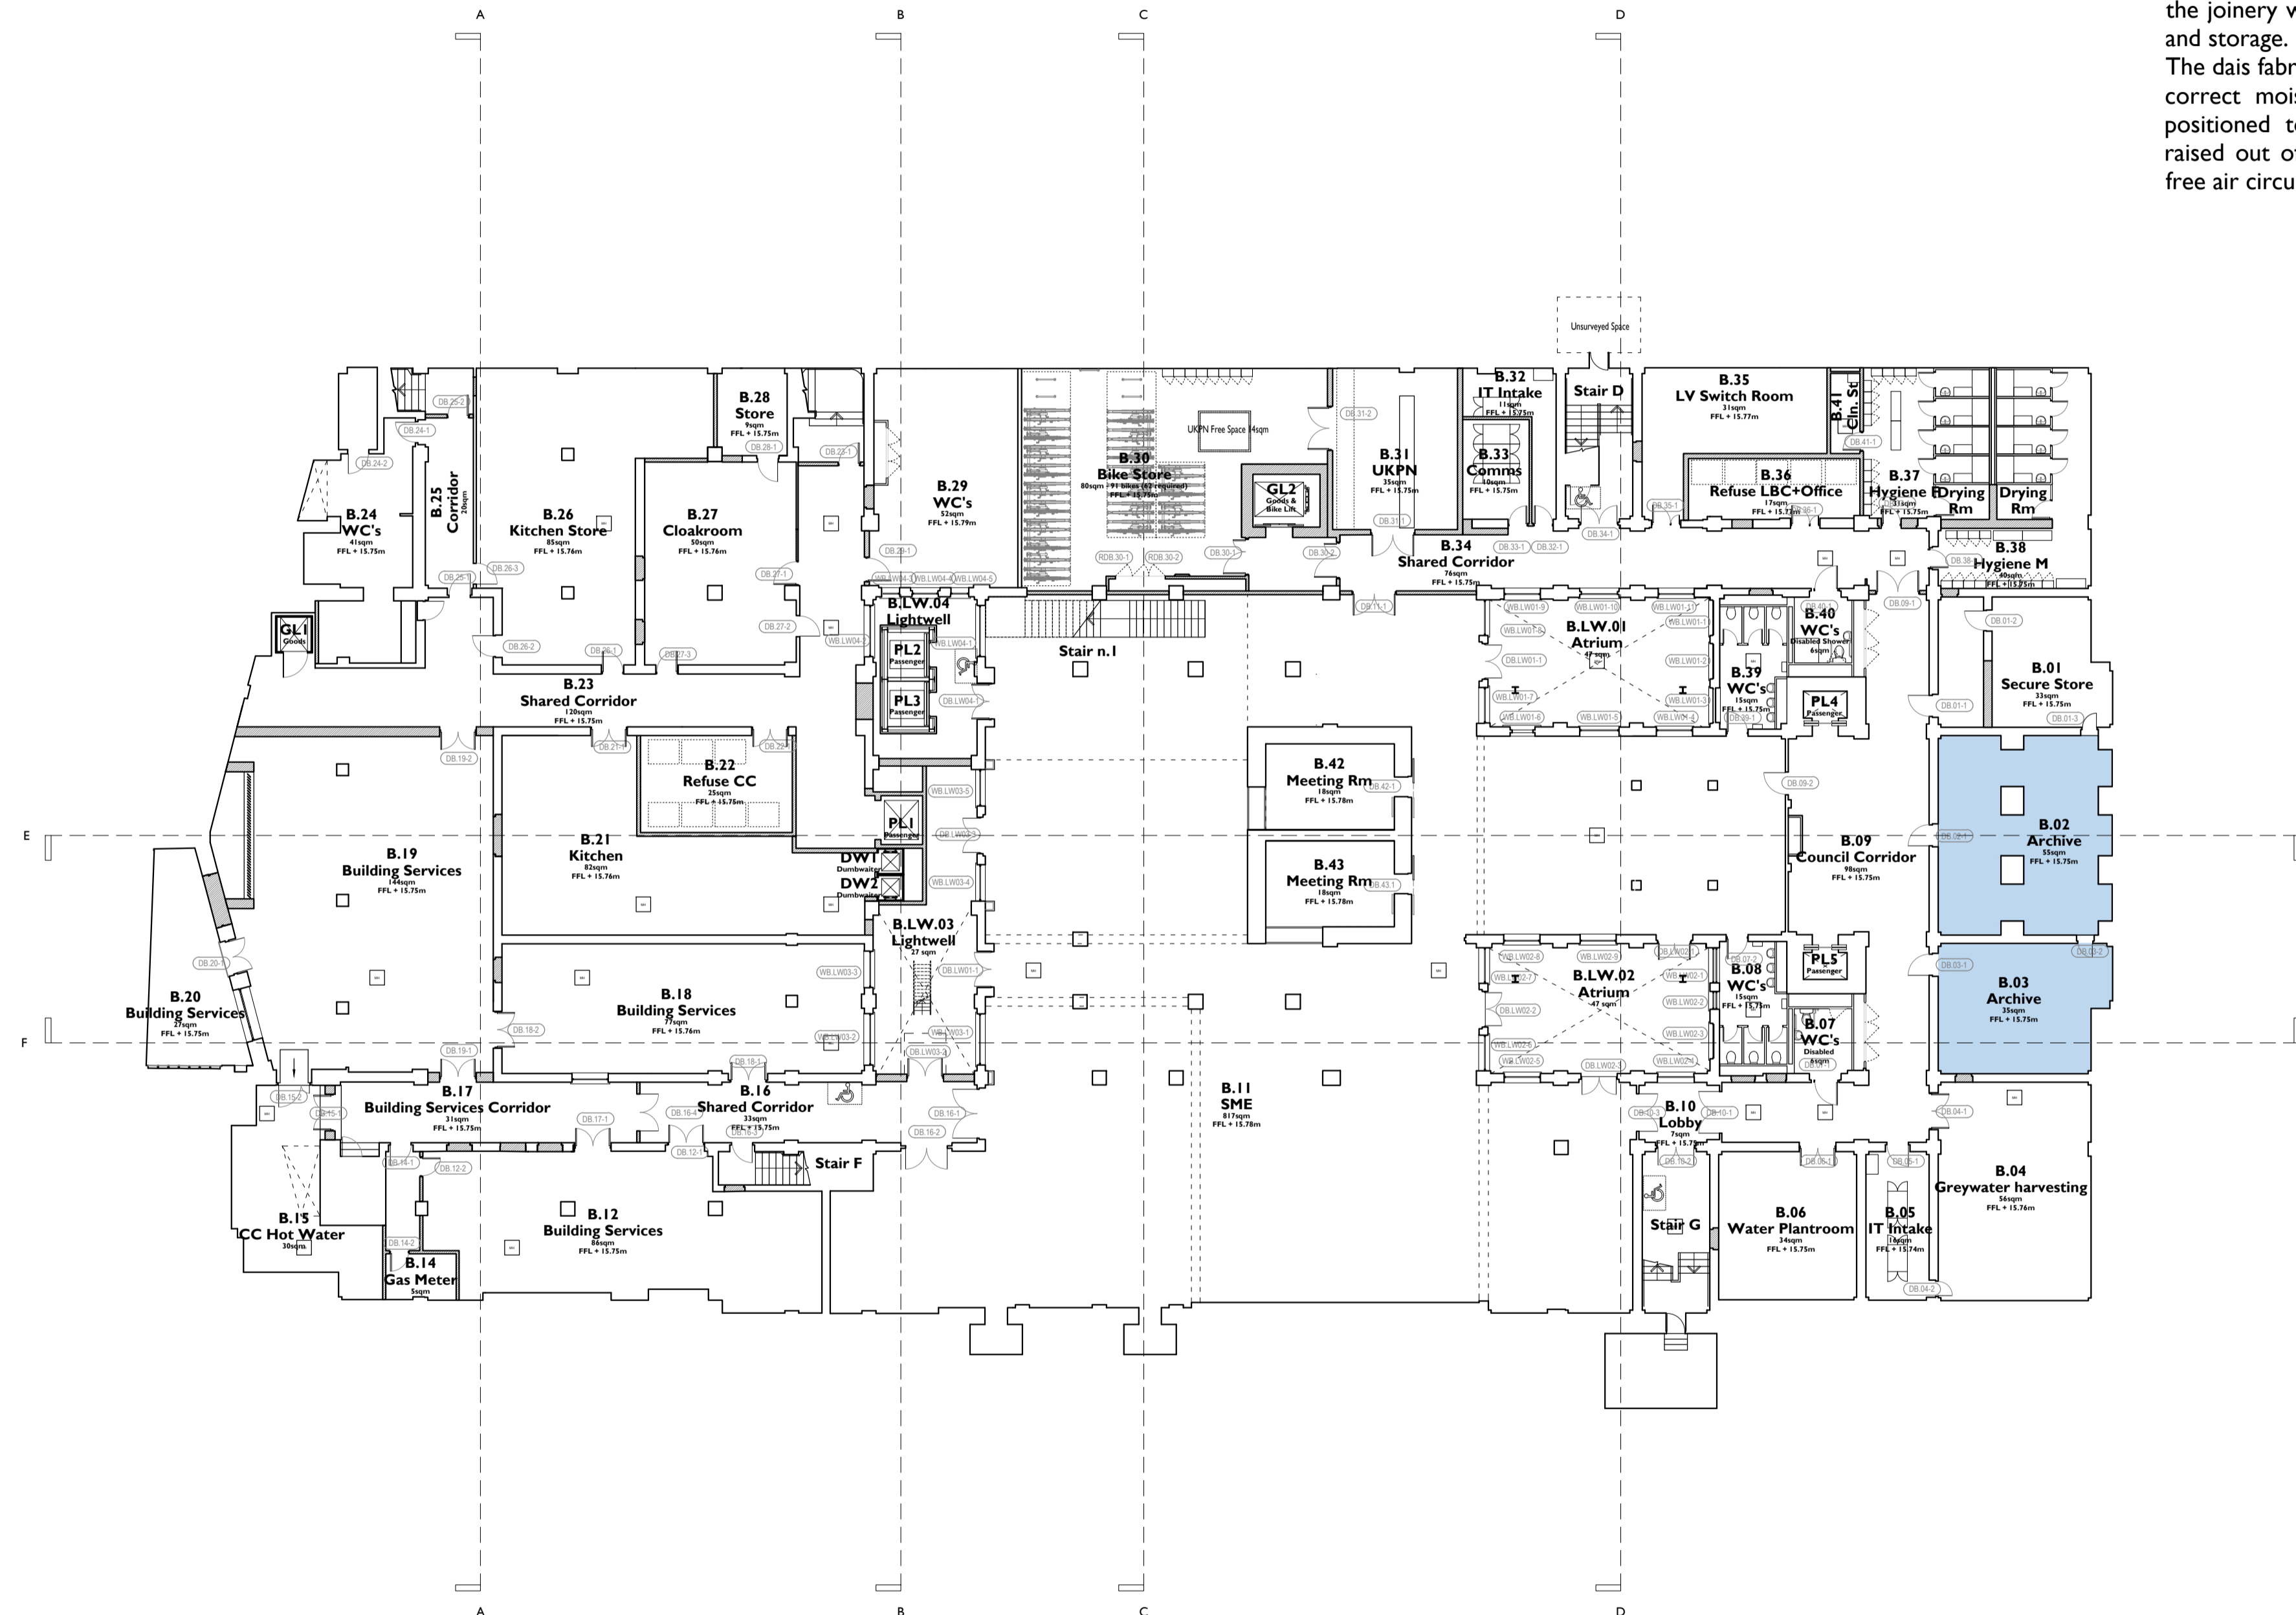
Store rooms designated for the storage of fabric removed from the dais within the Council Chamber

For the fabric removal itself, various hand tools will be used to remove panels without damaging the existing joinery, each section will be catalogued and labelled to where the item came from and a unique reference given to that item, once removed the joinery will be protected and labelled up ready for removal and storage.

The dais fabric will be kept in a heated dry store to maintain the correct moisture content. They will be stacked on bearers positioned to provide adequate support. The fabric will be raised out of contact with the ground and covered - allowing free air circulation.
