Project
 26 Leighton Road, London
 NW5 2QE

TENDER			
Drawing Title Specification for remedial works to front portico			
E+M project no. 19124	Scale NTS @A3	Suitability XXX	
drawing no. 19124 Spec01.			revision -

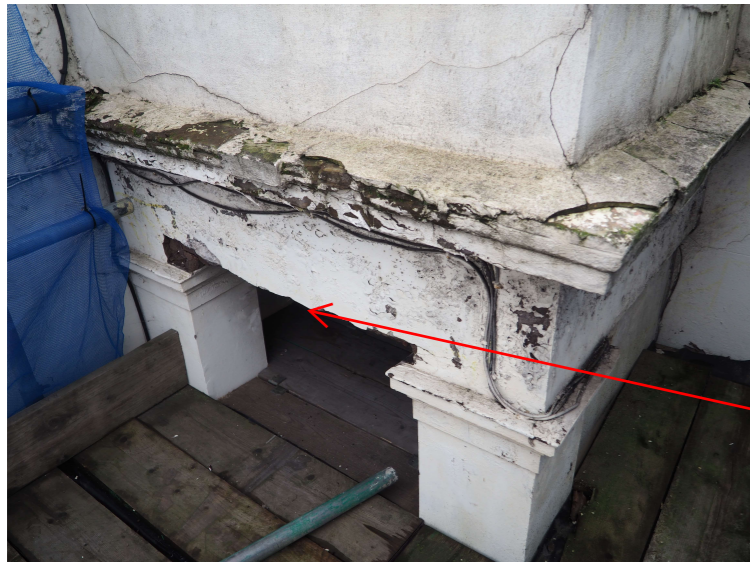
PHOTO 2: FRONT PORTICO

Location of supporting plate.

All vegetation to be removed off the portico and the mortar/ render to be made good.

Localised crack repairs to the concrete coping using a cementitious grout.

Cracks to render to be repaired in accordance to Architect's specification.
