## **Construction Dust Monitoring: St Pancras Commercial Centre, Camden**

December 2020

Report No.	Date	Status	Reviewed by
J3747A/Nov20/F1	18 December 2020	Final	Dr Denise Evans (Associate Director)

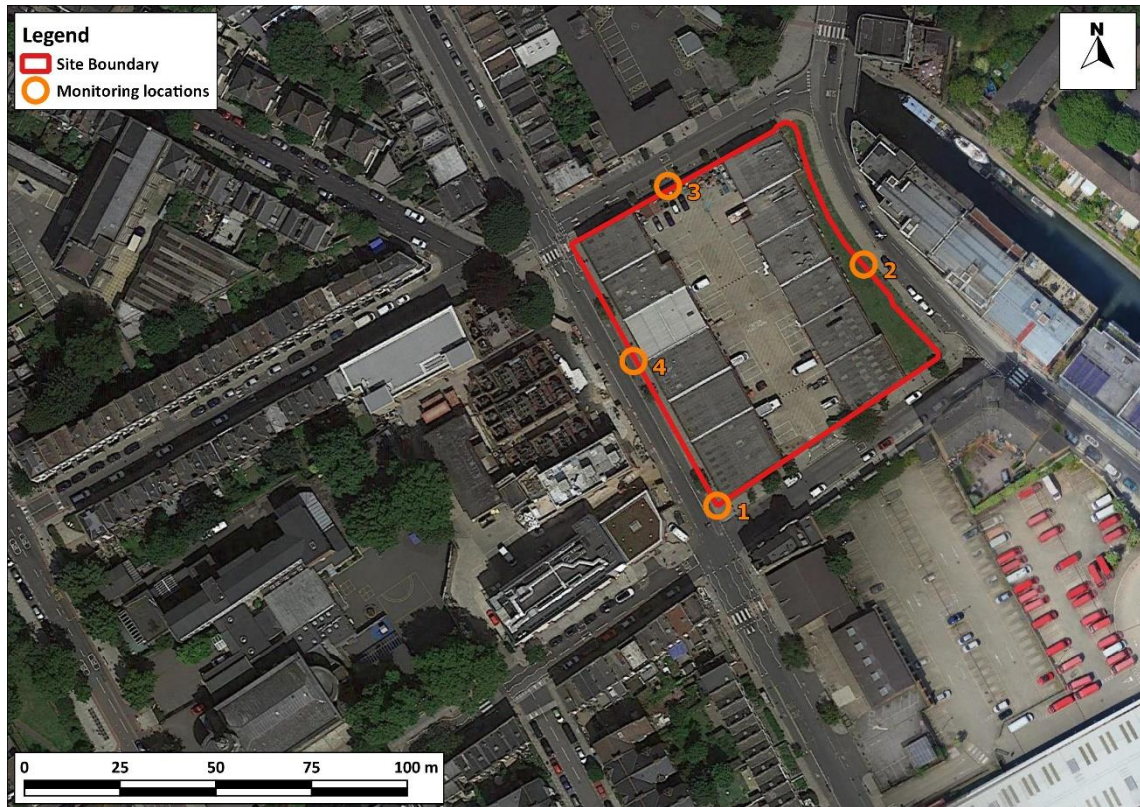
- 2.4 There are four Osiris monitors installed, the current locations of which are shown in Figure 1. Photographs of the precise locations are shown in Appendix A2. The locations of the monitors were discussed and agreed with the London Borough of Camden in November 2020 during the preparation of the Air Quality Monitoring Strategy.

**Figure 1: Dust Monitor Locations**

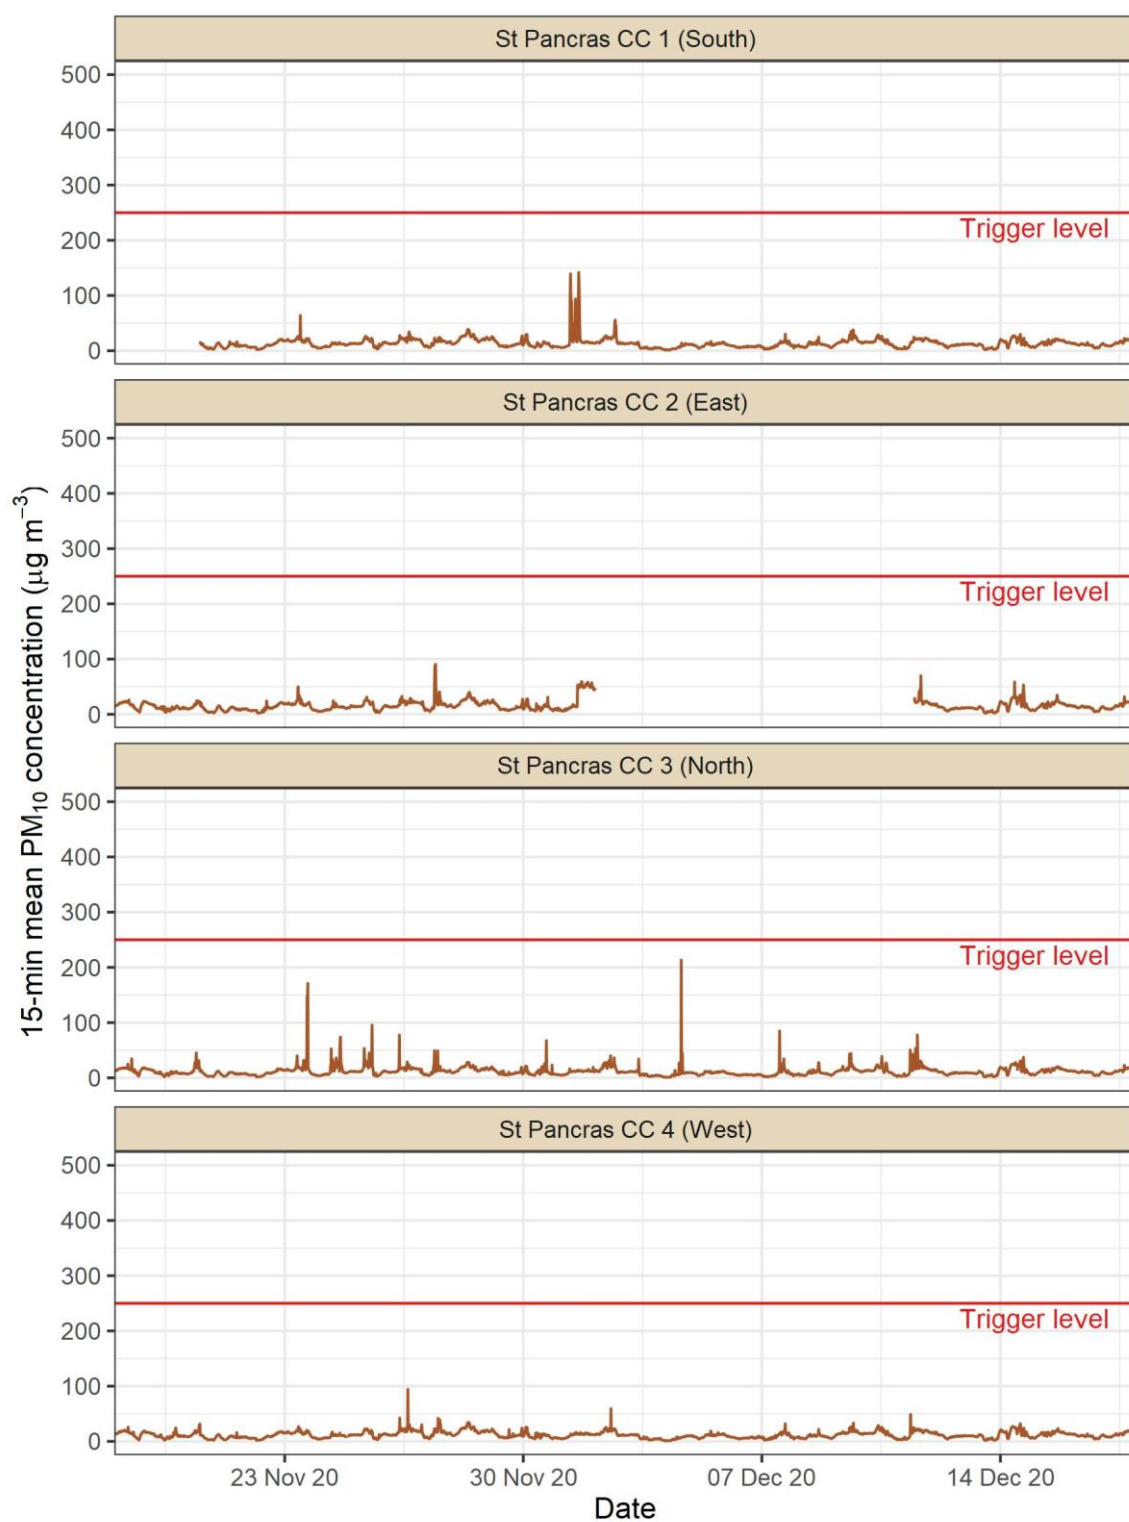
3.1 Monitoring statistics are presented in Table 1, and are shown in Figure 2 and Figure 3.

3.2 Data capture was greater than 90% at monitors 1, 3 and 4. A power supply issue (which has been resolved) resulted in approximately nine days of data loss at Monitor 2 during the assessed period. There were no exceedances of either of the PM<sub>10</sub> trigger levels at any monitor.

**Figure 3: 15-minute Mean PM<sub>10</sub> concentrations at St Pancras Commercial Centre**
