**LEVEL MONITORING - RELATIVE SURVEY READINGS**

### LEVEL MONITORING - RELATIVE MOVEMENT SKETCH

Client: Crawford & Co

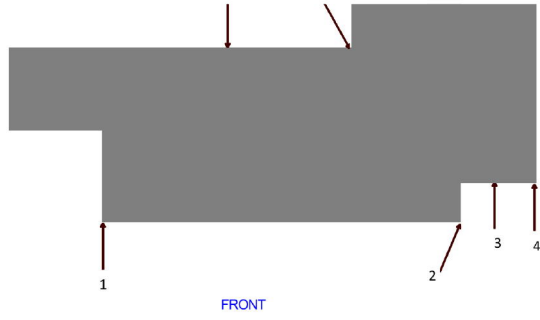
- 04/03/2021
- No new concerns raised
- It was not possible to install all stations within a common brickcourse. Therefore initial readings cannot be interpreted as

Initial readings cannot be interpreted as Distortion Data.

- Readings have been made relative to a manhole in the road. It has an assumed value of 10.0000m. If this is not appropriate, please advise if a deep datum is required?
- Further readings to be taken in April 21

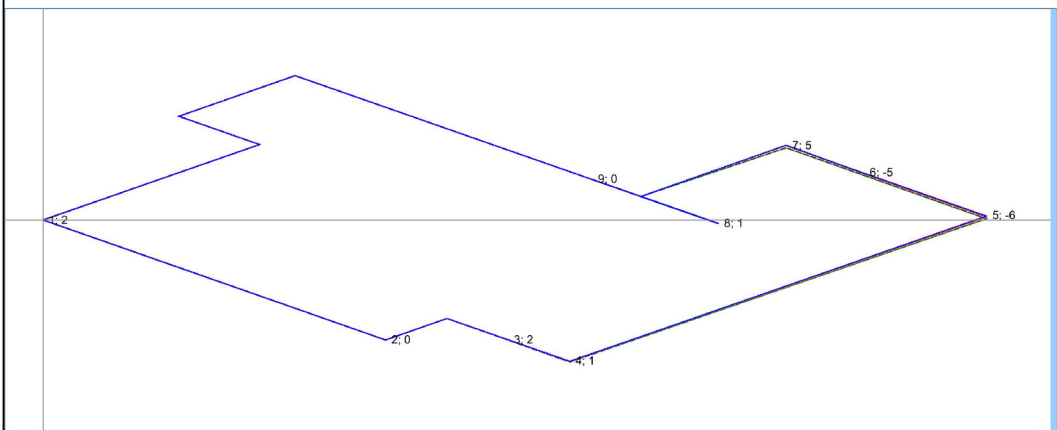
Reading 1 (14/5/20)	Reading 2 (13/8/20)	Reading 3 (1/10/20)	Reading 4 (10/11/20)	Reading 5 (2/3/21)	Reading 6 (0/1/00)
Reading 7 (0/1/00)	Reading 8 (0/1/00)	Reading 9 (0/1/00)	Reading 10 (0/1/00)	Reading 11 (0/1/00)	Reading 12 (0/1/00)

Vertical distorted scale 1: 5

Point labels give level difference of last reading from original datum in mm.

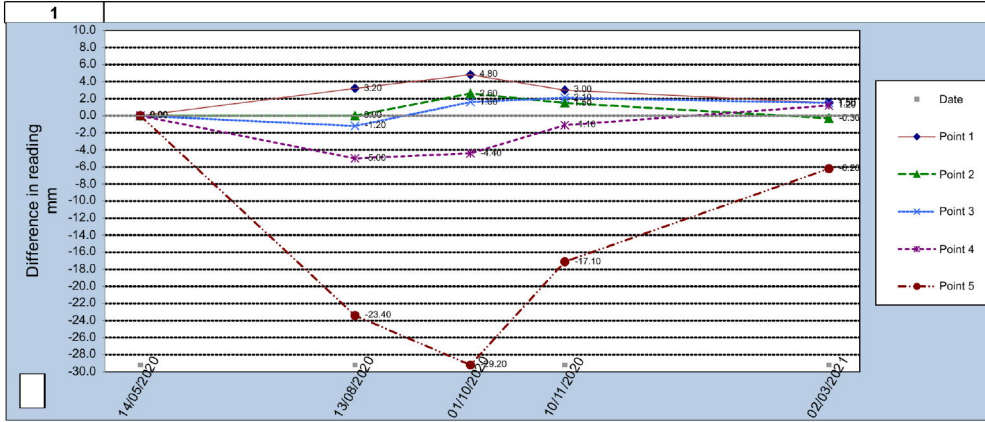
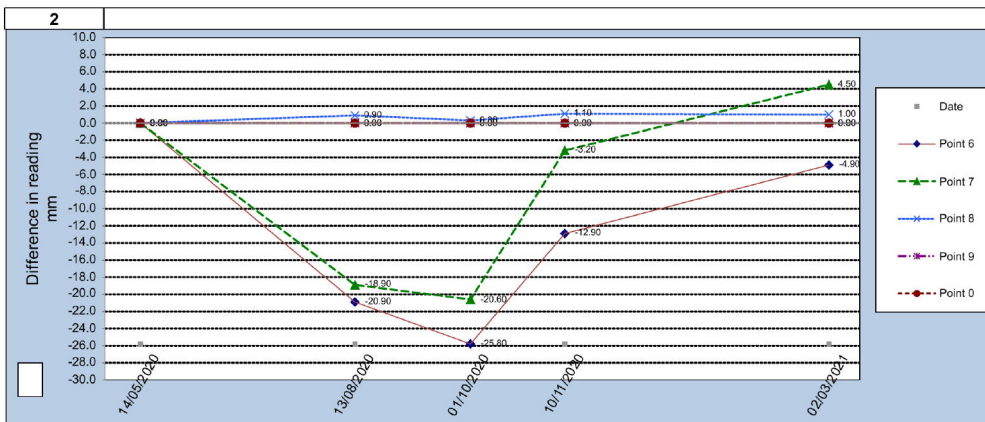
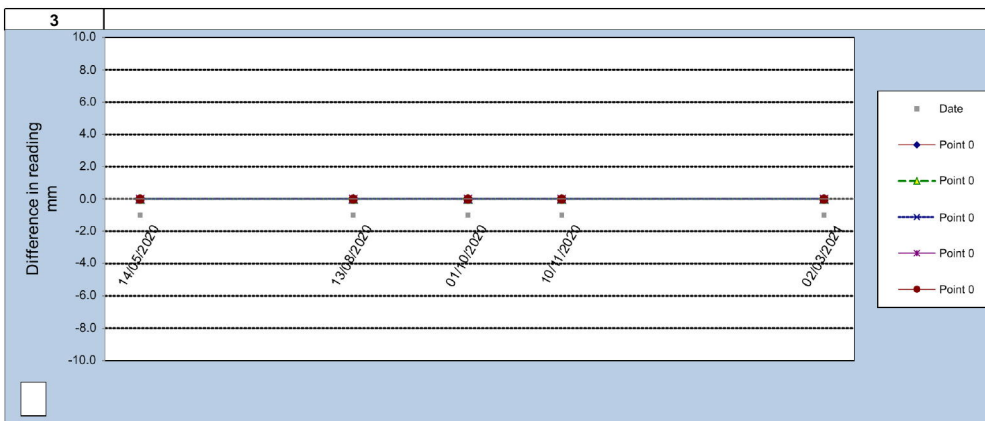
### LEVEL MONITORING - RELATIVE SURVEY READINGS

Chart Scale 1:1000
