client scale date JONATHAN & 1: 5 @ A3 11-09-20 NATHALIE ESFANDI drawn checked property MPP 55 CUMBERLAND TERRACE LONDON NW1 4HJ project

PROPOSED ALTERATIONS

MAIN ROOF- DETAILS AS PROPOSED SERVICE PENETRATIONS

drawing no. 11188-10 revision

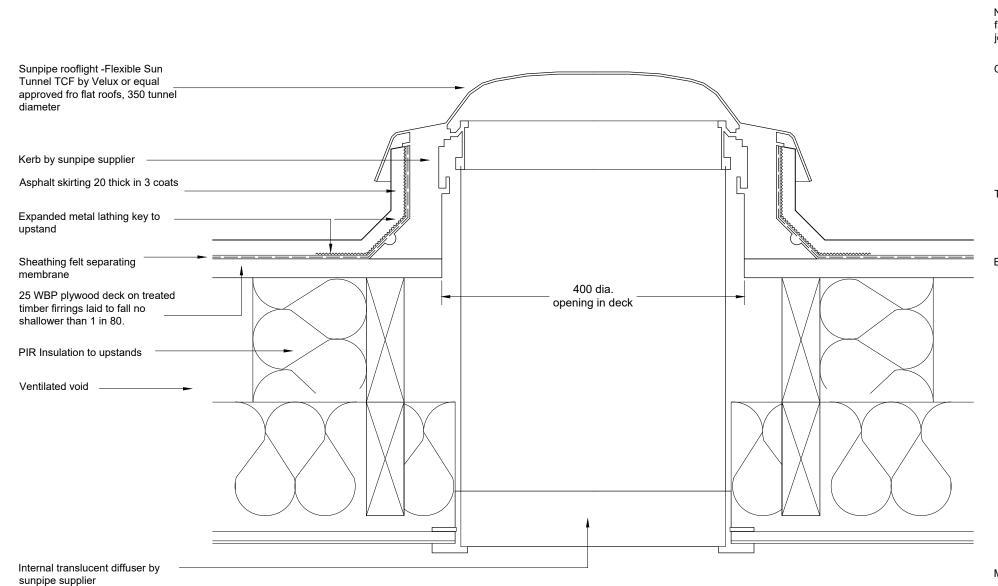
iron stacks, retained & painted & provided with birdguard Existing parapet retained, repaired where necessary & re-painted where previously painted Mastic sealant New metal weathering cravat fixed to stack with watertight joints & painted to match stack Code 6 lead flashing 150 min. Code 6 lead flashing Treated timber former Existing brickwork Mastic sealant

Detail 1- main roof, sunpipe rooflight section

Detail 2- main roof, head of stack

Retained existing or new cast

D 05-03-21 Detail I re- instated for sunpipe rooflight
