27 Great James Street, London WC1N 3ES

Design and Access Statement

Householder – Refurbishment of Front Basement Lightwell

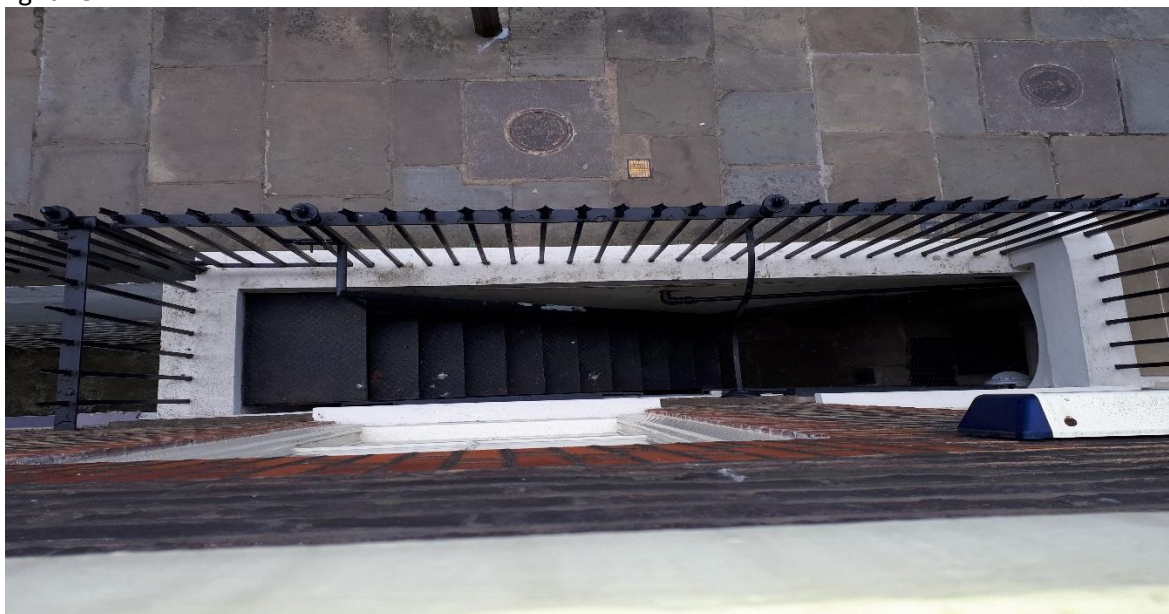
The Property is a terraced house built c1720. Listed as Grade II*. It comprises four storeys and a basement. There is a front basement lightwell, enclosed by cast iron railings and with a metal staircase giving access to the front well from the street. See photo below of view from above lightwell.

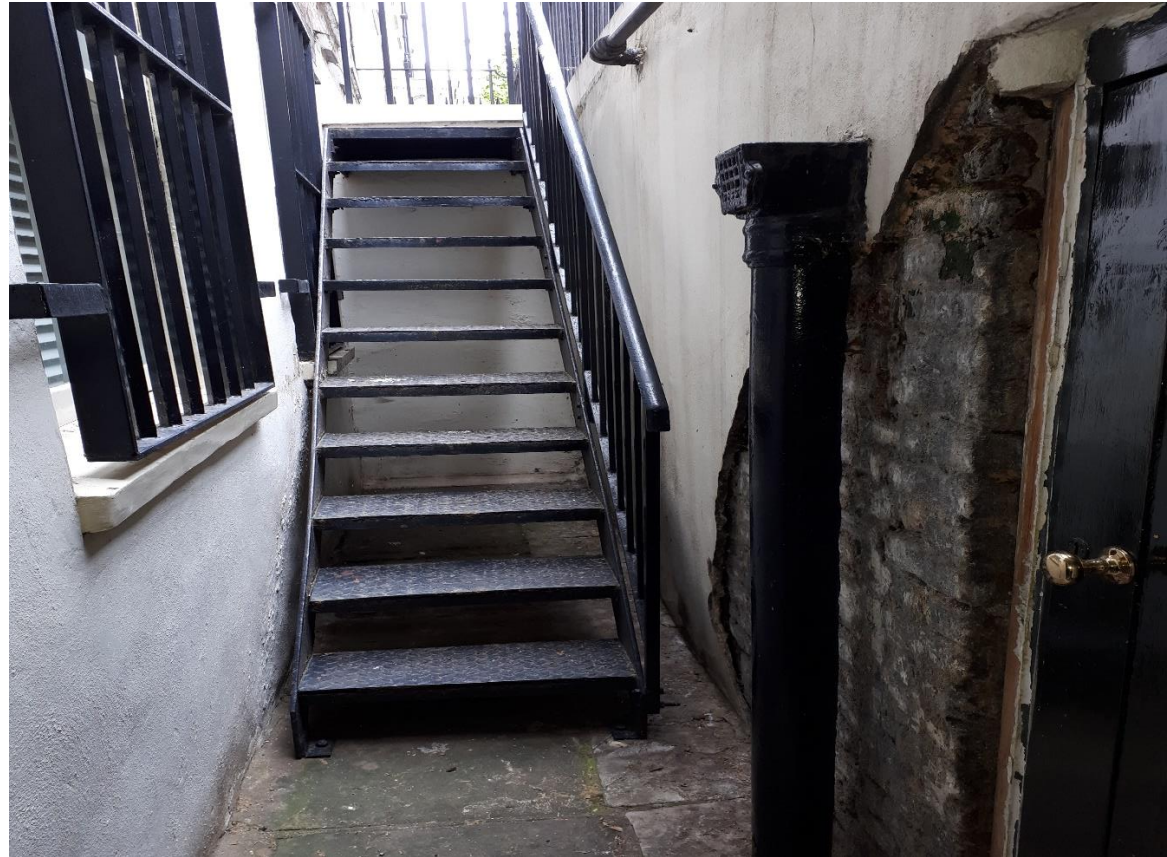
The front basement lightwell is currently rendered with a cement render. The cement render has failed in a number of places and has separated from the front lightwell wall as can be seen in the photo below.

Refurbishment of wall surface treatments of Front Basement Lightwell in the Property. Removal of current cement render. Making good of underlying brickwork, including repointing. If necessary, tying front basement lightwell wall to vaults with stainless steel helical reinforcements. The refurbished brick walls will then be treated with either a breathable masonry paint or a lime render which should inhibit failure of the render to adhere to the walls and allow moisture in the walls of the well to evaporate. If treated with a lime render, the walls will be painted with a breathable masonry paint once the render has hardened sufficiently.
