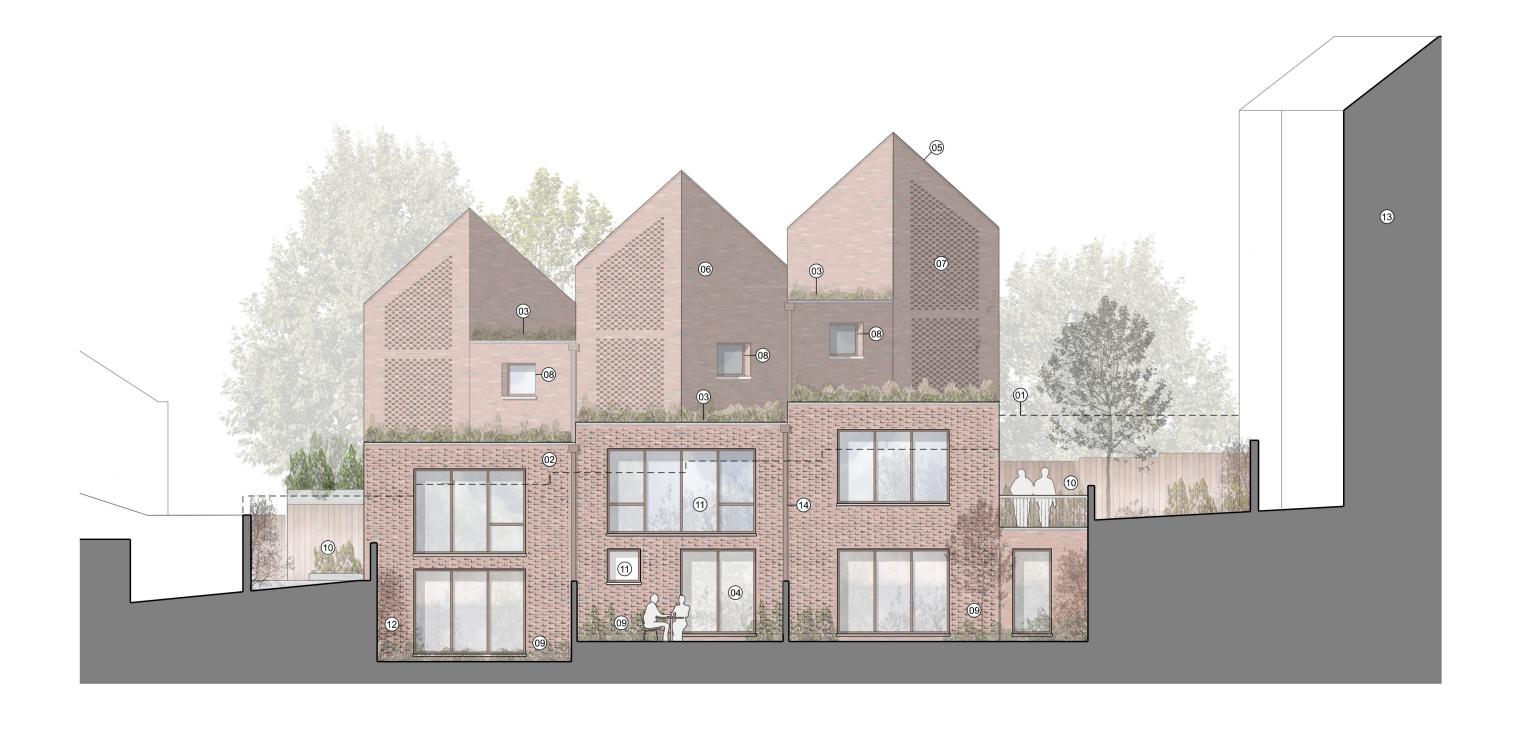
O2 Dotted line indicating fence to neighbour garden

Green roof with wildflower meadow

04 Aluminium/timber composite patio doors

05 Standing seam powder coated metal roof

66 Exposed brickwork - Flemish bond

Perforated brick screen in front of glazing

Opaque glazing to bathroom windows

Private terraces at lower level patio

Private terrace and garden at ground level
Aluminium/timber composite windows

Planting to lower level patio

South Mansions shown in section

Rainwater downpipes, powdercoated to match metal roof
