Notting Hill Genesis

Shoot Up Hill, London

Geo-environmental and Geotechnical Site Investigation

52193-R01 (02)

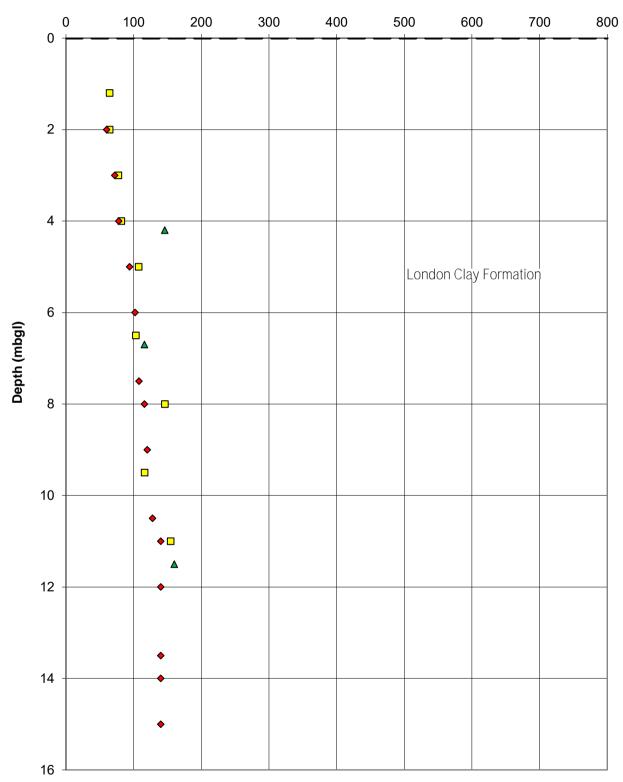
SPT London Clay Formation

TX London Clay Formation HV London Clay Formation

Figure 4 Natural moisture content vs depth
Figure 5 Undrained shear strength vs depth
