Existing Elevation 2 (NE)

Existing Elevation 3 (SW)

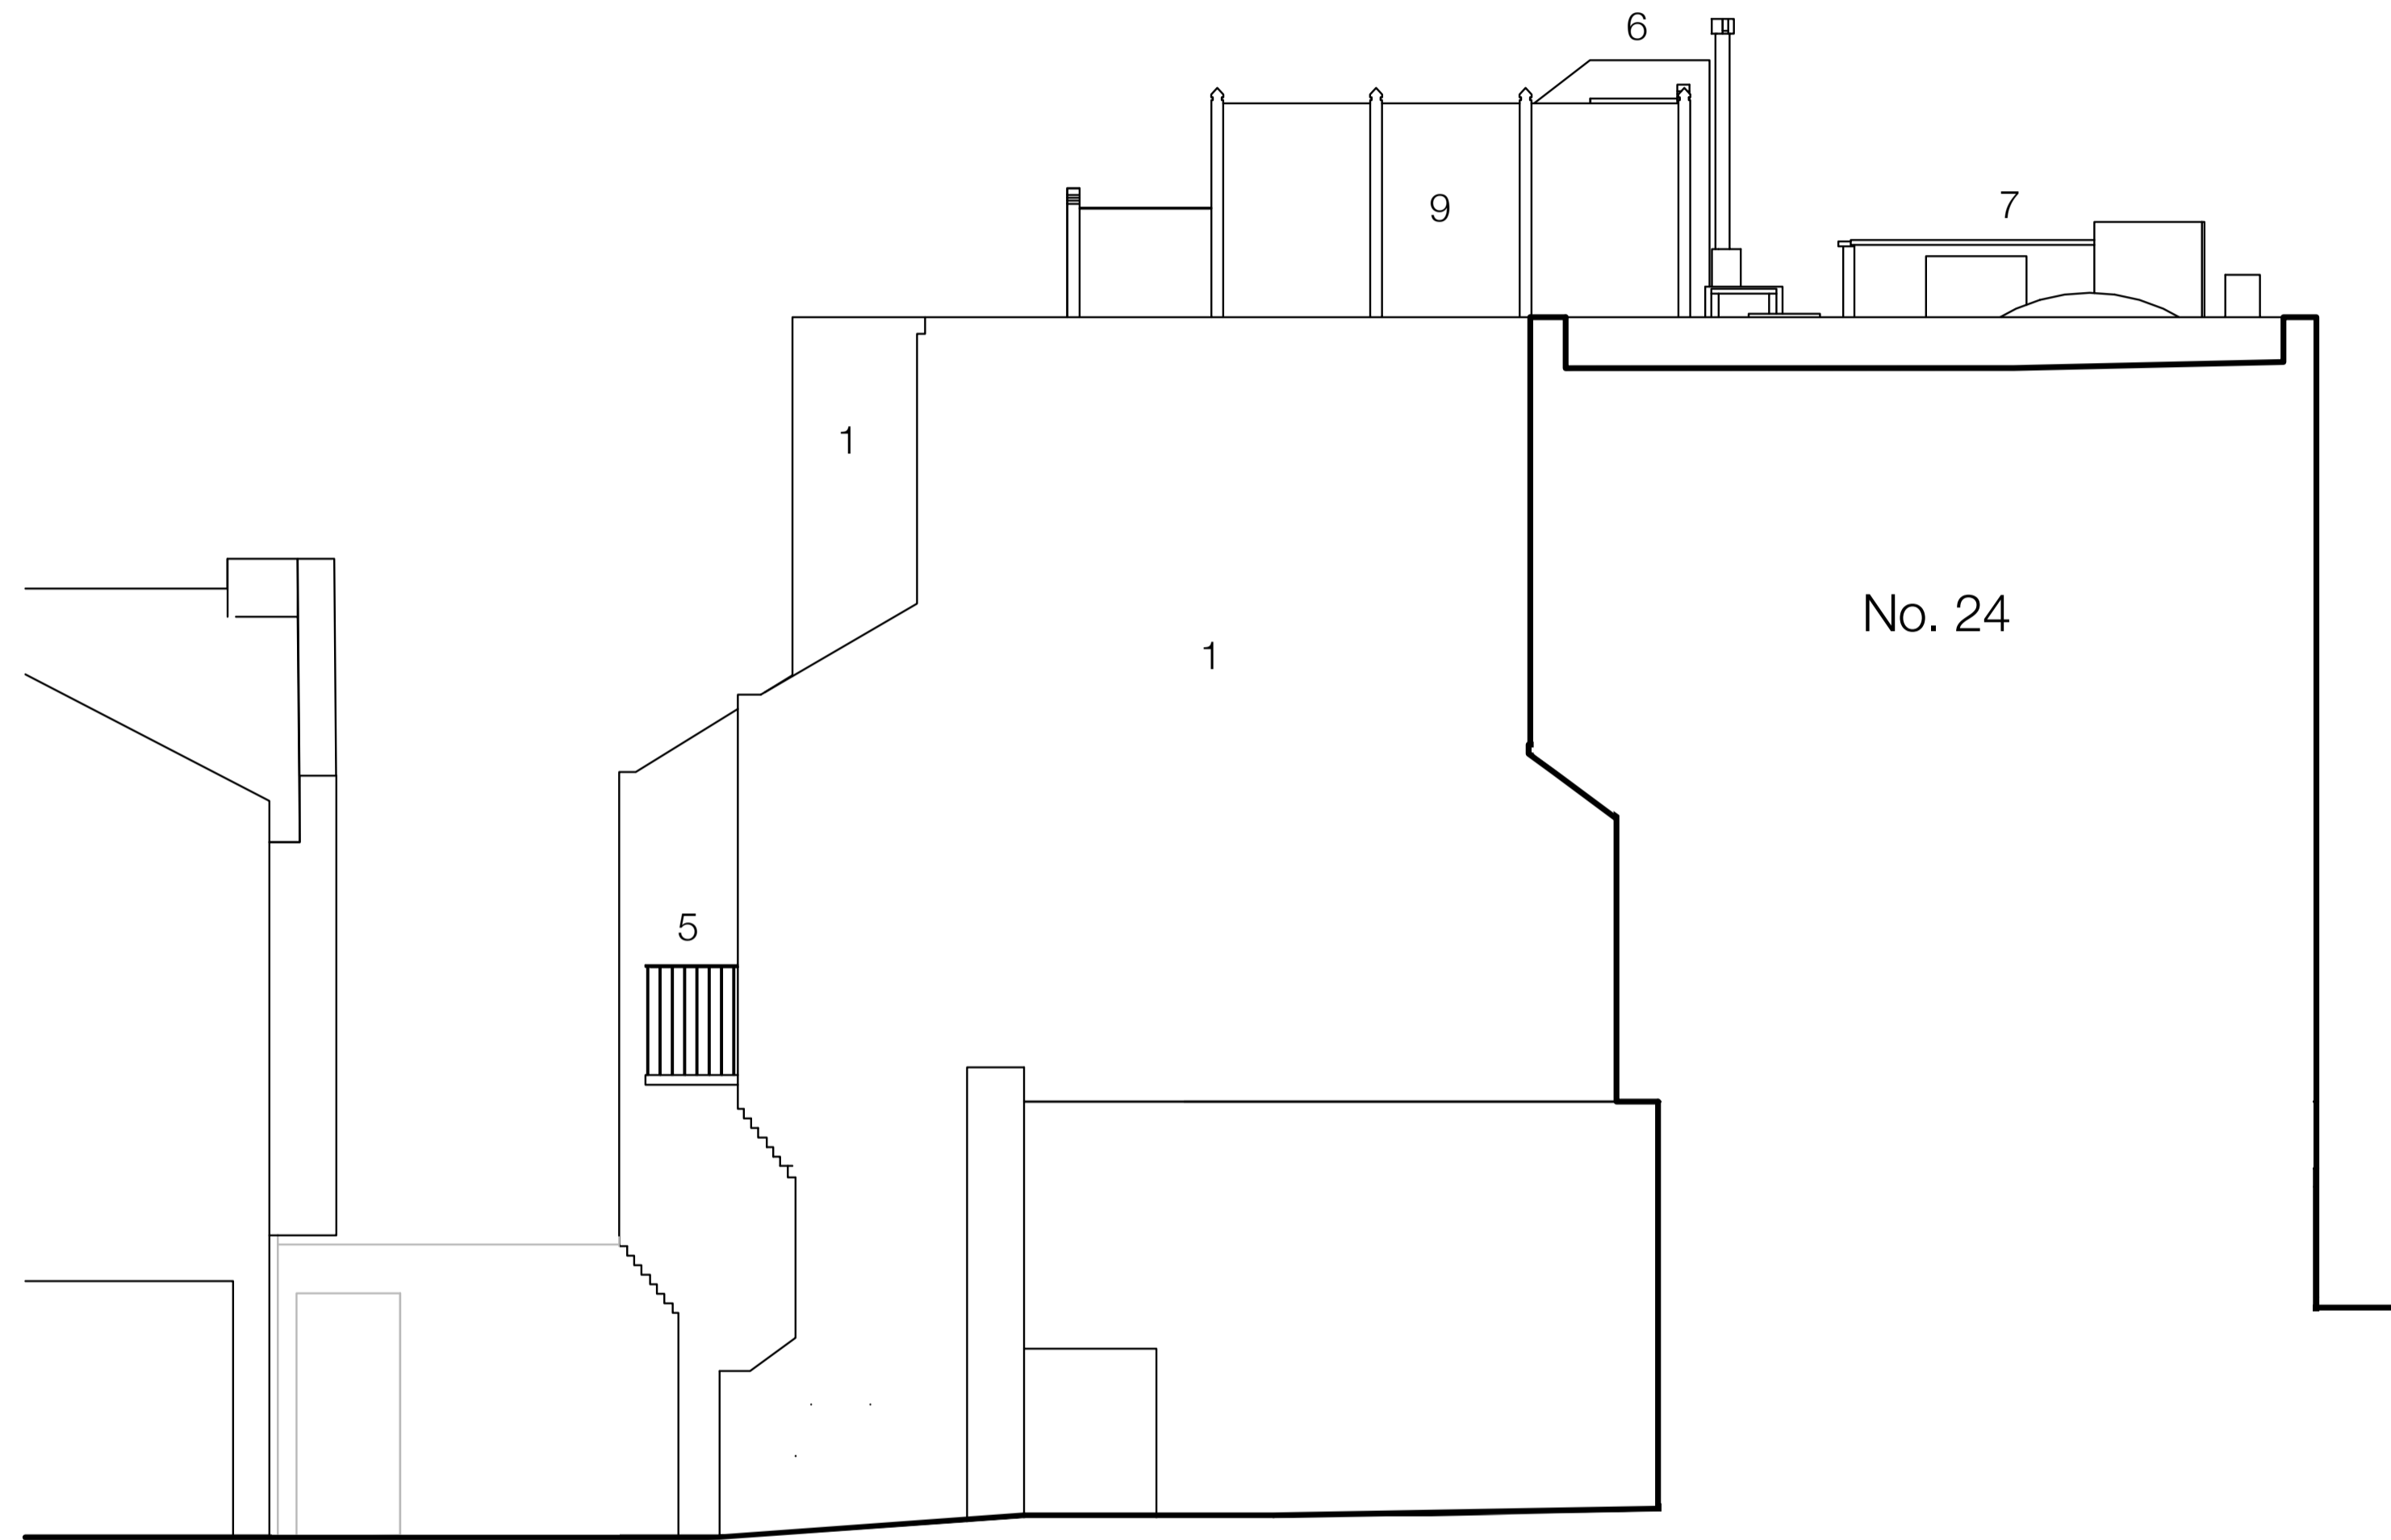
Existing materials

- 1. Existing mixed yellow London stock brickwork
- 2. Horizontal cladding boards, white
- 3. Dark stained timber windows & doors
- 4. Glazed lean-to roofs
- 5. Balcony with slim metal railings

Existing roofscape

- 6. Existing stair enclosure, cladding boards
- 7. Existing tank enclosures
- 8. Existing metal railings
- 9. Existing timber fencing to roof terrace
