**6 St George's Terrace**

**Proposed Rear (North) Elevation**

Project No.	Drawing No.	Rev.
<b>20-14</b>	<b>20.272</b>	<b>02</b>

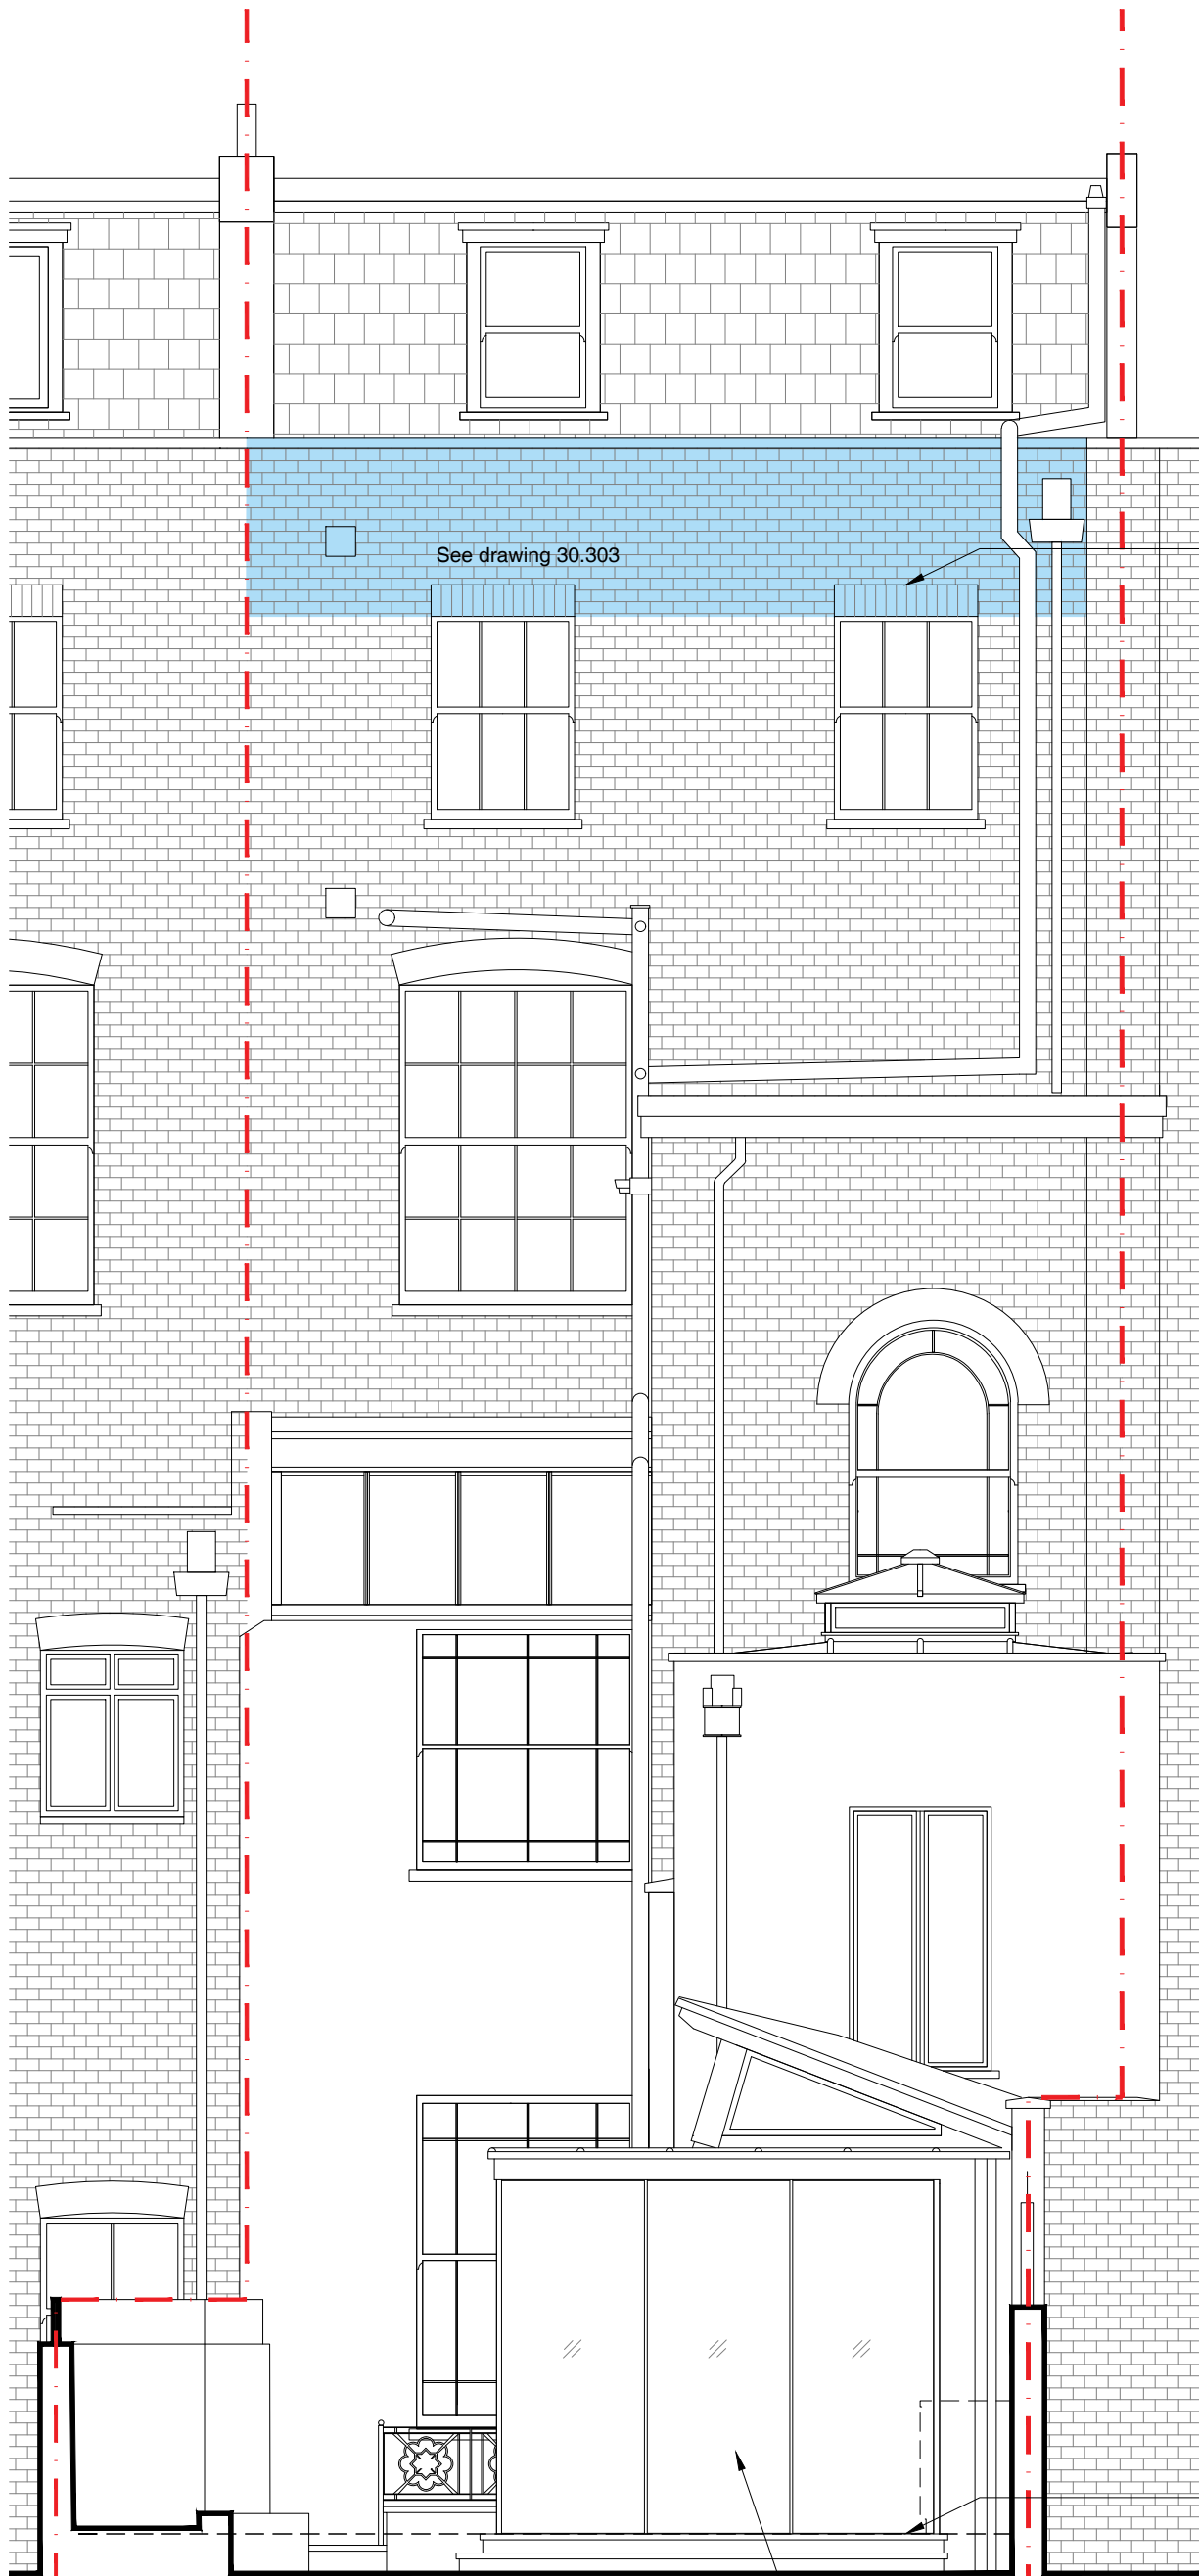
01  
20.272

Replace decayed wooden lintels above windows with precast concrete lintels as per SE details. Rebuild parapet wall, hidden gutter detail and replace coping stone. Replace two timber sash windows - size and design to match existing. See drawing 30.303

Repair blown or cracked render. Reinststate any missing rustication and detailing. Minimal original material to be removed during repair works

Clean, rub down and repair all timberwork with Repair Care products as per manufacturer's specifications. Redecorate timberwork using good quality white exterior wood paint

Rub down, clean and repair as necessary all metal work

Redecorate all render using primer and final coat of Dulux Weathershield Masonry Paint. Colour: White.

Redecorate all timberwork using primer and final coat of Dulux Weathershield Wood Paint. Colour: White. Entrance door colour: Black

Redecorate all metalwork with primer and two coats of exterior metal paint

Proposed Rear (North) Elevation  
Scale 1:50 @ A3

New Vitrocsa sliding doors  
see dwg 30.301

Dotted line showing proposed raised garden level and garden storage units. Design is developing and it will be submitted on a different application
