**TYBALDS ESTATE
CAMDEN
LONDON**

**ARBORICULTURAL METHOD
STATEMENT**

A Report to: The London Borough of Camden

Report No: RT-MME-154667-03 **Rev A**

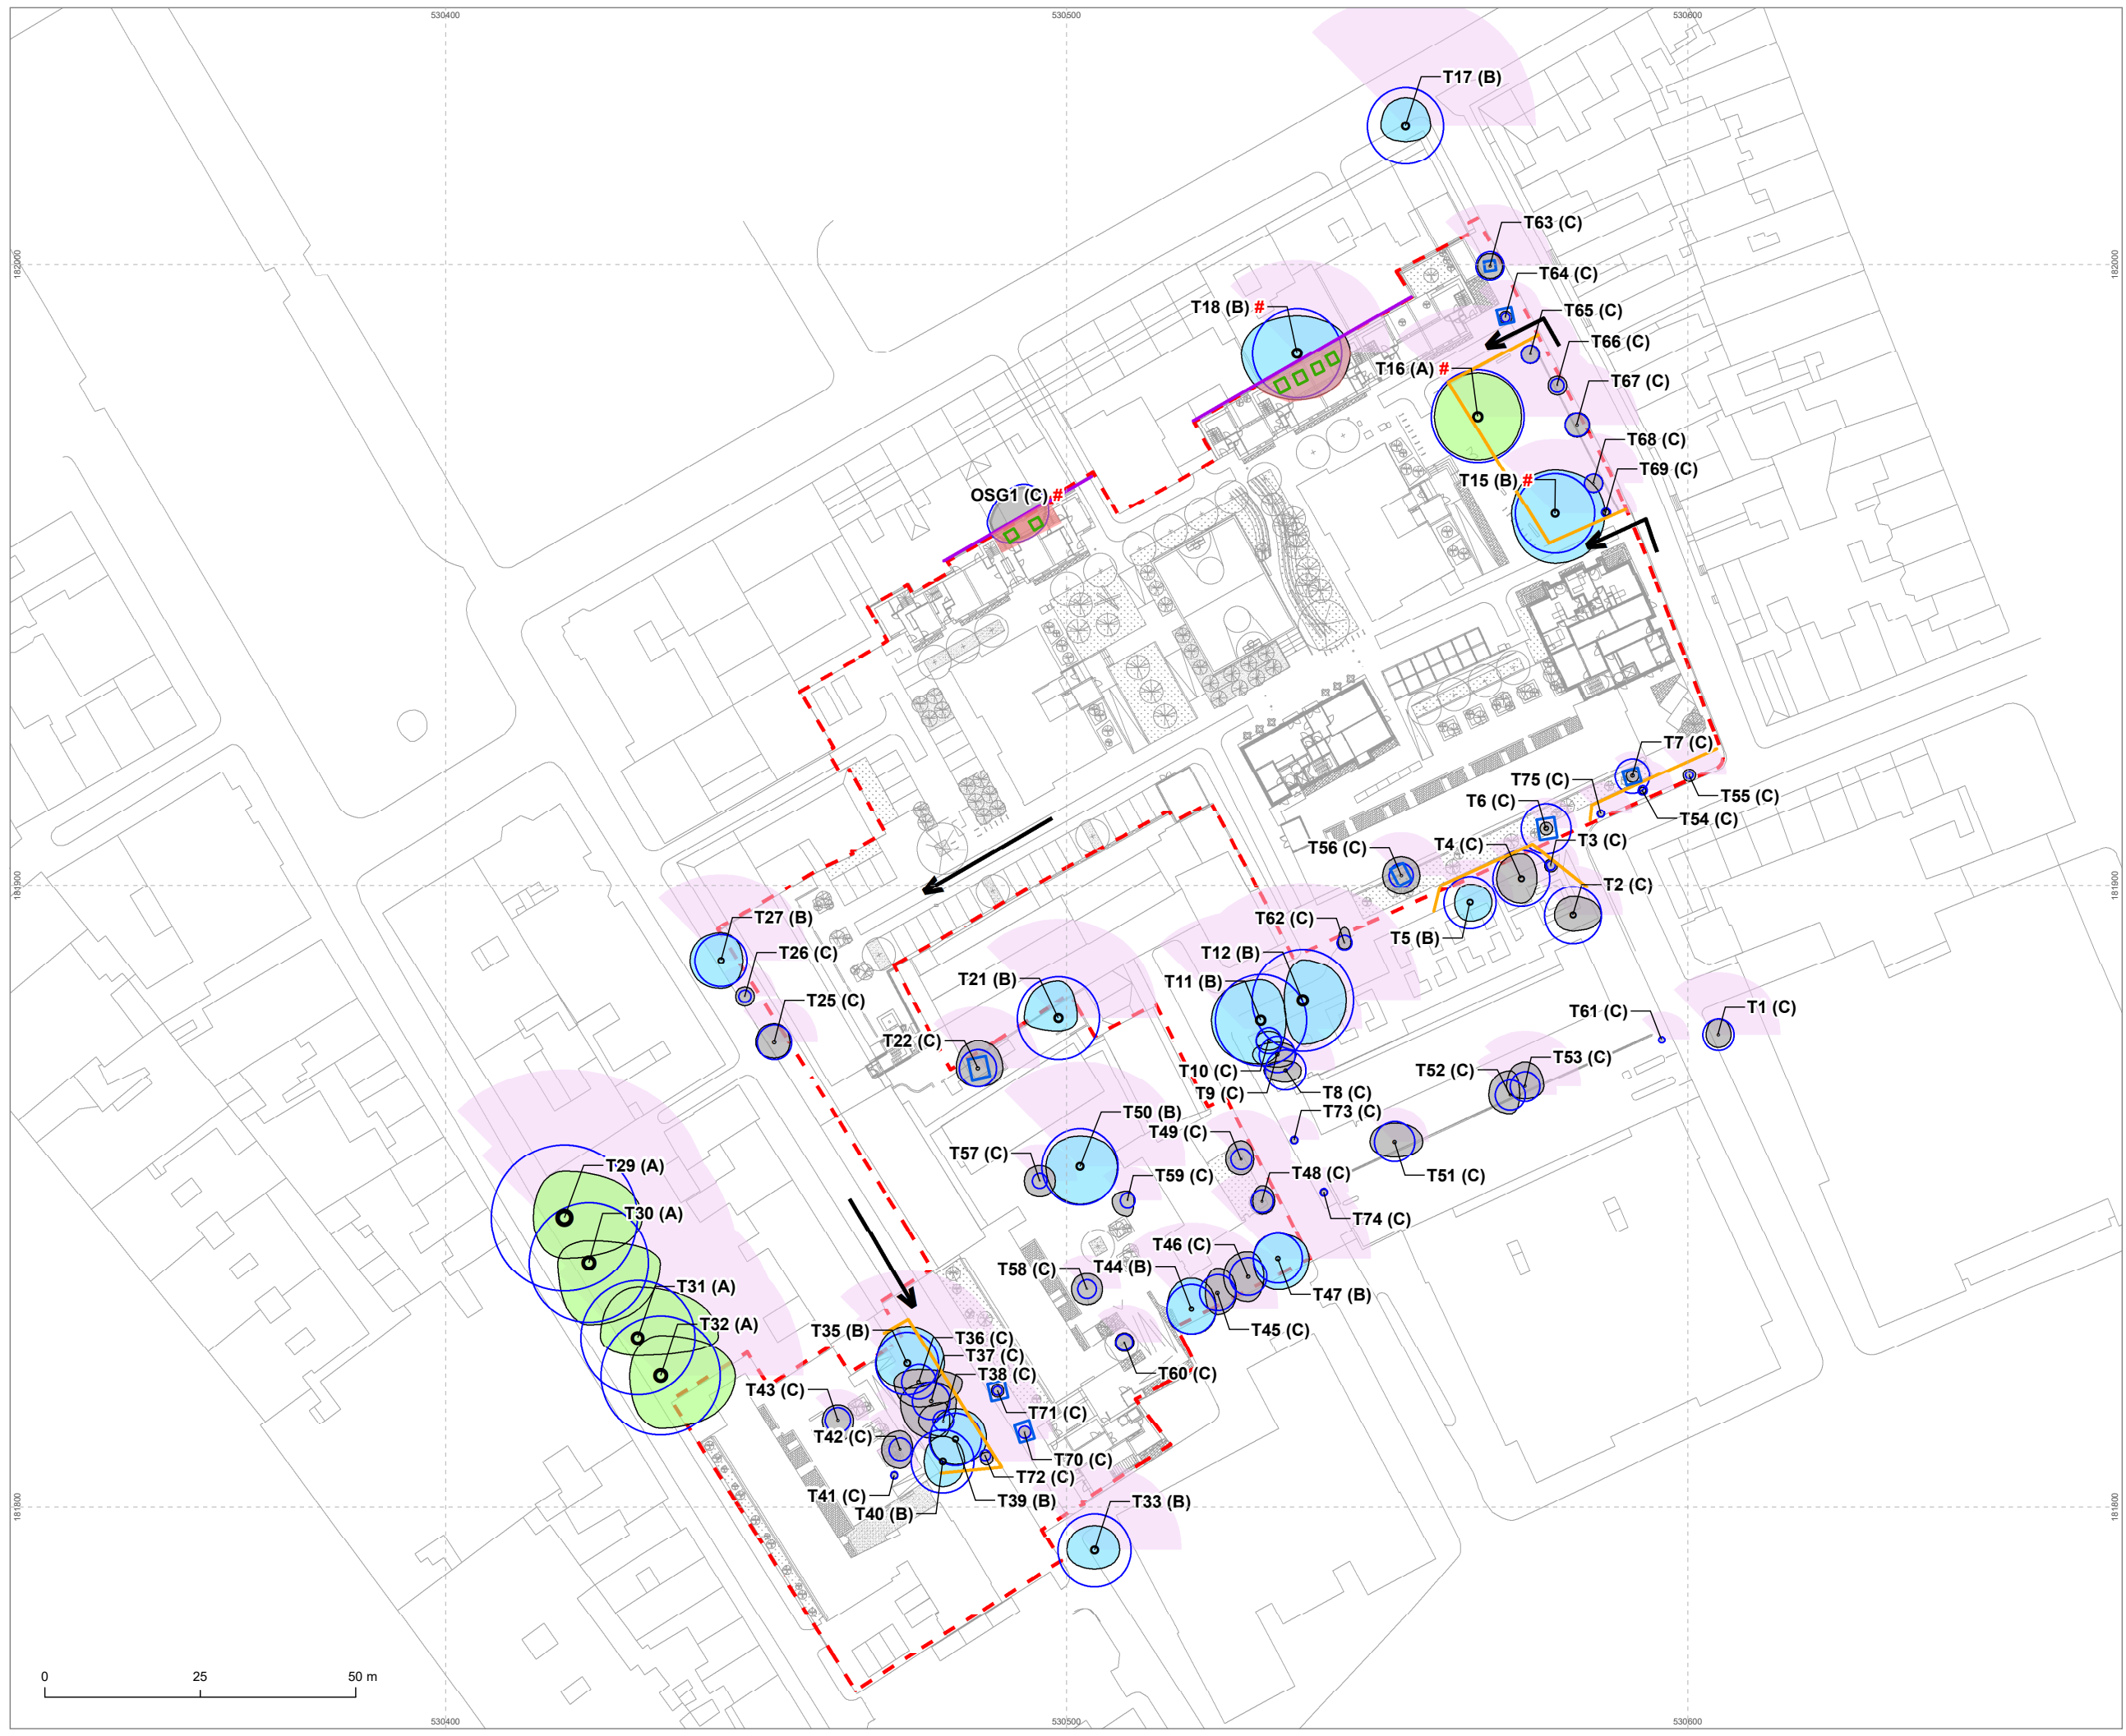
- Tree location and stem diameter
- Category A
- Category B
- Category C
- Current canopy - tree to be retained
- Root Protection Area
- Indicative tree shadow
- Exploratory trial pits
- Tree stem box
- Construction of new foundations under specific working methodology (subject to findings of trial pit excavation)
- Existing fence retained for tree protection
- Tree protection barrier BS5837:2012
- ➔ Site access
- Site boundary
- Proposed site layout
- # Tree pruning works required

The Tree Protection Plan attached to this report identifies only those trees that are to be retained and incorporated as part of the site development. The Tree Protection Plan identifies the various protection measures required to prevent damage to trees that are to provide long term benefits to the completed site. The Tree Protection Plan also identifies the various working elements of a construction site to confirm any potential impacts are minimised.

The location of the site compound, materials storage area and contractor's car parking are shown on the Tree Protection Plan, found in Section 7 of this report.
