Wesley Camden Methodist Church

Window Types (Typical Details)

Stage 5

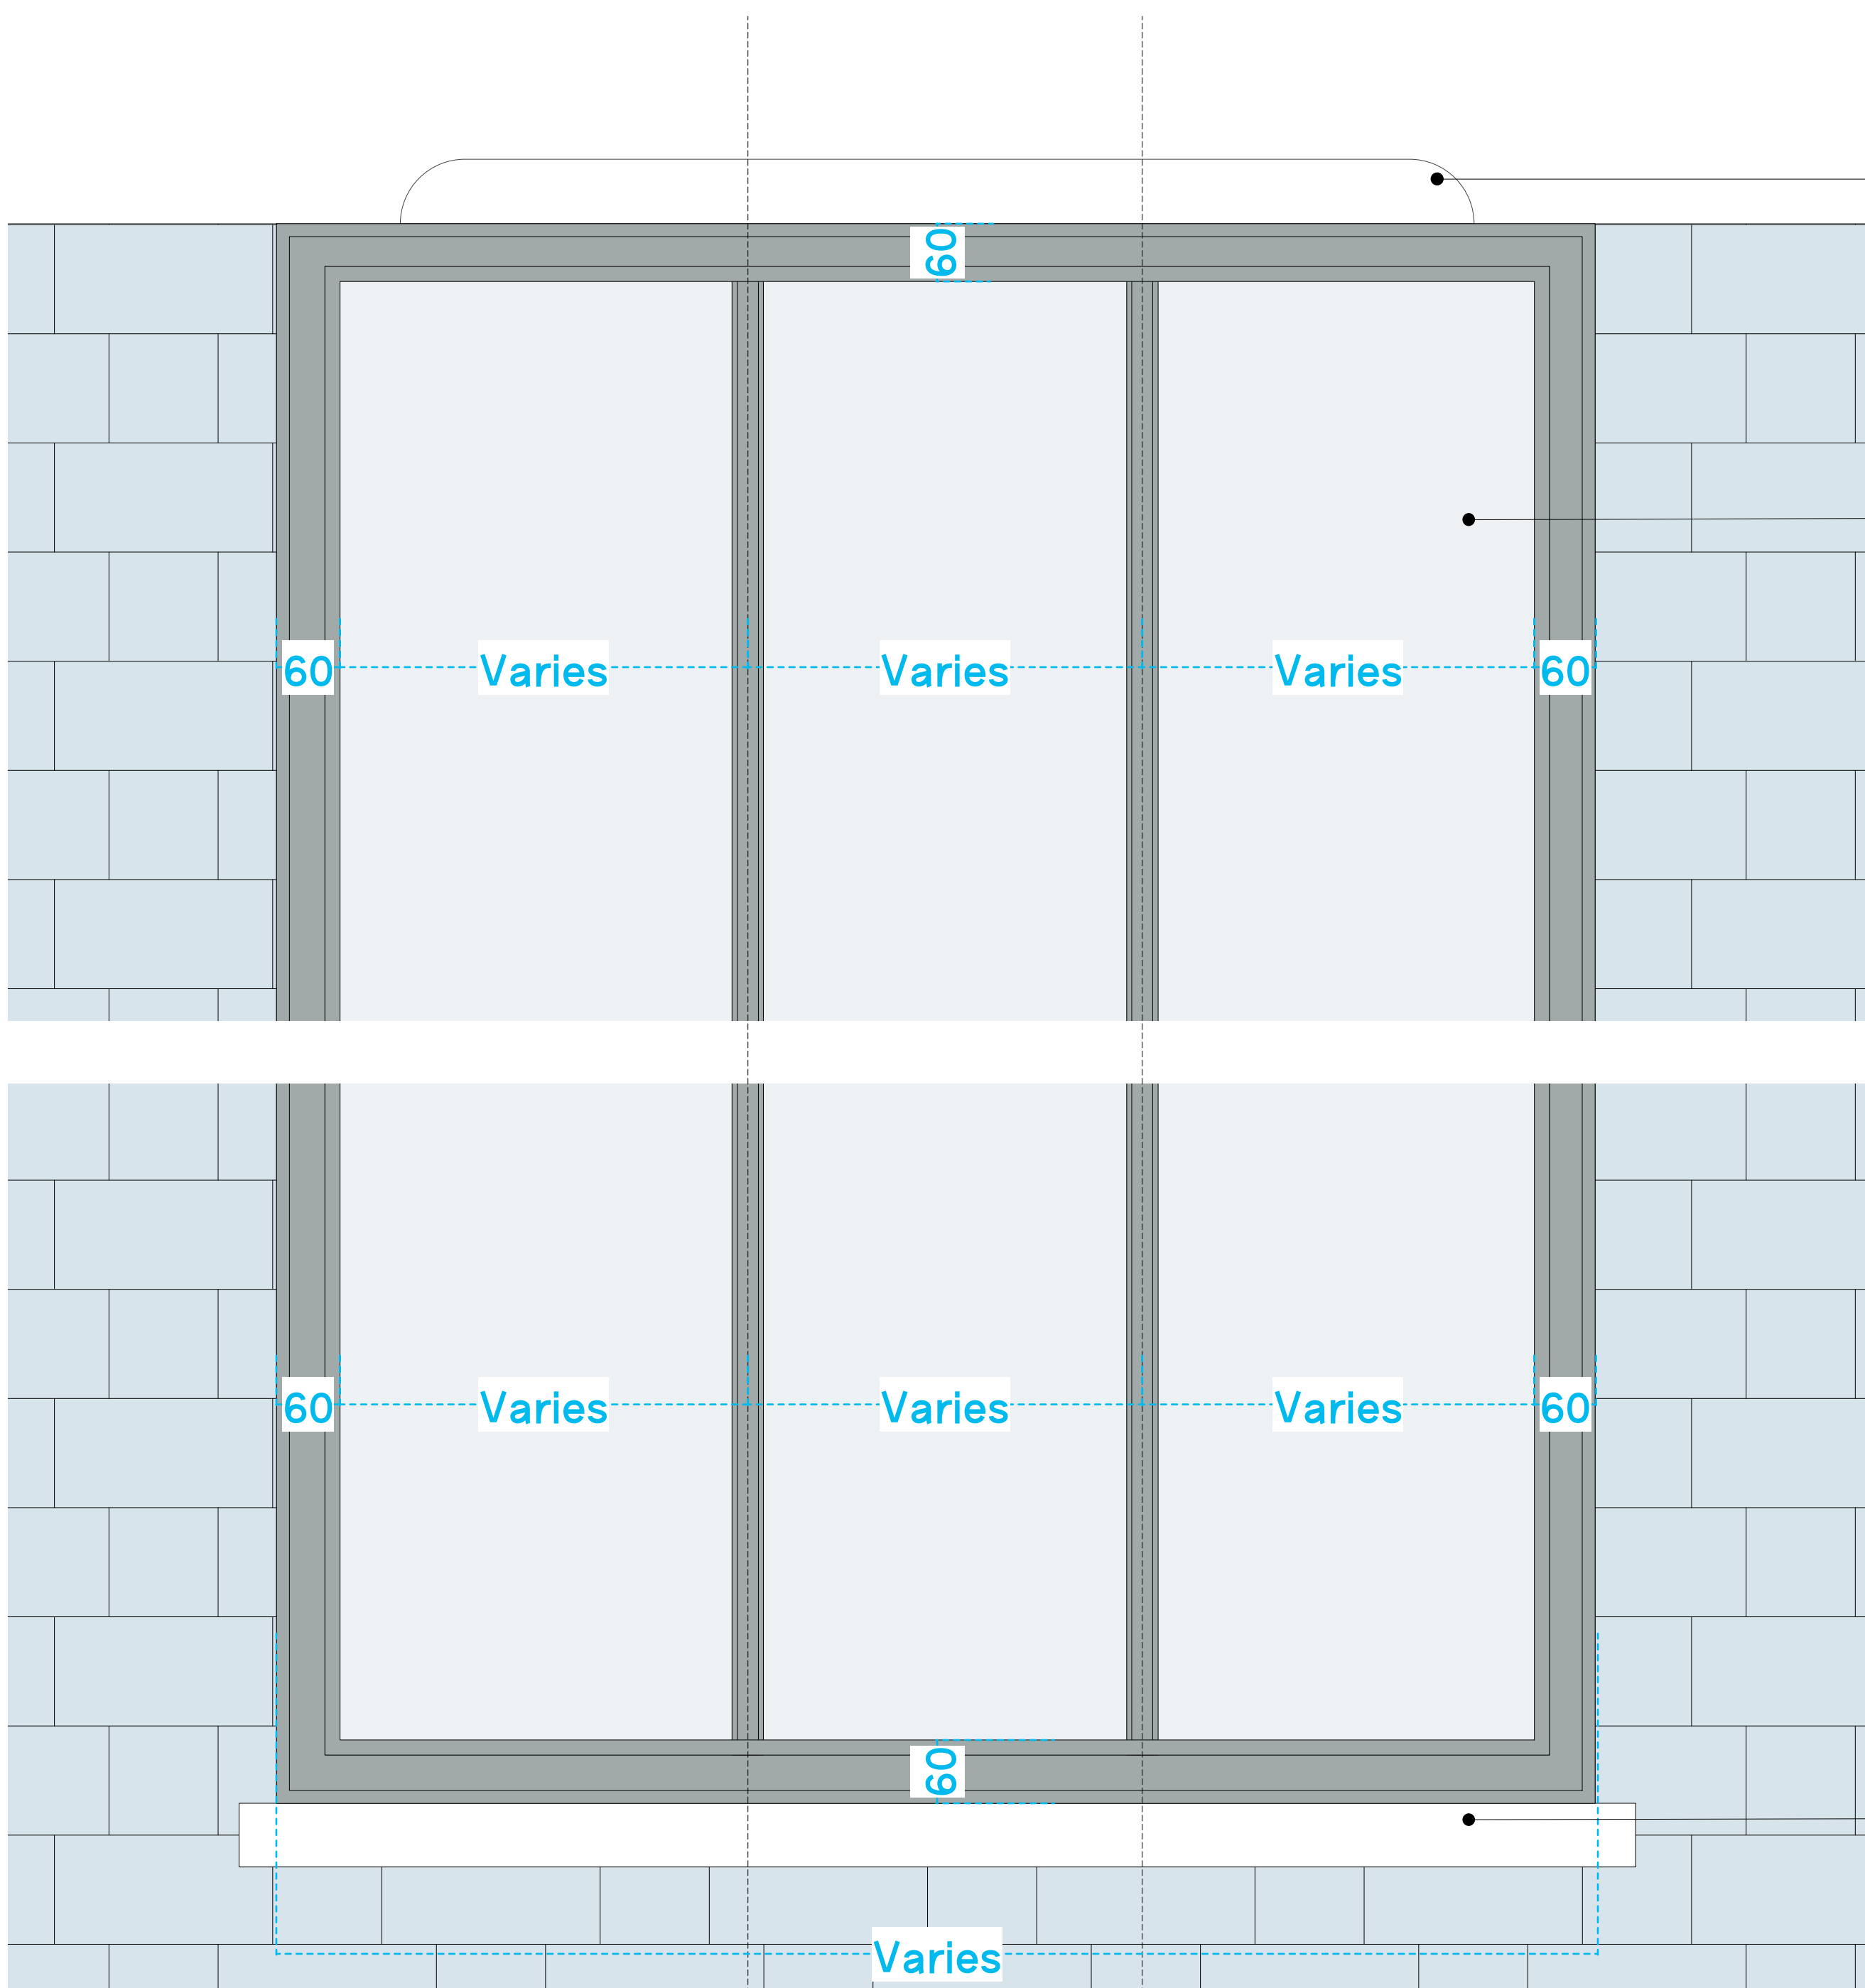
2 Typical Elevation
Scale: 1:5

Existing stone lintel/arch repaired where required

L10/310Steel Windows (WT.51-63)
New aluminium framed steel replacement window

Sealant

Pressed aluminium head closer
Colour / finish to match frame

New aluminium window frame

Existing stone cill repaired where required

Existing masonry wall

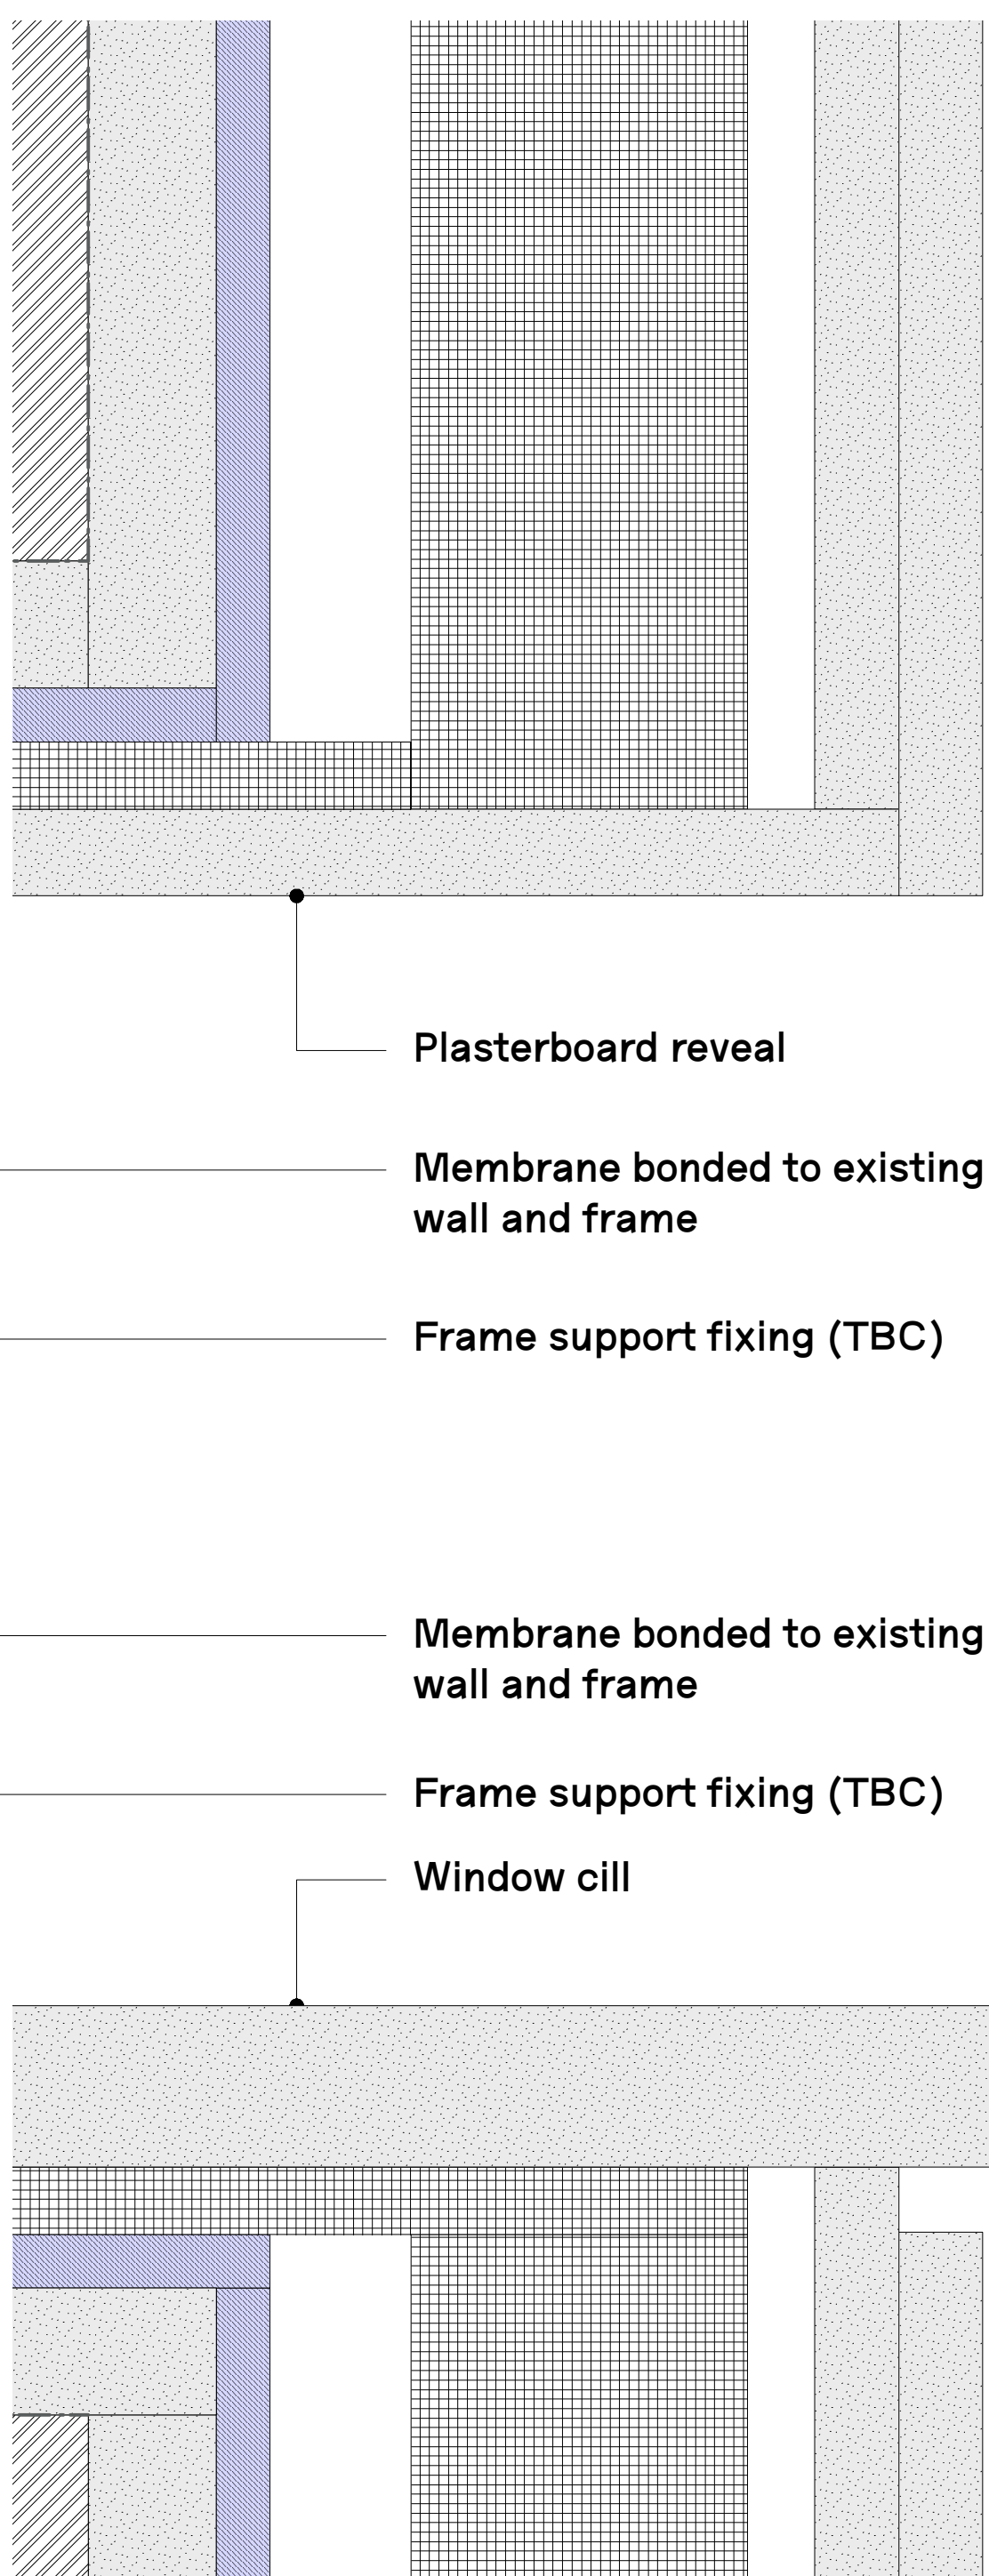
3 Typical Section
Scale: Actual Size

Plasterboard reveal

Membrane bonded to existing wall and frame

Frame support fixing (TBC)

Window cill
