1 G.05: Existing North Sectional Elevation
1:50 @ A3

2 G.05: Existing East Sectional Elevation
1:50 @ A3

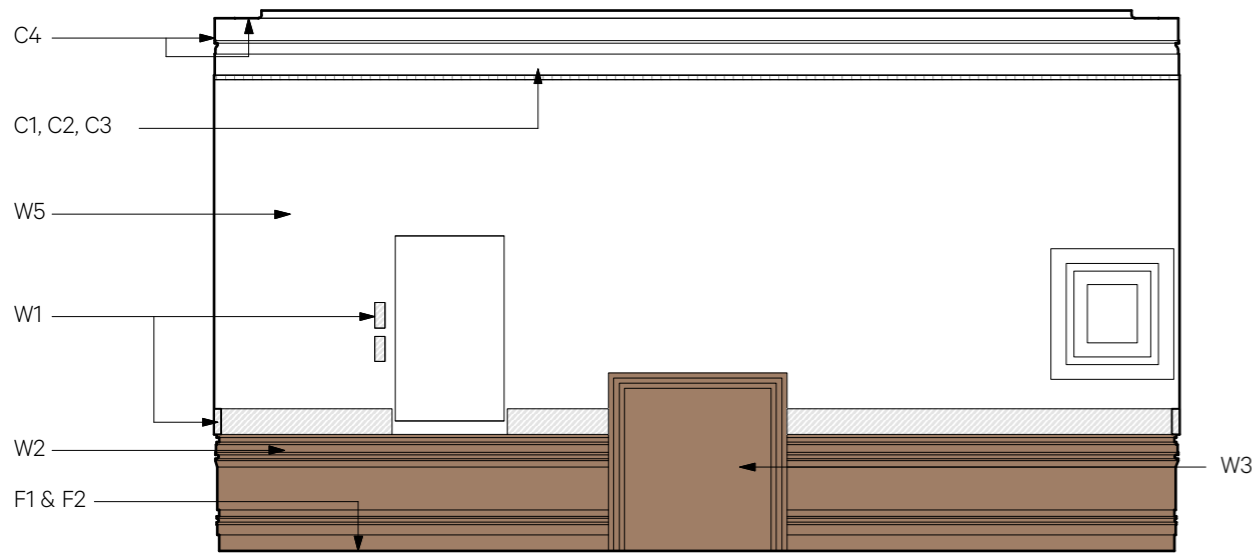
- Walls**
- W1 Existing services to be removed, including dado trunking. Refer to photographs P1-4.
 - W2 Existing hardwood panelling retained and protected throughout works. Refer to photographs P1-5.
 - W3 Existing hardwood fire place retained and protected throughout works. Refer to photographs P6-7.
 - W4 New penetration to east wall (between G.04 and G.05) located below existing cornice level for ventilation ductwork. Refer to photograph P8.
 - W5 Existing walls made good and redecorated. Refer to photographs P1-4.
 - W6 New power and data trunking with hardwood covering to match existing hardwood panelling.
 - W7 New heavy curtains to south and west elevations.
 - W8 New acoustic wall boards to provide mounting for AV screens.

- Floor**
- F1 Existing carpet to be carefully removed. Refer to photographs P9-12.
 - F2 Existing cork flooring to be restored (and replaced where necessary). Refer to photographs P9-12. Please refer to method statement submitted as part of this application.
 - F3 New flip-top sockets to centre of the room. Finish to match existing door hardware. Final arrangement to be agreed.

- Ceiling**
- C1 Existing suspended ceiling and fixings to be removed. Refer to photographs P1-3.
 - C2 Existing ceiling-level services and lighting to be removed. Refer to photographs P1-3.
 - C3 Existing above-ceiling services to be removed.
 - C4 Existing ceiling cornice retained and protected throughout the works. Existing condition to be surveyed following the removal of the existing suspended ceiling. Refer to photographs P13 & 14.
 - C5 Existing boxing out of window heads at ceiling level removed. Refer to photograph P18.
 - C6 New suspended ceiling.
 - C7 New chandeliers.
 - C8 New recessed track lighting.
 - C9 New recessed linear ventilation slot diffuser/extract.
 - C10 New shallow steel support for proposed chandeliers above suspended ceiling.

- Doors**
- D1 Existing doors to be retained and protected throughout works. Refer to photographs P15-17

- Windows**
- Wi1 Existing blinds to be removed. Refer to photograph P18.
 - Wi2 New heavy curtains.
