2 G.04: Proposed South Sectional Elevation 1:50 @ A1

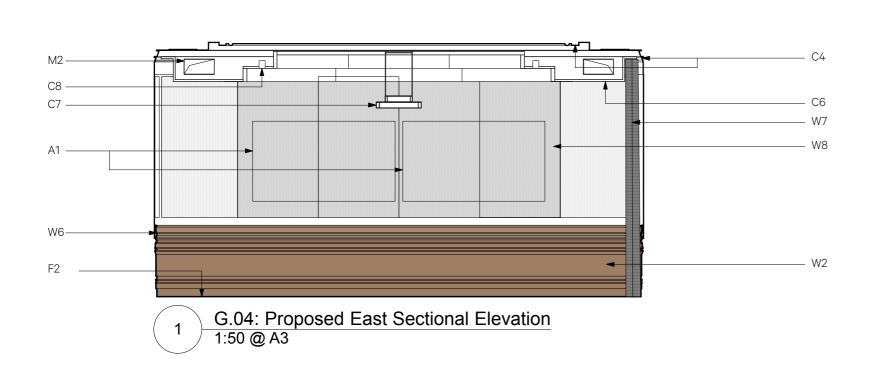
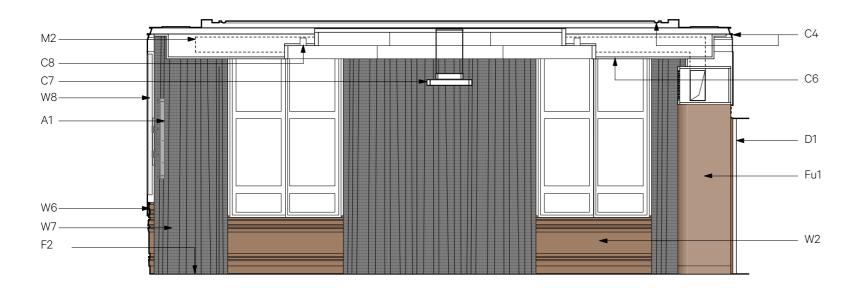
W2 Existing hardwood panelling retained and protected throughout works. Refer to photographs P1-4.

W3 New penetrations to west wall (between G.04 and G.05) located below existing cornice level for ventilation ductwork. Refer to photograph P4.

W4 Existing transfer grille above door to north elevation to be retained. Refer to photographs P1& P5.

W5 Existing walls made good and redecorated. Refer to photographs P1-4.

New power and data trunking with hardwood covering to match existing hardwood panelling.

W7 New heavy curtains to south elevation.

New acoustic wall boards to provide mounting for AV screens.

Existing cork flooring to be restored (and replaced where necessary). Refer to photographs P7-10. Please refer to method statement submitted as part of this application.

Existing ceiling cornice retained and protected throughout the works. Existing condition to be surveyed following the removal of the existing suspended ceiling. Refer to photograph P11.

C6 New plasterboard and acoustic plaster suspended ceiling.

C7 New chandelier.

C8 New recessed track lighting.

C9 New recessed linear ventilation slot diffuser/extract.

D1 Existing doors to be retained and protected throughout works. Refer to photographs PX1 & P2.

Wi2 New heavy curtains.

A1 New AV, including LCD screens to east elevation.

Fu1 New joinery units to house fan coil units, AV equipment and personal storage.

Fu2 Existing clock removed. Refer to photographs P1 & P4.

M1 New Air Handling Unit for mechanical ventilation

M2 New mechanical ventilation ductwork above new suspended ceiling.

M3 New FCUs within joinery units.
