1 G.04: Existing Plan  
1:50@A3

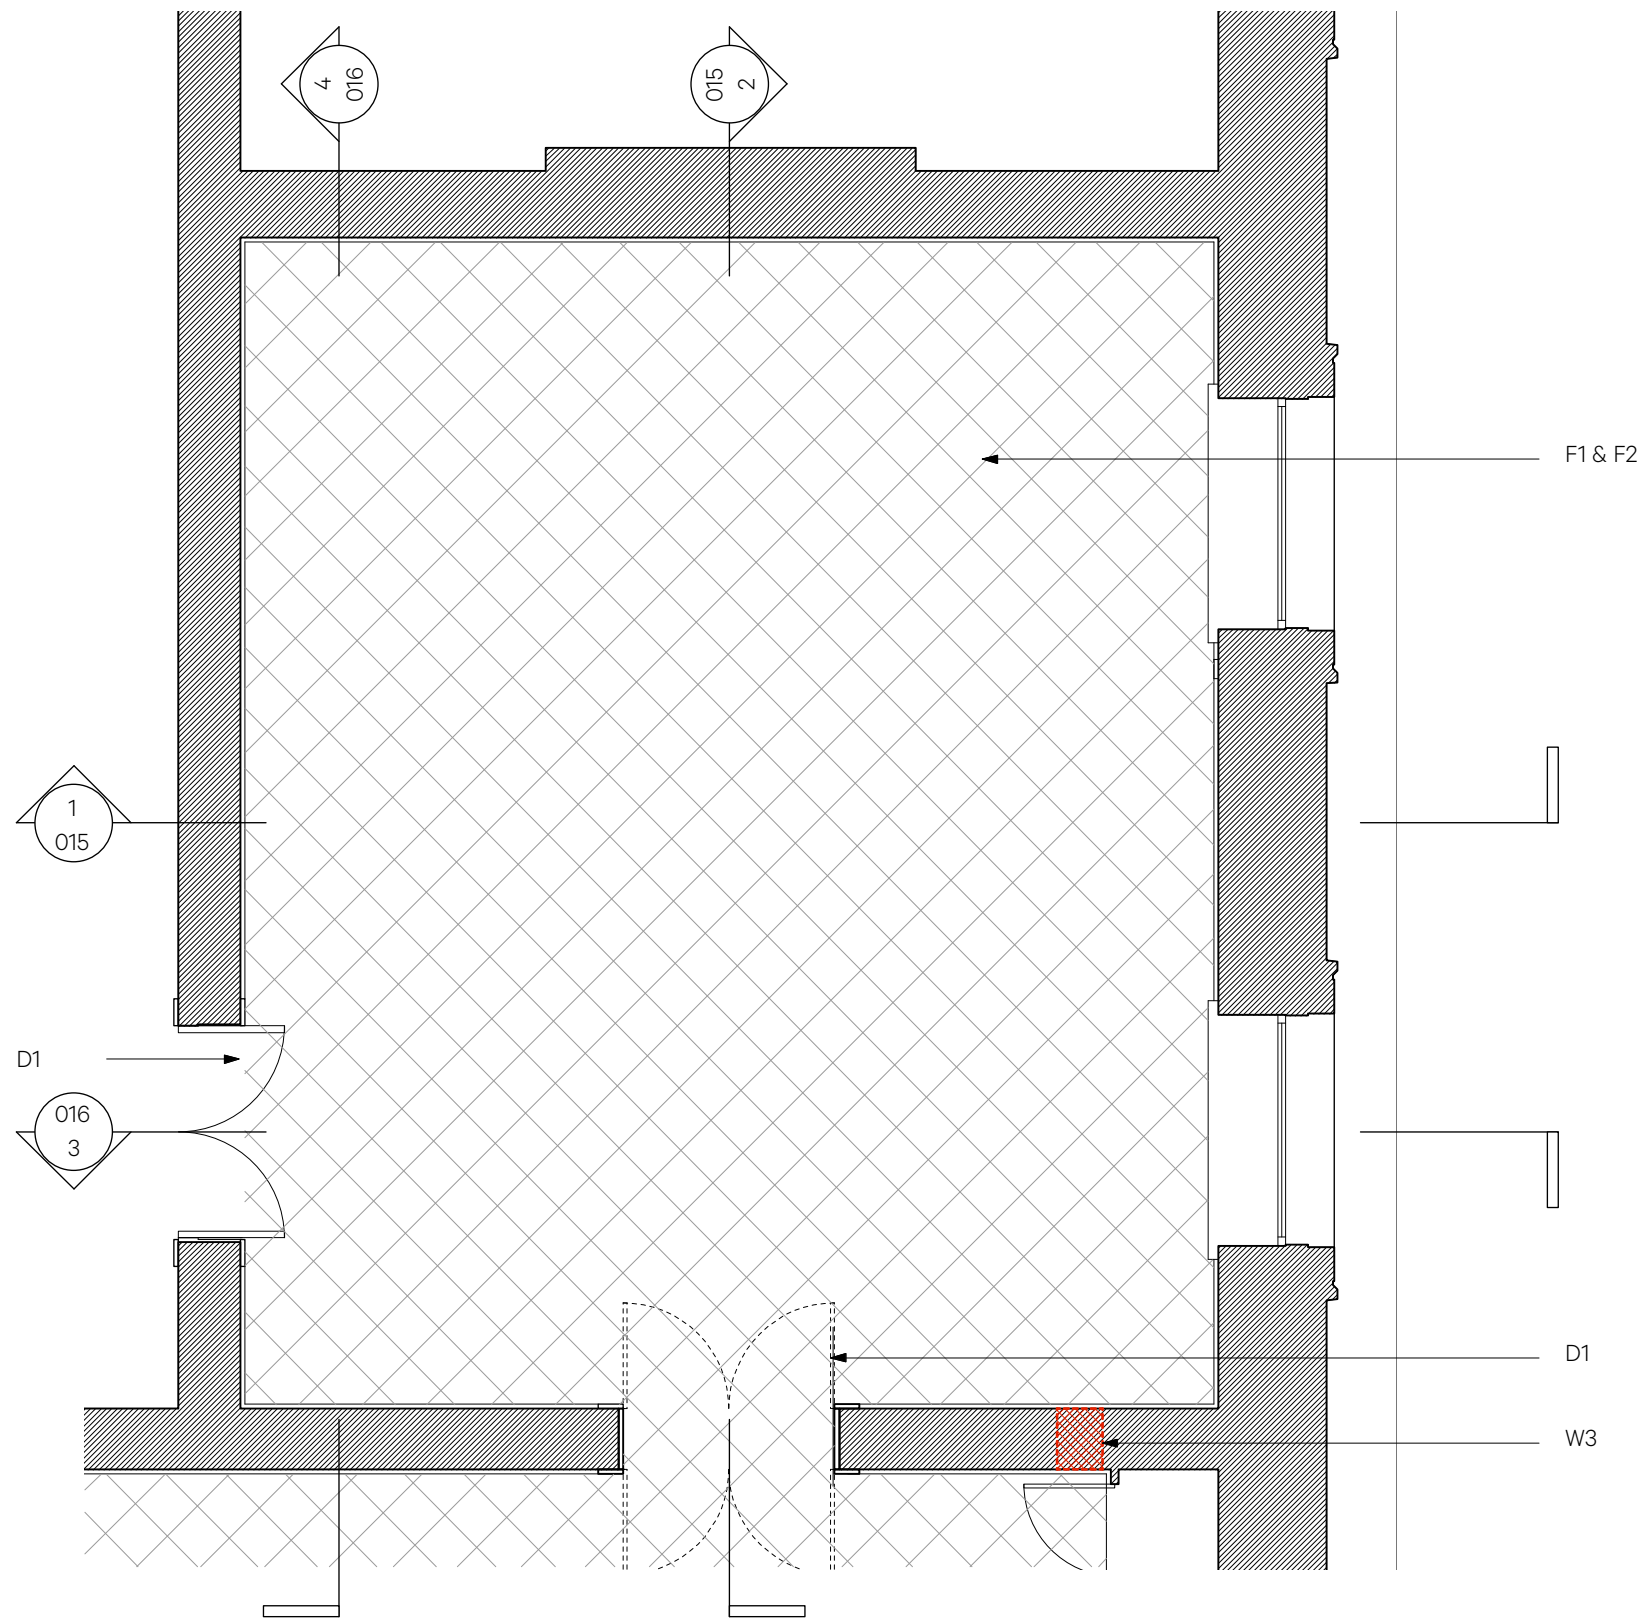
- W1 Existing services to be removed, including dado trunking. Refer to photographs P1-4.
- W2 Existing hardwood panelling retained and protected throughout works. Refer to photographs P1-4.
- W3 New penetrations to west wall (between G.04 and G.05) located below existing cornice level for ventilation ductwork. Refer to photograph P4.
- W4 Existing transfer grille above door to north elevation to be retained. Refer to photographs P1 & P5.
- W5 Existing walls made good and redecorated. Refer to photographs P1-4.
- W6 New power and data trunking with hardwood covering to match existing hardwood panelling.
- W7 New heavy curtains to south elevation.
- W8 New acoustic wall boards to provide mounting for AV screens.

- F1 Existing carpet to be carefully removed. Refer to photographs P7-10.
- F2 Existing cork flooring to be restored (and replaced where necessary). Refer to photographs P7-10. Please refer to method statement submitted as part of this application.

- D1 Existing doors to be retained and protected throughout works. Refer to photographs P1 & P12.
