1 G.04: Existing East Sectional Elevation
1:50 @ A3

2 G.04: Existing South Sectional Elevation
1:50 @ A3

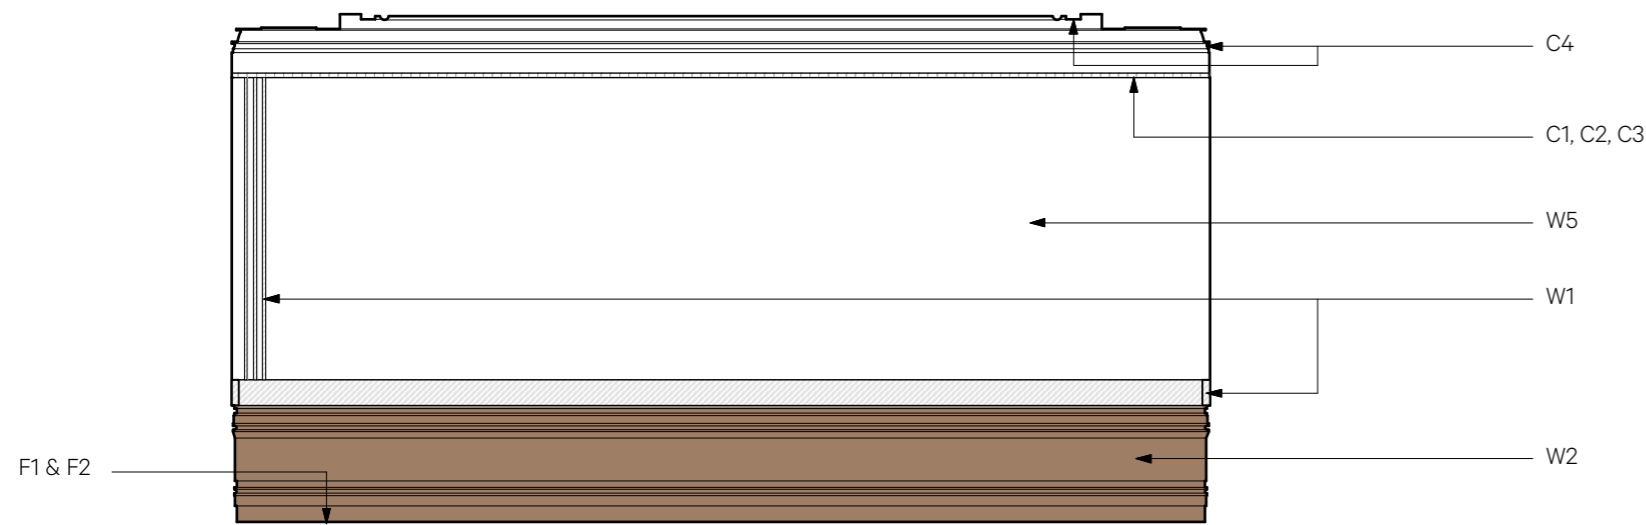
- W1 Existing services to be removed, including dado trunking. Refer to photographs P1-4.
- W2 Existing hardwood panelling retained and protected throughout works. Refer to photographs P1-4.
- W3 New penetrations to west wall (between G.04 and G.05) located below existing cornice level for ventilation ductwork. Refer to photograph P4.
- W4 Existing transfer grille above door to north elevation to be retained. Refer to photographs P1 & P5.
- W5 Existing walls made good and redecorated. Refer to photographs P1-4.
- W6 New power and data trunking with hardwood covering to match existing hardwood panelling.
- W7 New heavy curtains to south elevation.
- W8 New acoustic wall boards to provide mounting for AV screens.

- C1 Existing suspended ceiling and fixings to be removed. Refer to photographs P1-4.
- C2 Existing ceiling-level services and lighting to be removed. Refer to photographs P1-4.
- C3 Existing above-ceiling services to be generally removed, with the exception of existing water pipes serving the library above.
- C4 Existing ceiling cornice retained and protected throughout the works. Existing condition to be surveyed following the removal of the existing suspended ceiling. Refer to photograph P11.
- C5 Existing boxing out of window heads at ceiling level removed. Refer to photograph P6.
- C6 New suspended ceiling.
- C7 Chandelier.
- C8 New recessed track lighting.
- C9 New recessed linear ventilation slot diffuser/extract.

- D1 Existing doors to be retained and protected throughout works. Refer to photographs P1 & P12.

- Fu1 New joinery units to house fan coil units, AV equipment and personal storage.
- Fu2 Existing clock removed. Refer to photographs P1 & P4.

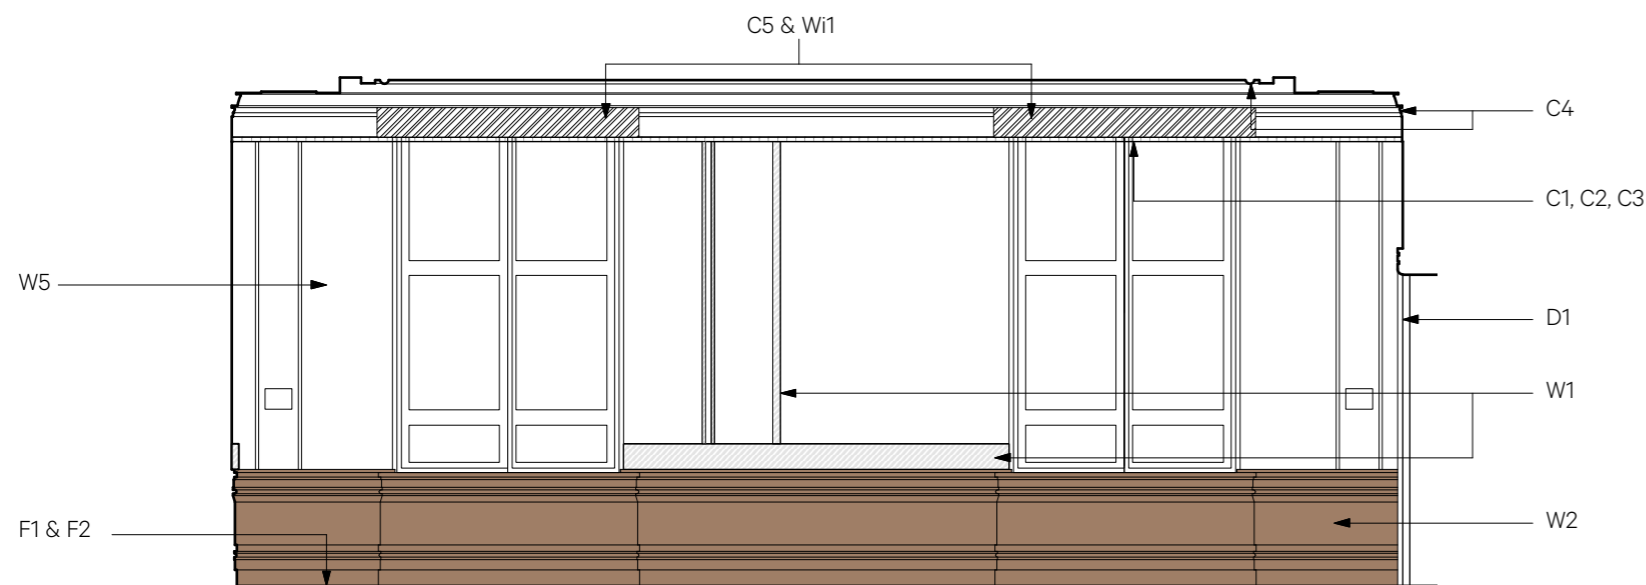
- W1 Existing blinds to be removed. Refer to photograph P6.
- W2 New heavy curtains.
