3 **G.04: Existing West Sectional Elevation**
1:50 @ A3

4 **G.04: Existing North Sectional Elevation**
1:50 @ A3

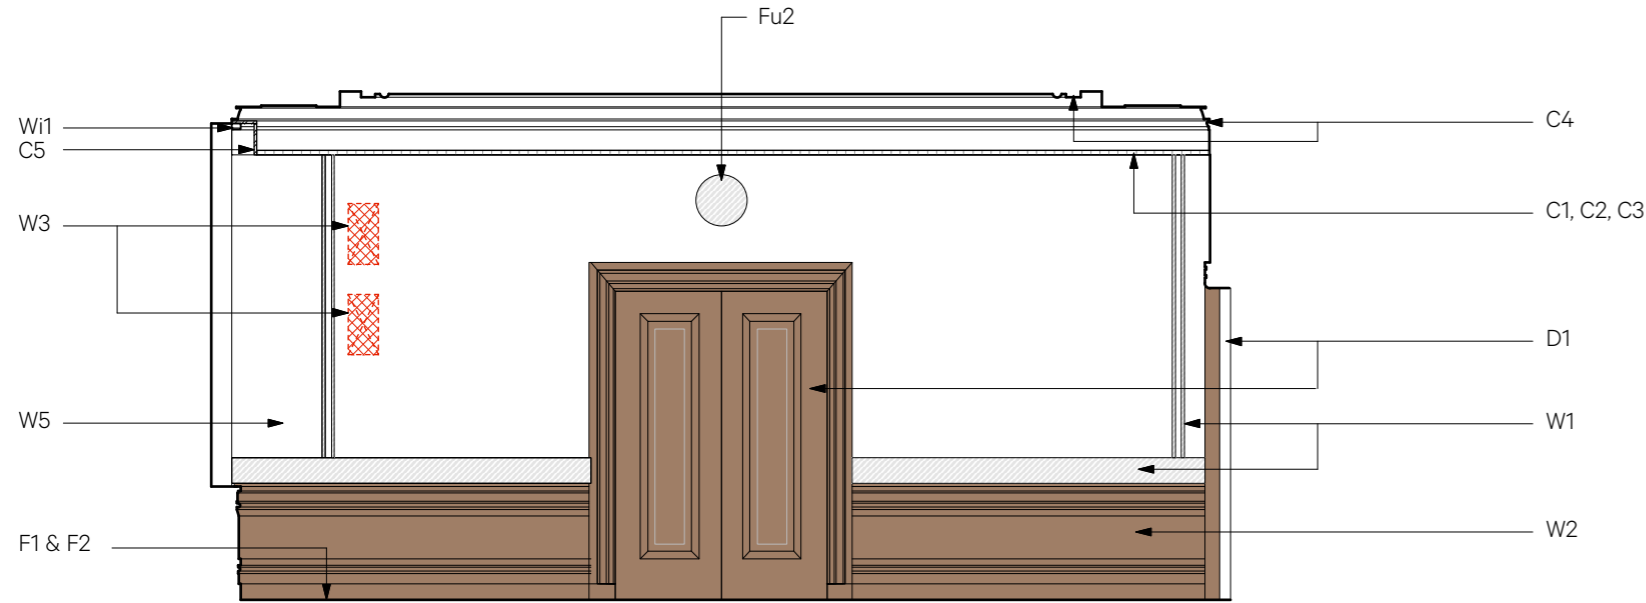
- W1 Existing services to be removed, including dado trunking. Refer to photographs P1-4.
- W2 Existing hardwood panelling retained and protected throughout works. Refer to photographs P1-4.
- W3 New penetrations to west wall (between G.04 and G.05) located below existing cornice level for ventilation ductwork. Refer to photograph P4.
- W4 Existing transfer grille above door to north elevation to be retained. Refer to photographs P1 & P5.
- W5 Existing walls made good and redecorated. Refer to photographs P1-4.
- W6 New power and data trunking with hardwood covering to match existing hardwood panelling.
- W7 New heavy curtains to south elevation.
- W8 New acoustic wall boards to provide mounting for AV screens.

- C1 Existing suspended ceiling and fixings to be removed. Refer to photographs P1-4.
- C2 Existing ceiling-level services and lighting to be removed. Refer to photographs P1-4.
- C3 Existing above-ceiling services to be generally removed, with the exception of existing water pipes serving the library above.
- C4 Existing ceiling cornice retained and protected throughout the works. Existing condition to be surveyed following the removal of the existing suspended ceiling. Refer to photograph P11.
- C5 Existing boxing out of window heads at ceiling level removed. Refer to photograph P6.
- C6 New suspended ceiling.
- C7 Chandelier.
- C8 New recessed track lighting.
- C9 New recessed linear ventilation slot diffuser/extract.
