LEVEL MONITORING - RELATIVE SURVEY READINGS

LEVEL MONITORING - RELATIVE MOVEMENT SKETCH

Client Ref: SU1905449

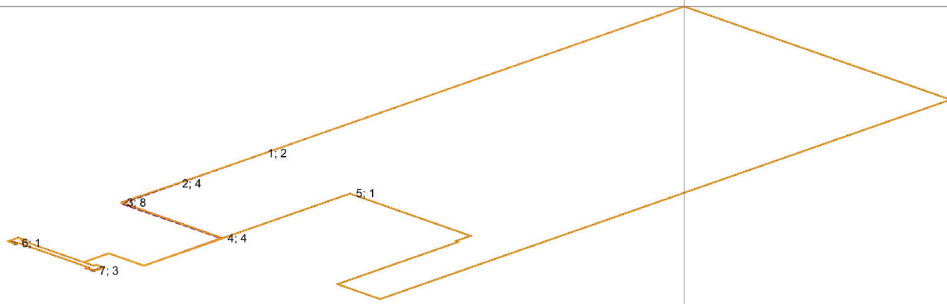
Reading 1 (29/6/20)	Reading 2 (27/8/20)	Reading 3 (20/10/20)	Reading 4 (7/1/21)	Reading 5 (9/3/21)	Reading 6 (12/5/21)
Reading 7 (13/7/21)	Reading 8 (22/9/21)	Reading 9 (0/1/00)	Reading 10 (0/1/00)	Reading 11 (0/1/00)	Reading 12 (0/1/00)

Notes:
Vertical distorted scale 1: 5
Point labels give level difference of last reading from original datum in mm.

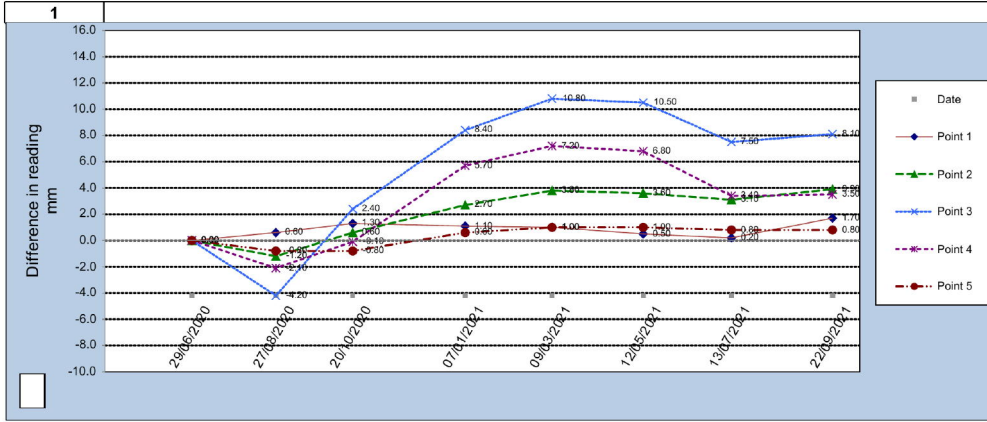
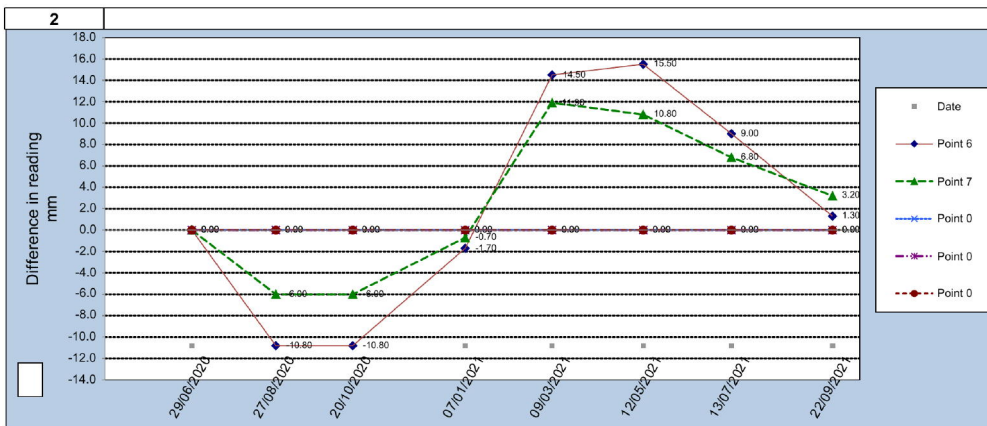
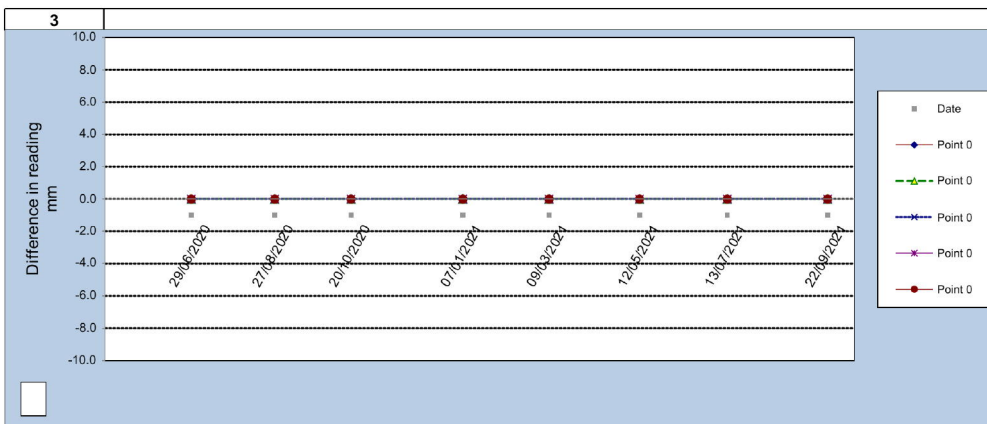
LEVEL MONITORING - RELATIVE SURVEY READINGS

Chart Scale 1:1000
