**GROUND MOVEMENT ANALYSIS REPORT**

**PROPOSED BASEMENT CONSTRUCTION:  
31 ELSWORTHY ROAD, LONDON NW3 3BY**

**Report ref:** **10588A/JRCB/R1**

**Date:** **29<sup>th</sup> September 2021**

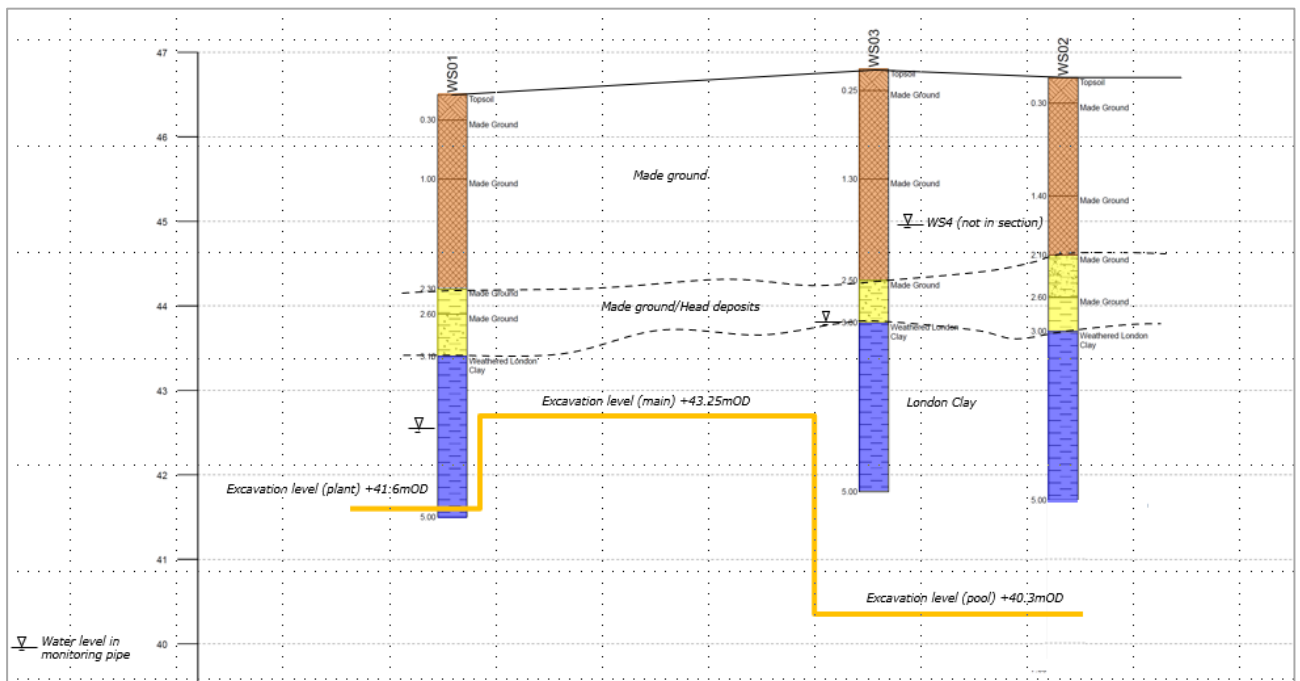
A schematic cross section through the boreholes is as follows:

It is noted that the boreholes did not extend to the level of the deepest basement. We are confident that the in-situ London Clay was encountered in the boreholes and that the risk of unforeseen ground below 5m depth is low. Historical BGS borehole records indicate that the London Clay extends to >50m depth in this area.

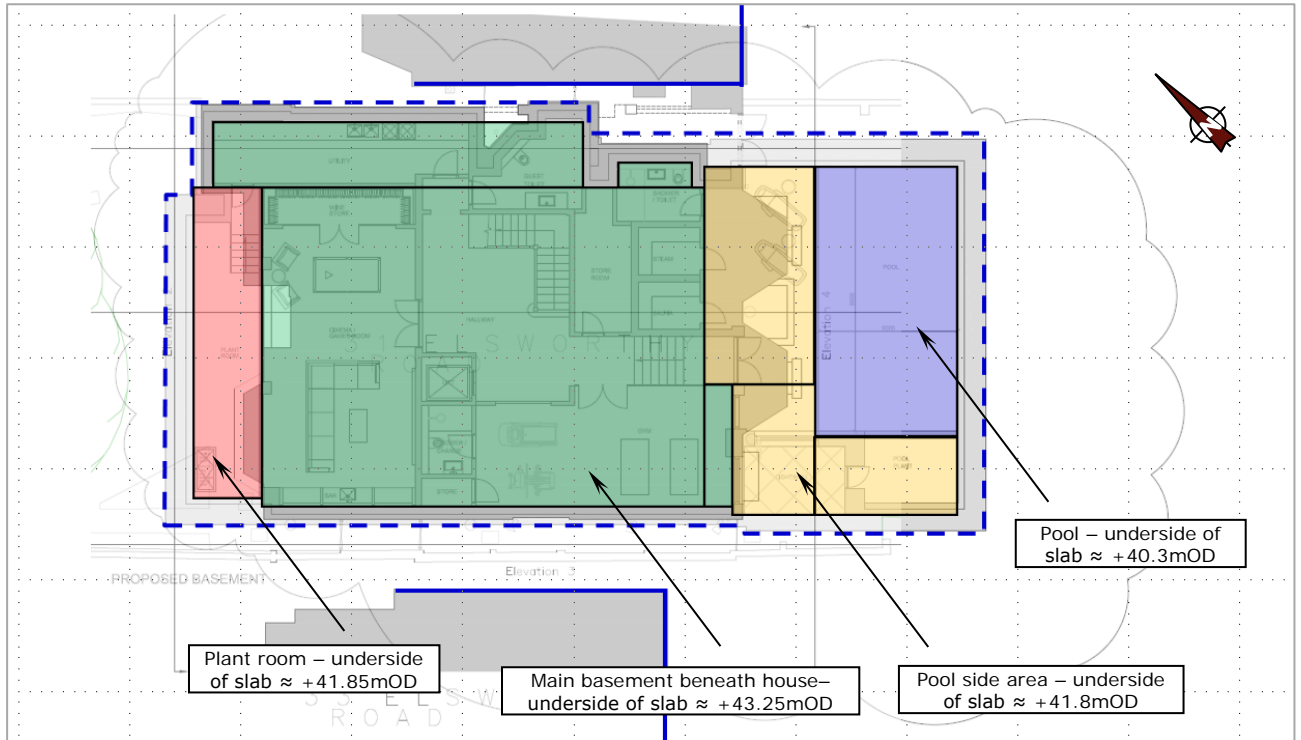
A plan of the proposed basement footprint is shown below (BB Partnership Ltd drawing GEO\_201, Jan 21):

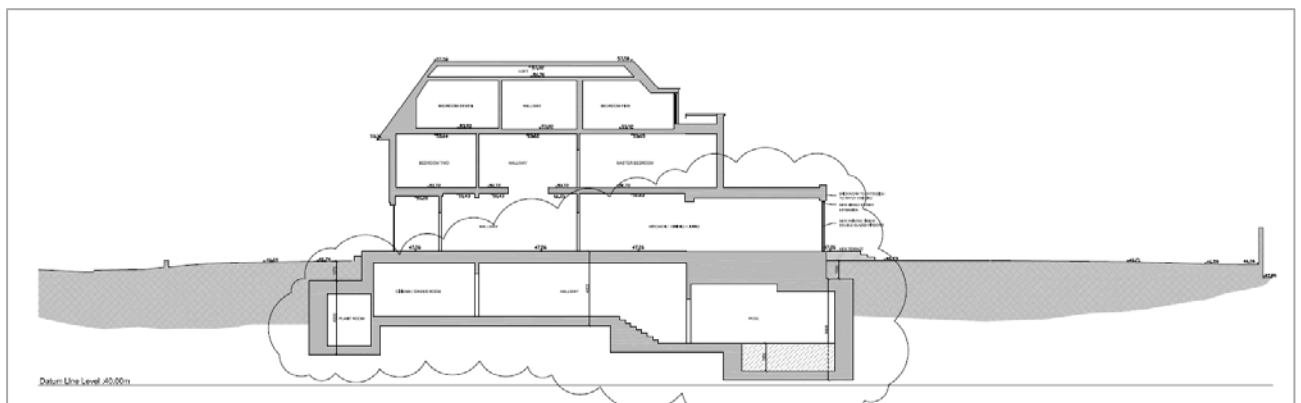
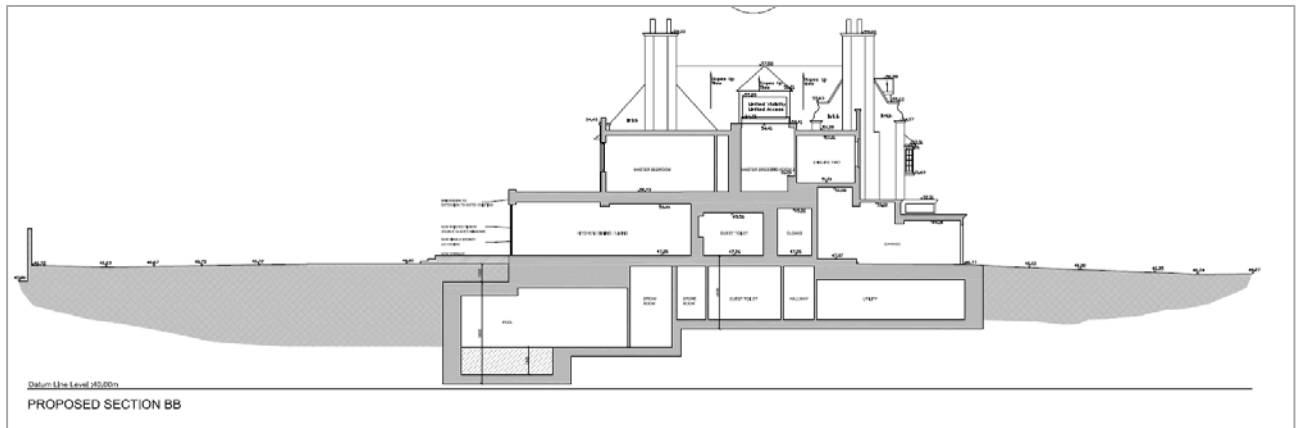
In section, the proposed layout is as follows (BB Partnership Ltd drawing GEO\_215/C, Sep 21):

- ✚ Conventional underpinning of the existing foundations down to new basement levels
- ✚ Sequential basement wall construction in rear and front gardens where no structure is currently present
- ✚ Excavation of basement

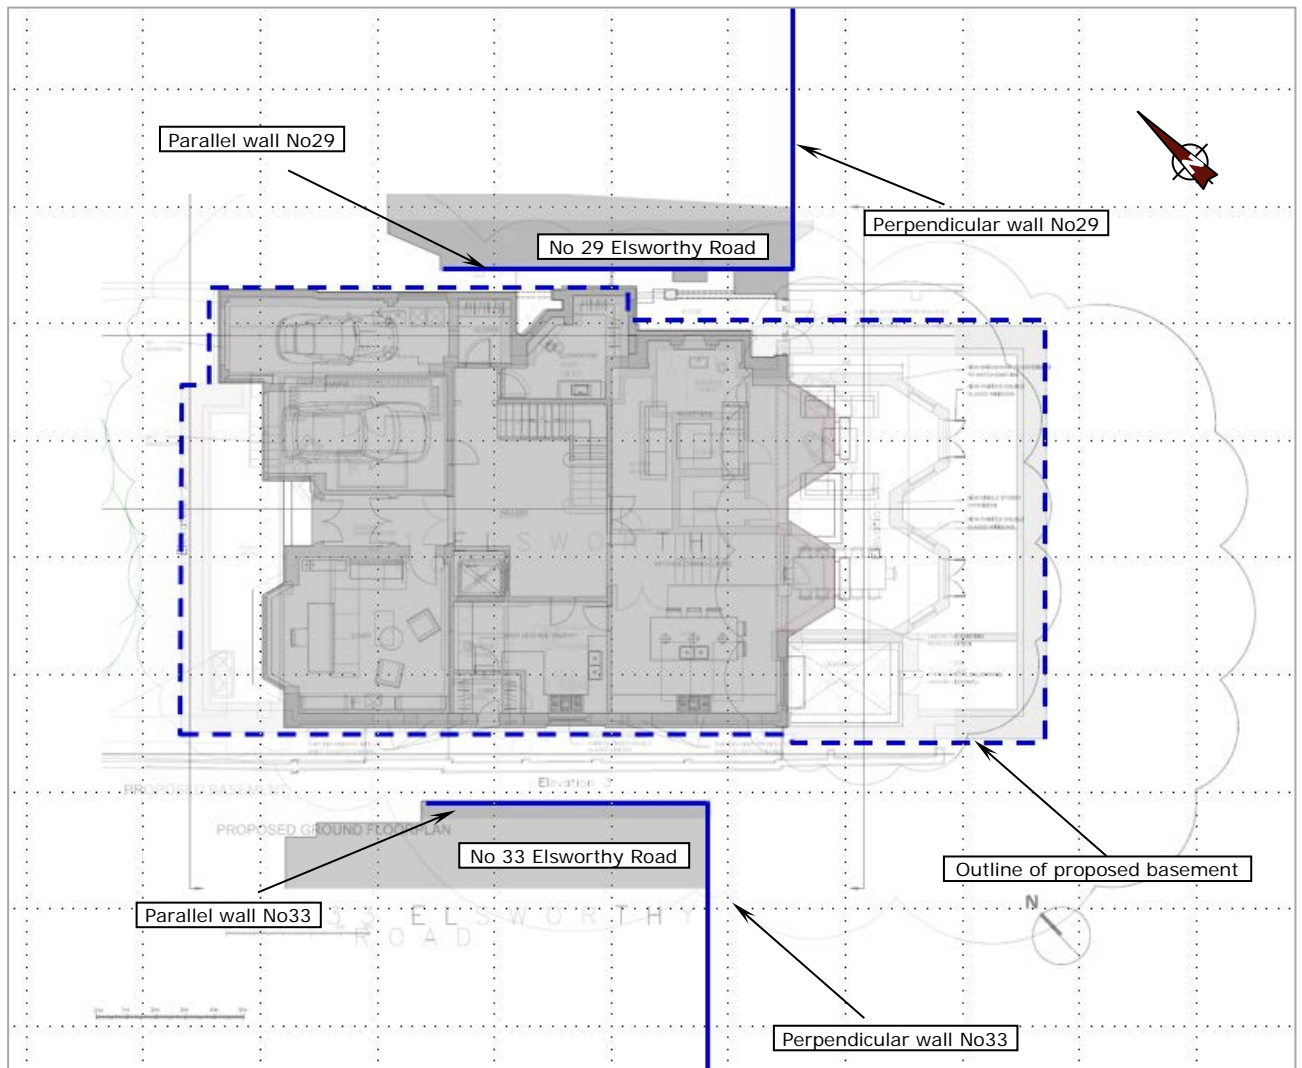
The purpose of this analysis is to calculate the potential horizontal and vertical movements beneath the most critical zones of the adjacent properties/infrastructure and allow an assessment of the damage classification. A sketch showing the existing site layout, the proposed basement and the adjacent properties is as follows:

Structures within the zone of influence of the basement excavation and potentially at risk (shown in solid blue above) are taken as the perpendicular and parallel walls of both adjacent properties.

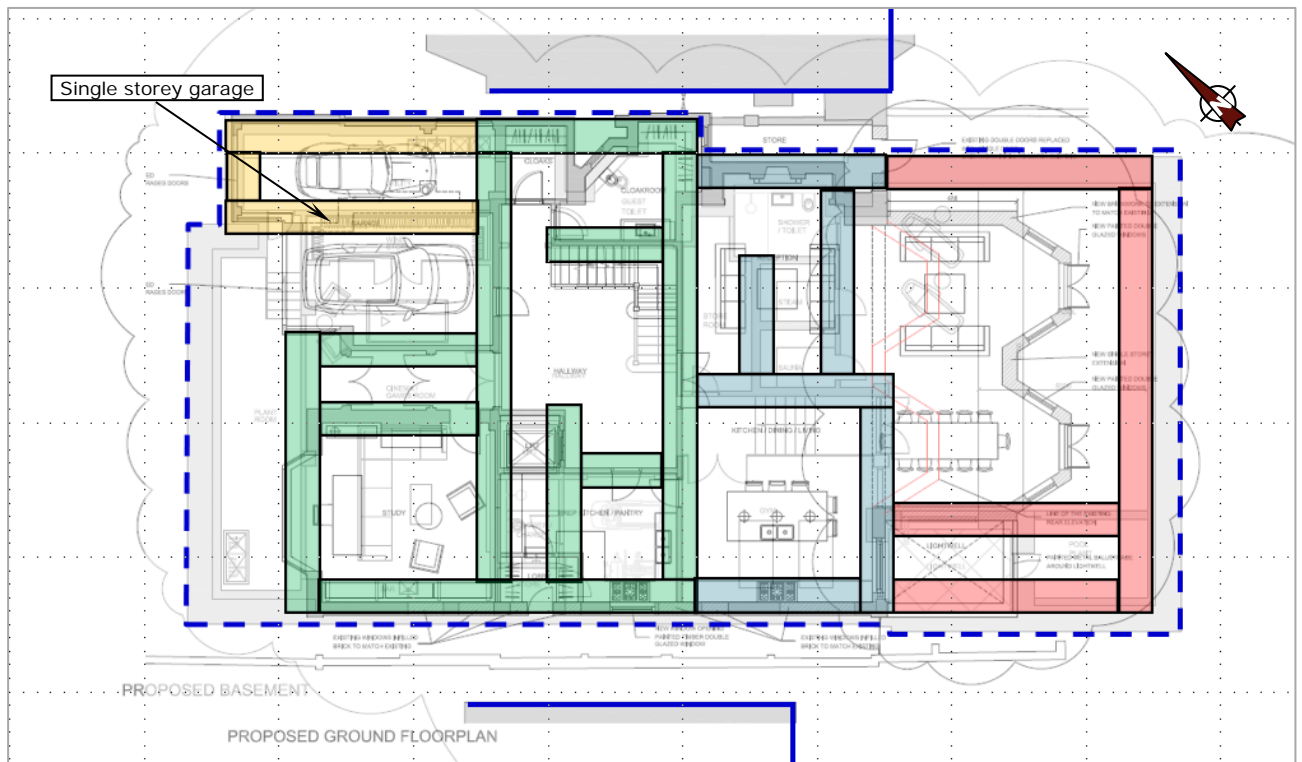
The analytical technique depends on the selection of appropriate rectangular areas to simulate loading by the new underpins. We have assumed that the following peripheral walls and internal walls will be underpinned and the new loaded areas are shown in the following drawing:

The analysis assumes that all elements equate to loads over a series of rectangular areas representing the foundations. The following loadings have been assumed:

Main house/hallway (green)	-	70kPa
Main house/pool area (blue)	-	70kPa
Single-storey garage (yellow)	-	30kPa
Pool/pool area (red)	-	20kPa

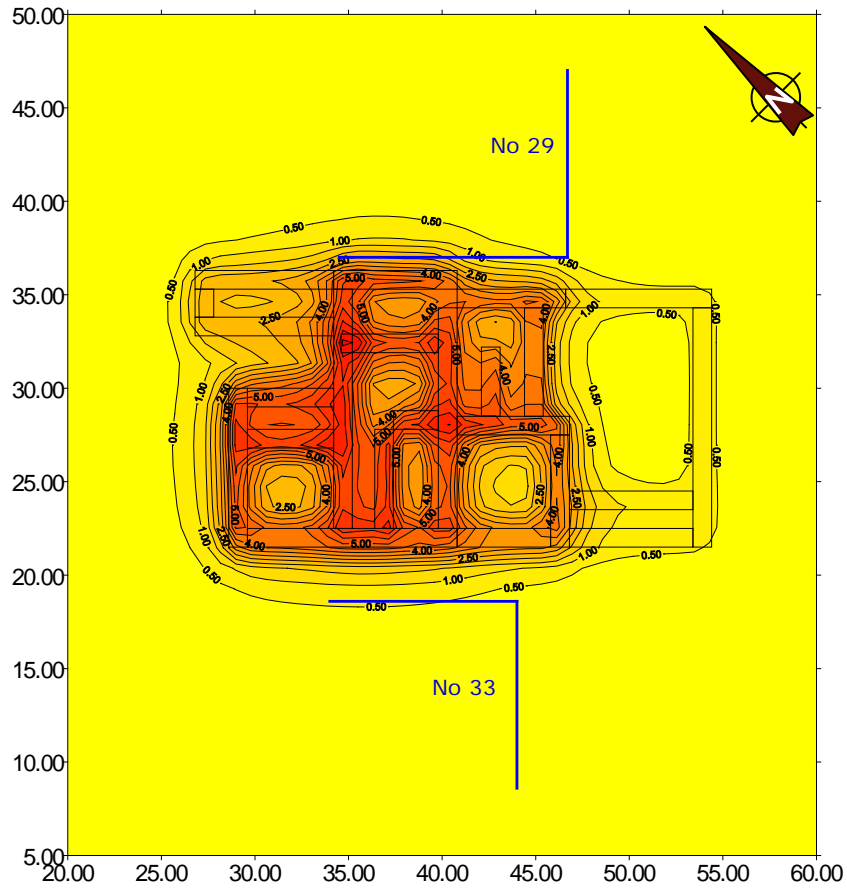
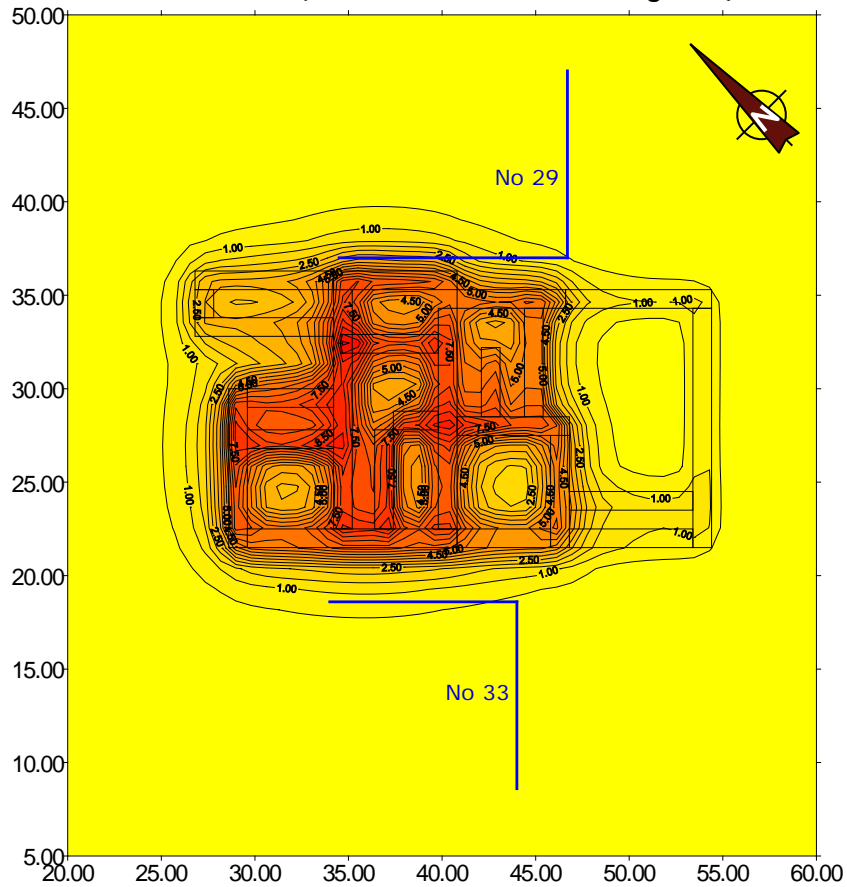
FIGURE 2

Settlement due to underpinning/foundation loading

Contour output

End of construction (100% immediate and 20% long term)

Post construction (0% immediate and 80% long term)

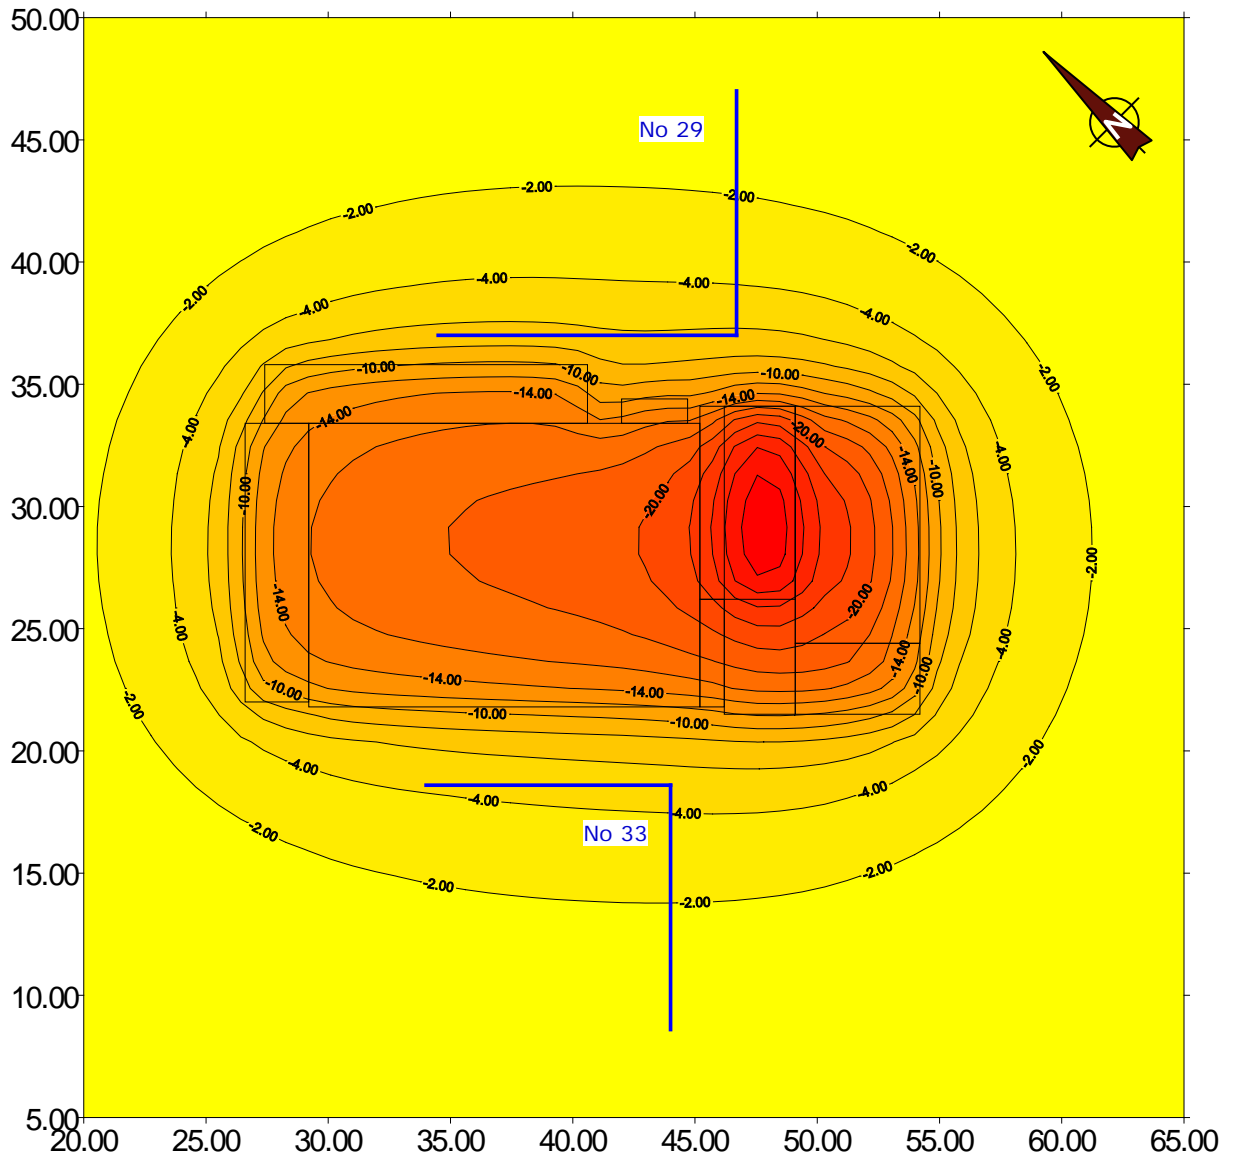
FIGURE 4

Contour output

Post construction (0% immediate and 80% long term)

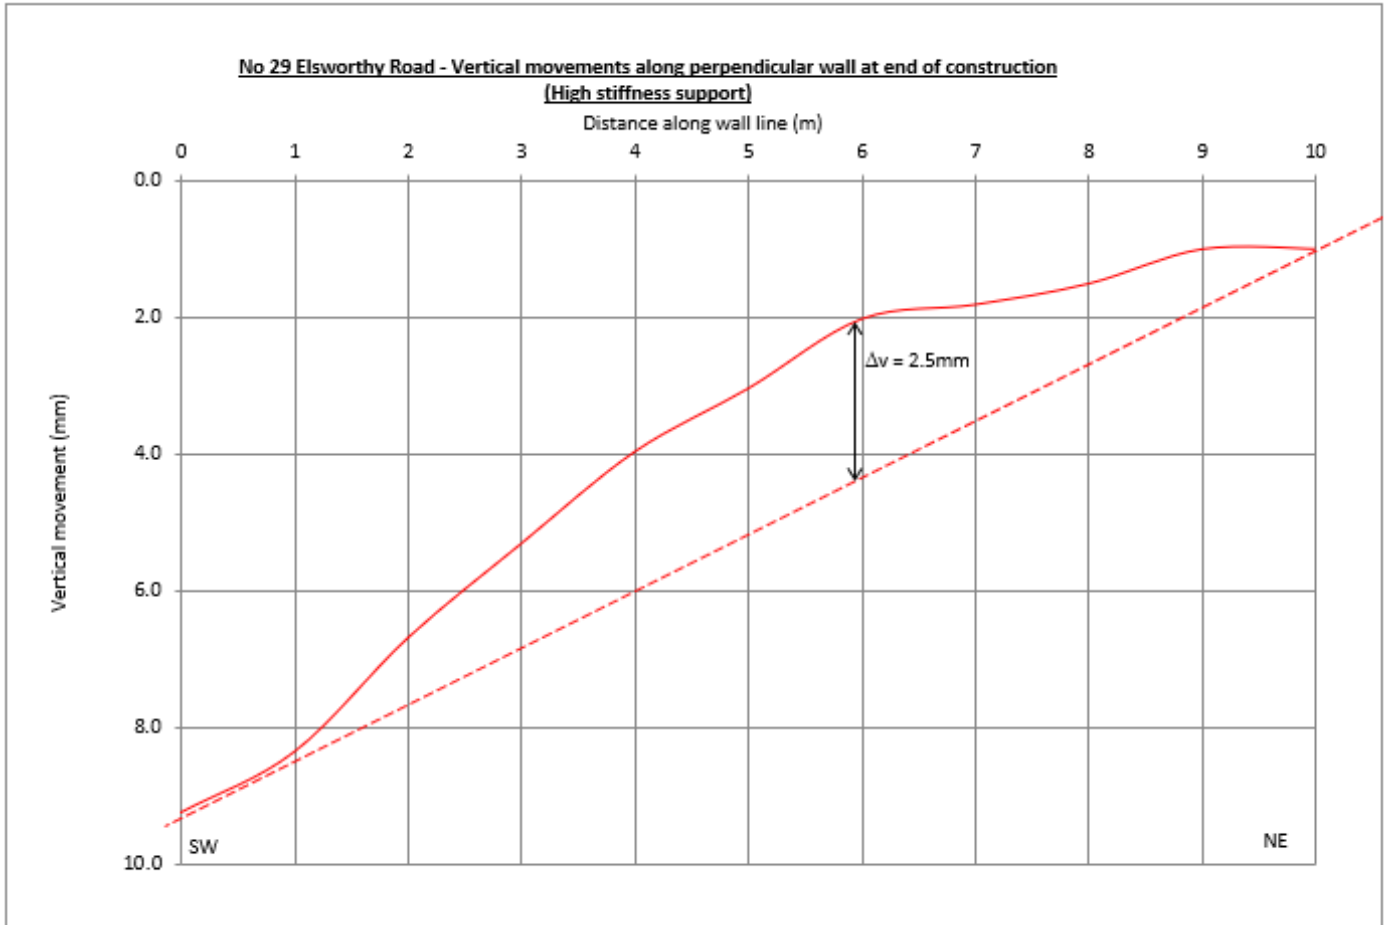
FIGURE 5

Settlement profile – No 29 Elsworthy Road perpendicular wall (High stiffness)

End of construction

Perpendicular wall - vertical movement at end of construction HIGH				
Distance along wall line (m)	Installation	Settlement (loading)	Settlement (excavation)	Net vertical movement at end of construction (mm)
	Estimated from CIRIA chart	Due to foundations - from Bouss spreadsheet (mm)	Settlement due to basement excavation - estimated from CIRIA chart (mm)	
0.0	5.0	0.7	3.5	9.2
1.0	4.0	0.3	4.0	8.3
2.0	3.0	0.2	3.5	6.7
3.0	2.0	0.1	3.2	5.3
4.0	1.0	0.1	2.9	4.0
5.0	0.5	0.0	2.5	3.0
6.0	0.0	0.0	2.0	2.0
7.0	0.0	0.0	1.8	1.8
8.0	0.0	0.0	1.5	1.5
9.0	0.0	0.0	1.0	1.0
10.0	0.0	0.0	1.0	1.0

Profiles of the assessed vertical movement along the line of this wall are shown for both high and intermediate stiffness support in Figures 5 to 8. The  $\Delta v$  values obtained from these profiles are used in assessing vertical strains for damage assessment.

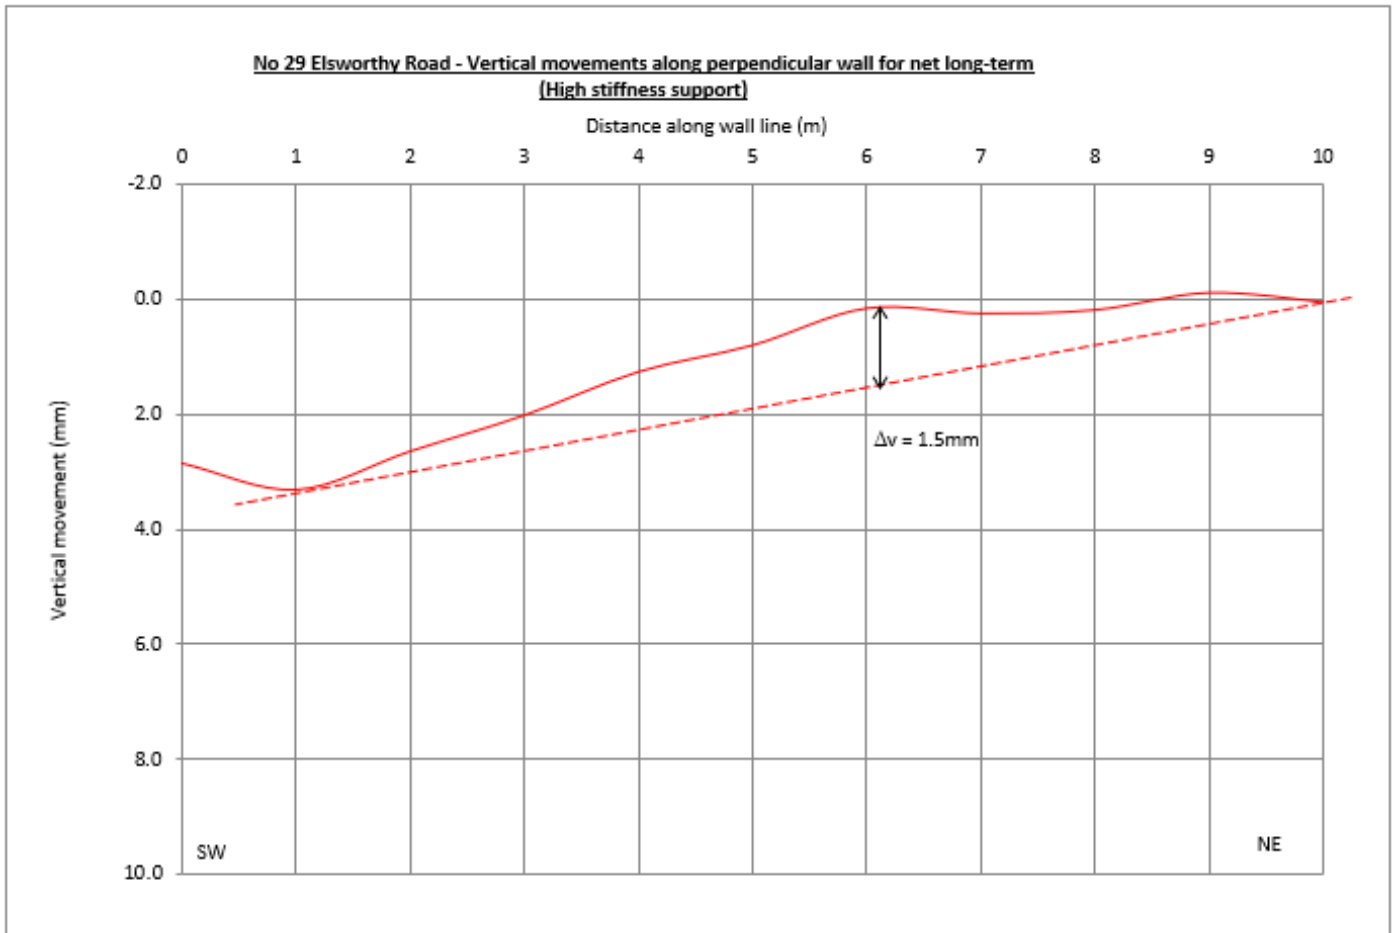
**Settlement profile – No 29 Elsworthy Road perpendicular wall (High stiffness)**

Long term

Distance along wall line (m)	Perpendicular wall - vertical movement long-term HIGH		
	Settlement (loading)	Heave (unloading)	Net total movement long-term (mm)
	Due to foundations - from Bouss spreadsheet (mm)	Post-construction heave - from Bouss spreadsheet (mm)	
0.0	1.0	-6.4	2.9
1.0	0.5	-5.0	3.3
2.0	0.2	-4.0	2.6
3.0	0.1	-3.3	2.0
4.0	0.1	-2.7	1.3
5.0	0.1	-2.3	0.8
6.0	0.0	-1.9	0.1
7.0	0.0	-1.6	0.2
8.0	0.0	-1.3	0.2
9.0	0.0	-1.1	-0.1
10.0	0.0	-1.0	0.0

(Note: total long term net is determined using the end of construction movement and the post construction movements)

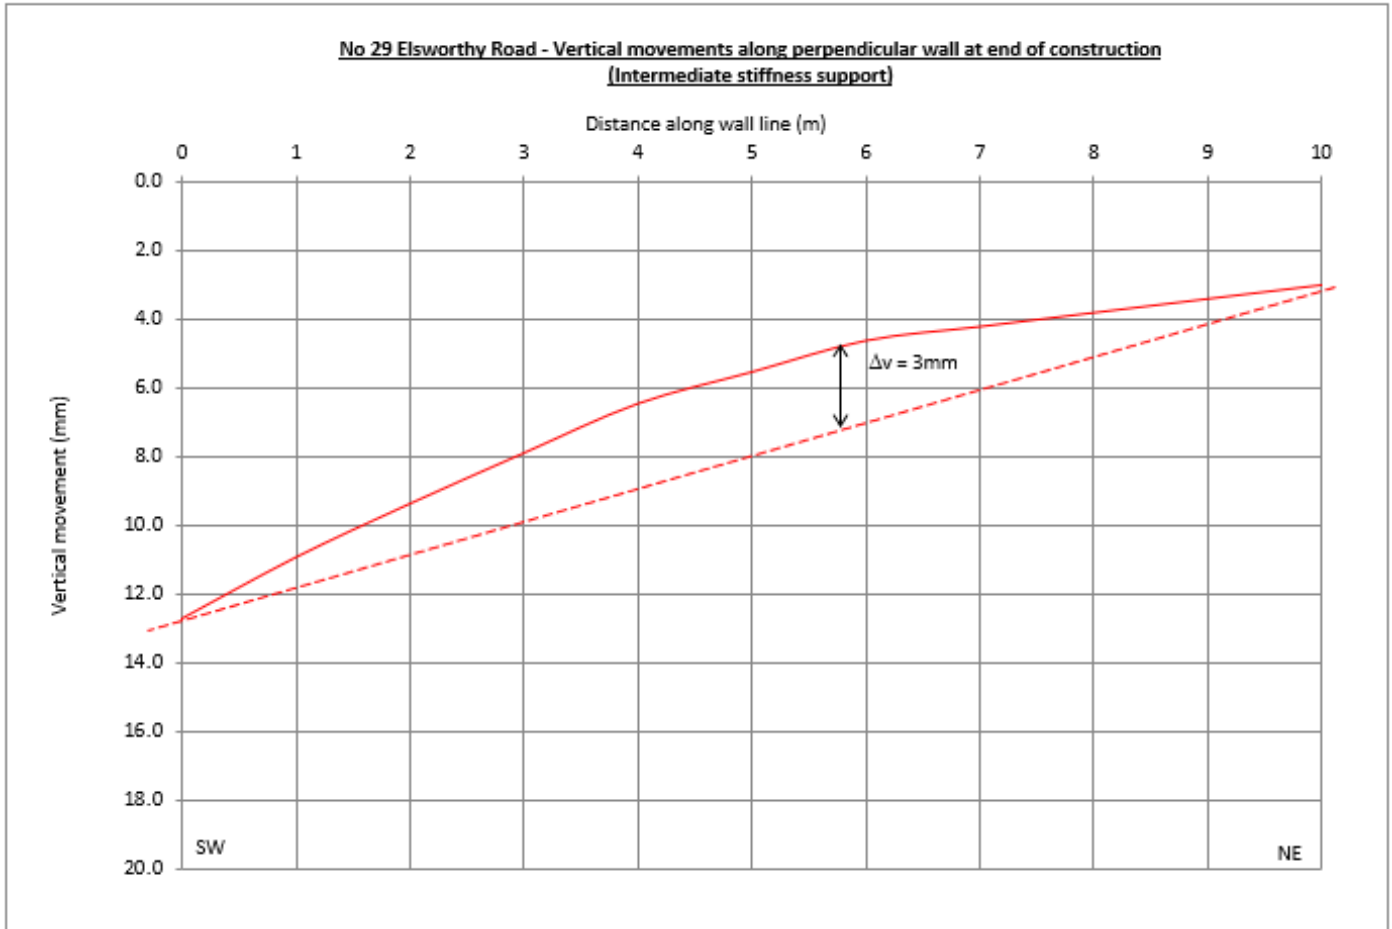
**FIGURE 7**

**Settlement profile – No 29 Elsworthy Road perpendicular wall (Intermediate stiffness)**

**End of construction**

<b>Perpendicular wall - vertical movement at end of construction INTERMEDIATE</b>				
Distance along wall line (m)	Installation	Settlement (loading)	Settlement (excavation)	Net vertical movement at end of construction (mm)
	Estimated from CIRIA chart	Due to foundations - from Bouss spreadsheet (mm)	Settlement due to basement excavation - estimated from CIRIA chart (mm)	
0.0	5.0	0.7	7.0	12.7
1.0	4.0	0.3	6.6	10.9
2.0	3.0	0.2	6.2	9.4
3.0	2.0	0.1	5.8	7.9
4.0	1.0	0.1	5.4	6.5
5.0	0.5	0.0	5.0	5.5
6.0	0.0	0.0	4.6	4.6
7.0	0.0	0.0	4.2	4.2
8.0	0.0	0.0	3.8	3.8
9.0	0.0	0.0	3.4	3.4
10.0	0.0	0.0	3.0	3.0

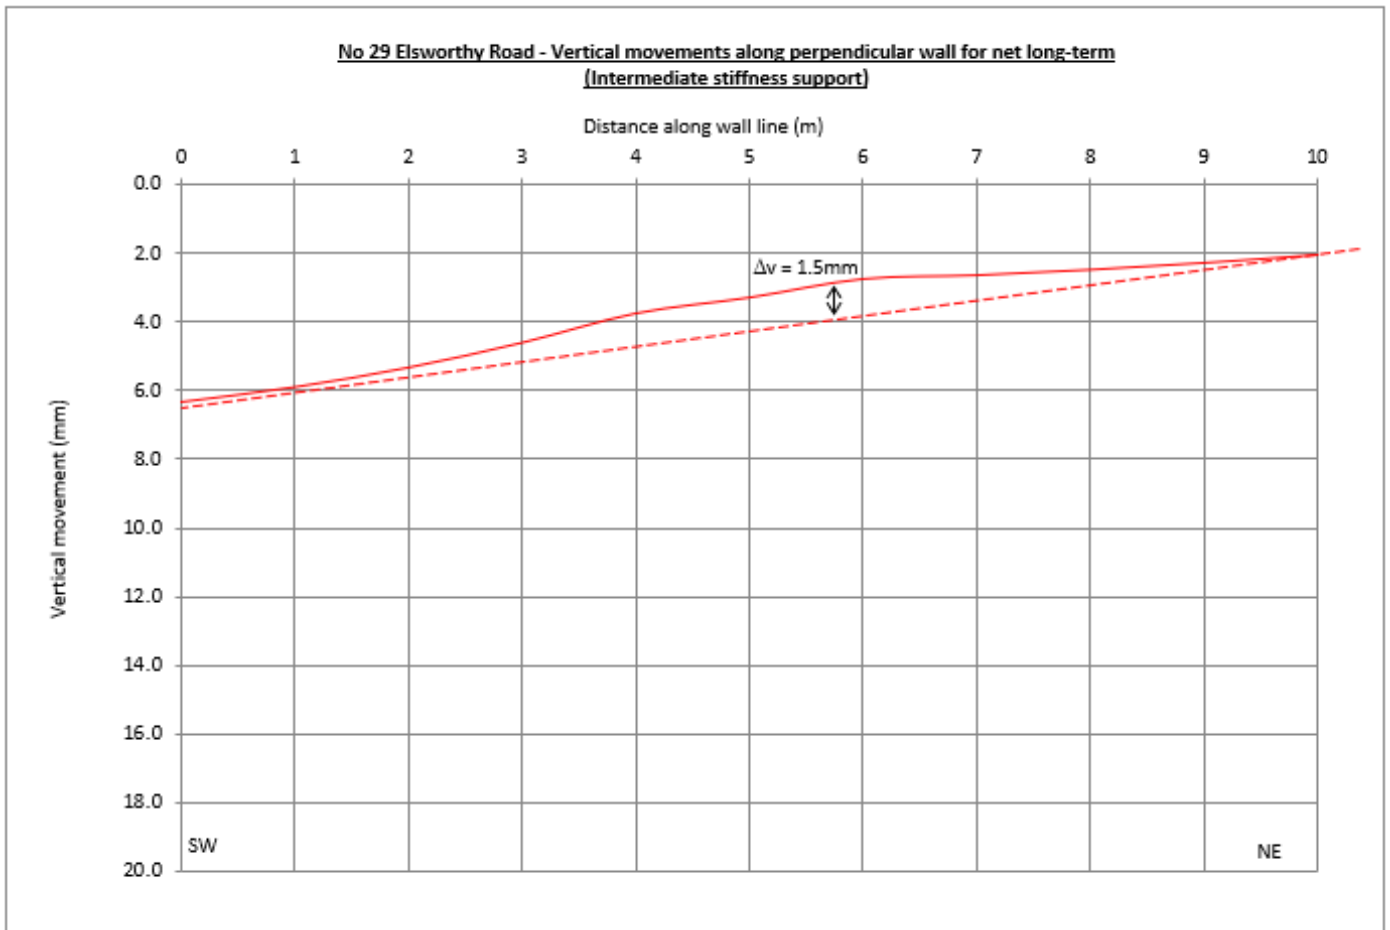
Settlement profile – No 29 Elsworthy Road perpendicular wall (Intermediate stiffness)

Long term

Distance along wall line (m)	Perpendicular wall - vertical movement long-term INT		
	Settlement (loading)	Heave (unloading)	Net total movement long-term (mm)
	Due to foundations - from Bouss spreadsheet (mm)	Post-construction heave - from Bouss spreadsheet (mm)	
0.0	1.0	-6.4	6.4
1.0	0.5	-5.0	5.9
2.0	0.2	-4.0	5.3
3.0	0.1	-3.3	4.6
4.0	0.1	-2.7	3.8
5.0	0.1	-2.3	3.3
6.0	0.0	-1.9	2.7
7.0	0.0	-1.6	2.6
8.0	0.0	-1.3	2.5
9.0	0.0	-1.1	2.3
10.0	0.0	-1.0	2.0

(Note: total long term net movement is determined using the end of construction movement and the post construction movements)

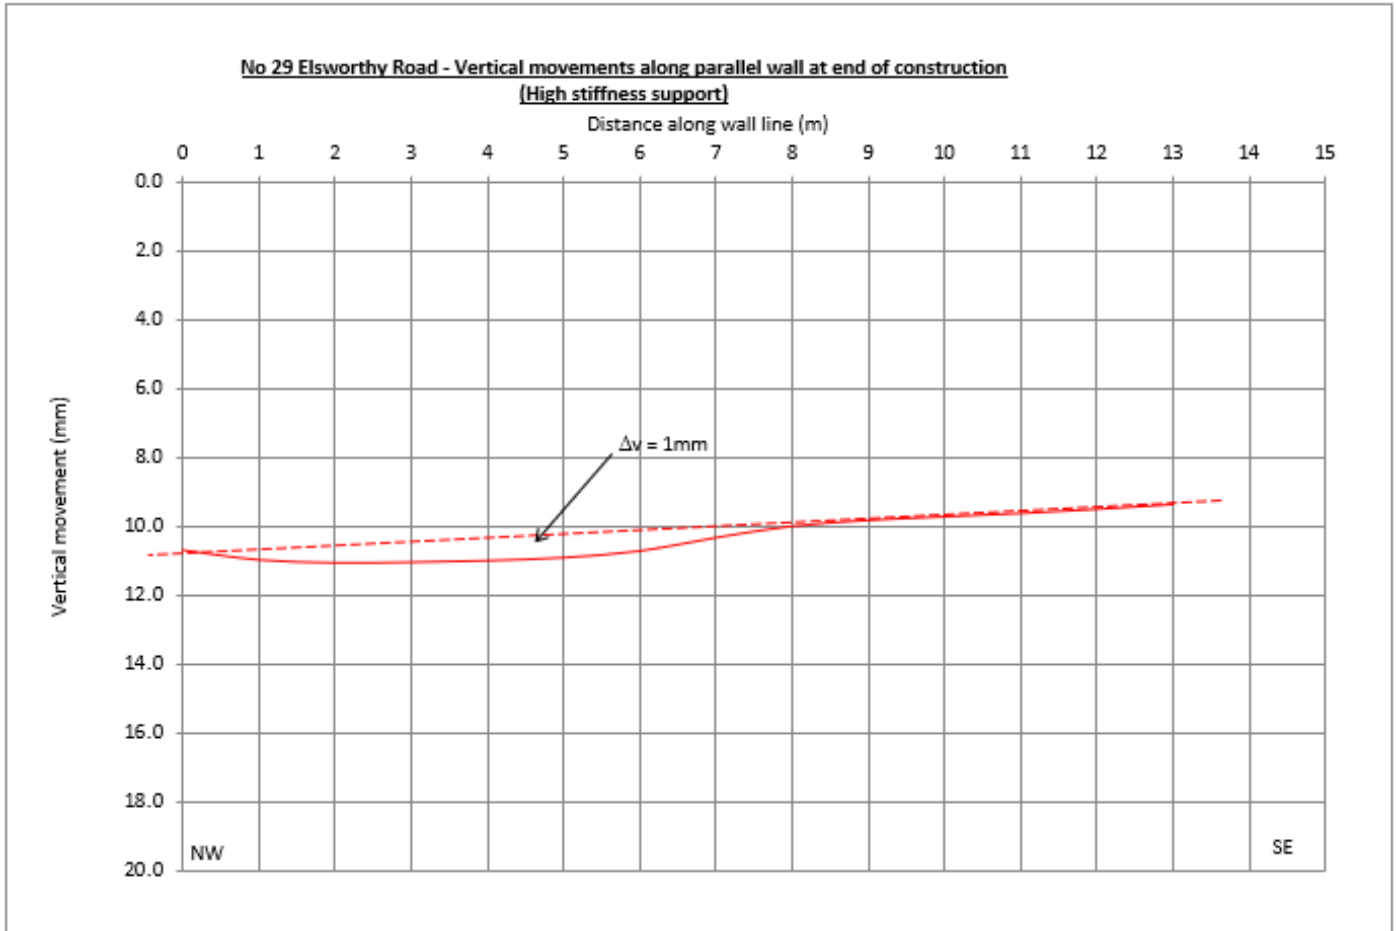
**FIGURE 9**

**Settlement profile – No 29 Elsworthy Road parallel wall (High stiffness)**

**End of construction**

<b>Parallel wall - vertical movement at end of construction HIGH</b>				
Distance along wall line (m)	Installation	Settlement (loading)	Settlement (excavation)	Net vertical movement at end of construction (mm)
	Estimated from CIRIA chart	Due to foundations - from Bouss spreadsheet (mm)	Settlement due to basement excavation - estimated from CIRIA chart	
0.0	5.0	1.7	4.0	10.7
1.0	5.0	2.0	4.0	11.0
2.0	5.0	2.1	4.0	11.1
3.0	5.0	2.1	4.0	11.1
4.0	5.0	2.0	4.0	11.0
5.0	5.0	1.9	4.0	10.9
6.0	5.0	1.7	4.0	10.7
7.0	5.0	1.3	4.0	10.3
8.0	5.0	1.0	4.0	10.0
9.0	5.0	0.8	4.0	9.8
10.0	5.0	0.7	4.0	9.7
11.0	5.0	0.6	4.0	9.6
12.0	5.0	0.5	4.0	9.5
13.0	5.0	0.3	4.0	9.3

Profiles of the assessed vertical movement along the line of this wall are shown for both high and intermediate stiffness support in Figures 9 to 12. The  $\Delta v$  values obtained from these profiles are used in assessing vertical strains for damage assessment.

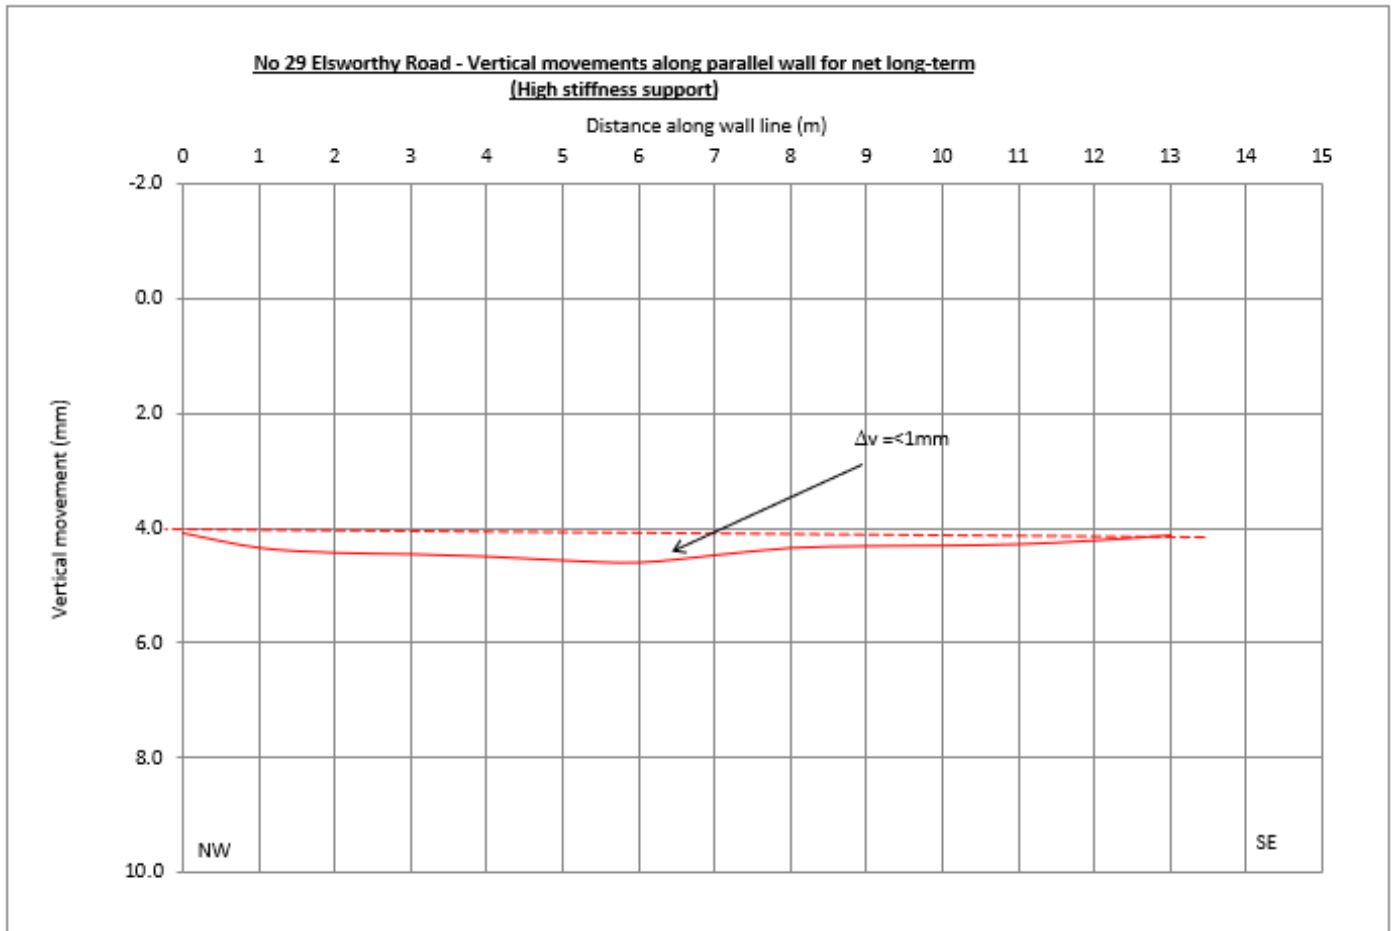
Settlement profile – No 29 Elsworthy Road parallel wall (High stiffness)

Long term

Distance along wall line (m)	Parallel wall - vertical movement long-term HIGH		
	Settlement (loading)	Heave (unloading)	Net total movement long-term (mm)
	Due to foundations - from Bouss spreadsheet (mm)	Post-construction heave - from Bouss spreadsheet (mm)	
0.0	2.2	-6.6	4.1
1.0	2.6	-6.6	4.3
2.0	2.7	-6.6	4.4
3.0	2.7	-6.6	4.4
4.0	2.7	-6.5	4.5
5.0	2.5	-6.4	4.6
6.0	2.3	-6.1	4.6
7.0	1.8	-5.9	4.5
8.0	1.3	-5.7	4.3
9.0	1.1	-5.5	4.3
10.0	0.9	-5.4	4.3
11.0	0.8	-5.3	4.3
12.0	0.6	-5.3	4.2
13.0	0.5	-5.2	4.1

(Note: total long term net is determined using the end of construction movement and the post construction movements)

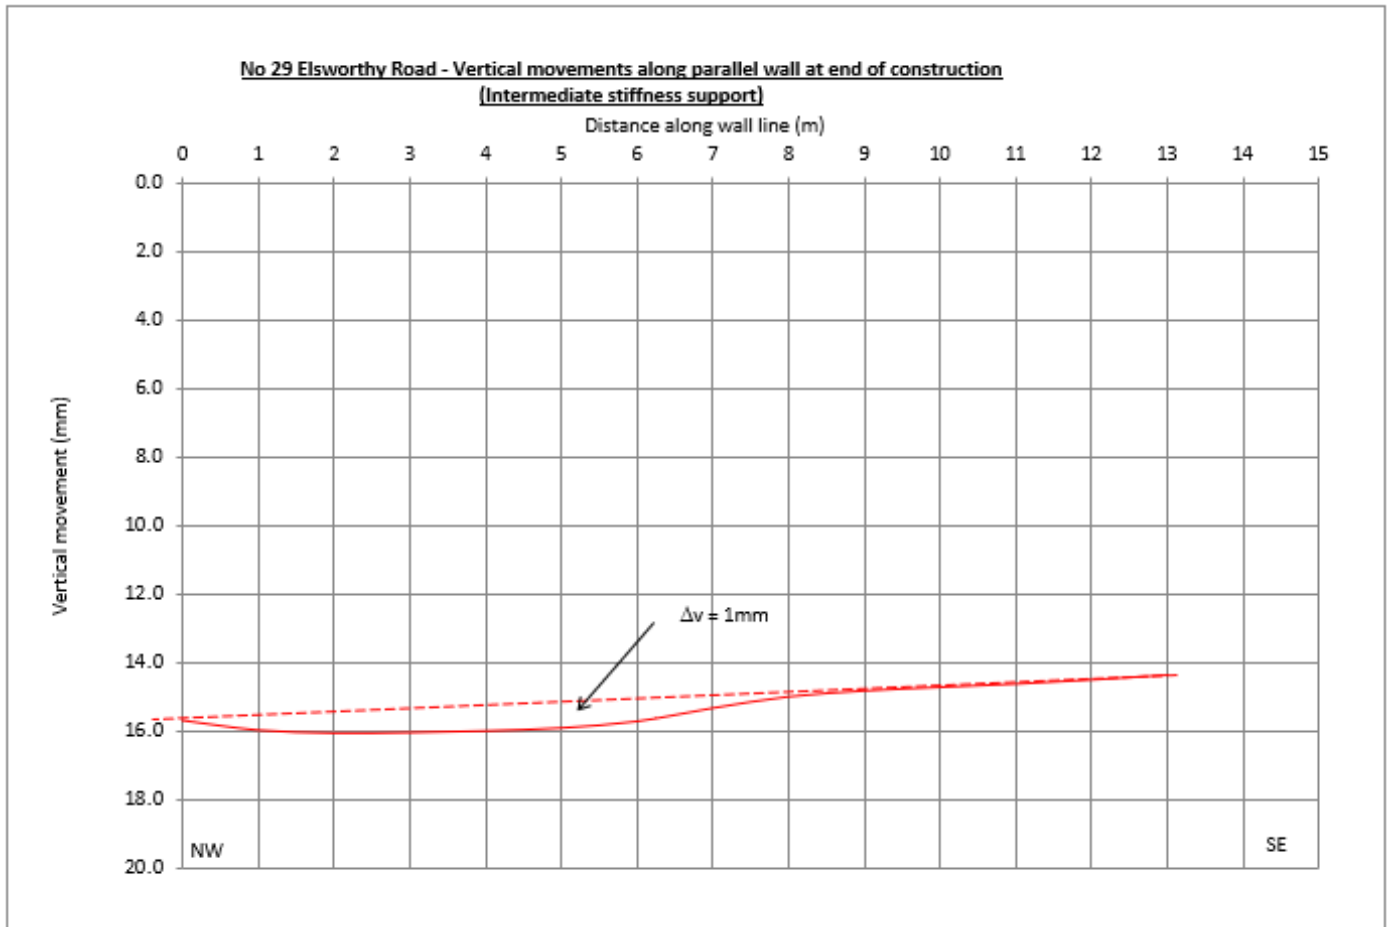
FIGURE 11

Settlement profile – No 29 Elsworthy Road parallel wall (Intermediate stiffness)

End of construction

Parallel wall - vertical movement at end of construction Intermediate				
Distance along wall line (m)	Installation	Settlement (loading)	Settlement (excavation)	Net vertical movement at end of construction (mm)
	Estimated from CIRIA chart	Due to foundations - from Bouss spreadsheet (mm)	Settlement due to basement excavation - estimated from CIRIA chart	
0.0	5.0	1.7	9.0	15.7
1.0	5.0	2.0	9.0	16.0
2.0	5.0	2.1	9.0	16.1
3.0	5.0	2.1	9.0	16.1
4.0	5.0	2.0	9.0	16.0
5.0	5.0	1.9	9.0	15.9
6.0	5.0	1.7	9.0	15.7
7.0	5.0	1.3	9.0	15.3
8.0	5.0	1.0	9.0	15.0
9.0	5.0	0.8	9.0	14.8
10.0	5.0	0.7	9.0	14.7
11.0	5.0	0.6	9.0	14.6
12.0	5.0	0.5	9.0	14.5
13.0	5.0	0.3	9.0	14.3

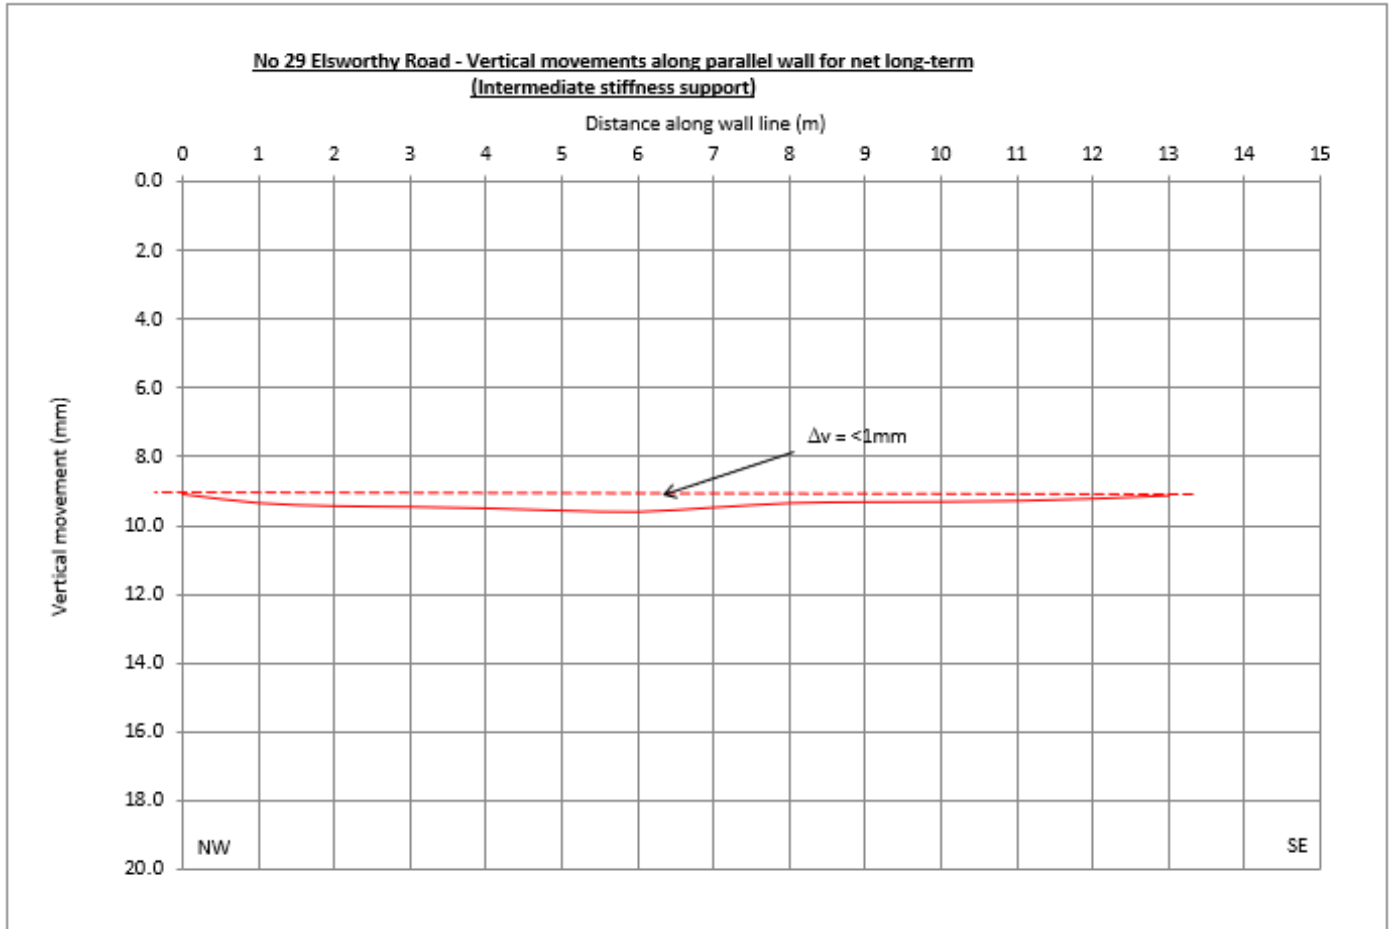
Settlement profile – No 29 Elsworthy Road parallel wall (Intermediate stiffness)

Long term

Distance along wall line (m)	Parallel wall - vertical movement long-term Intermediate		Net total movement long-term (mm)
	Settlement (loading) Due to foundations - from Bouss spreadsheet (mm)	Heave (unloading) Post-construction heave - from Bouss spreadsheet (mm)	
0.0	2.2	-6.6	9.1
1.0	2.6	-6.6	9.3
2.0	2.7	-6.6	9.4
3.0	2.7	-6.6	9.4
4.0	2.7	-6.5	9.5
5.0	2.5	-6.4	9.6
6.0	2.3	-6.1	9.6
7.0	1.8	-5.9	9.5
8.0	1.3	-5.7	9.3
9.0	1.1	-5.5	9.3
10.0	0.9	-5.4	9.3
11.0	0.8	-5.3	9.3
12.0	0.6	-5.3	9.2
13.0	0.5	-5.2	9.1

(Note: total long term net movement is determined using the end of construction movement and the post construction movements)

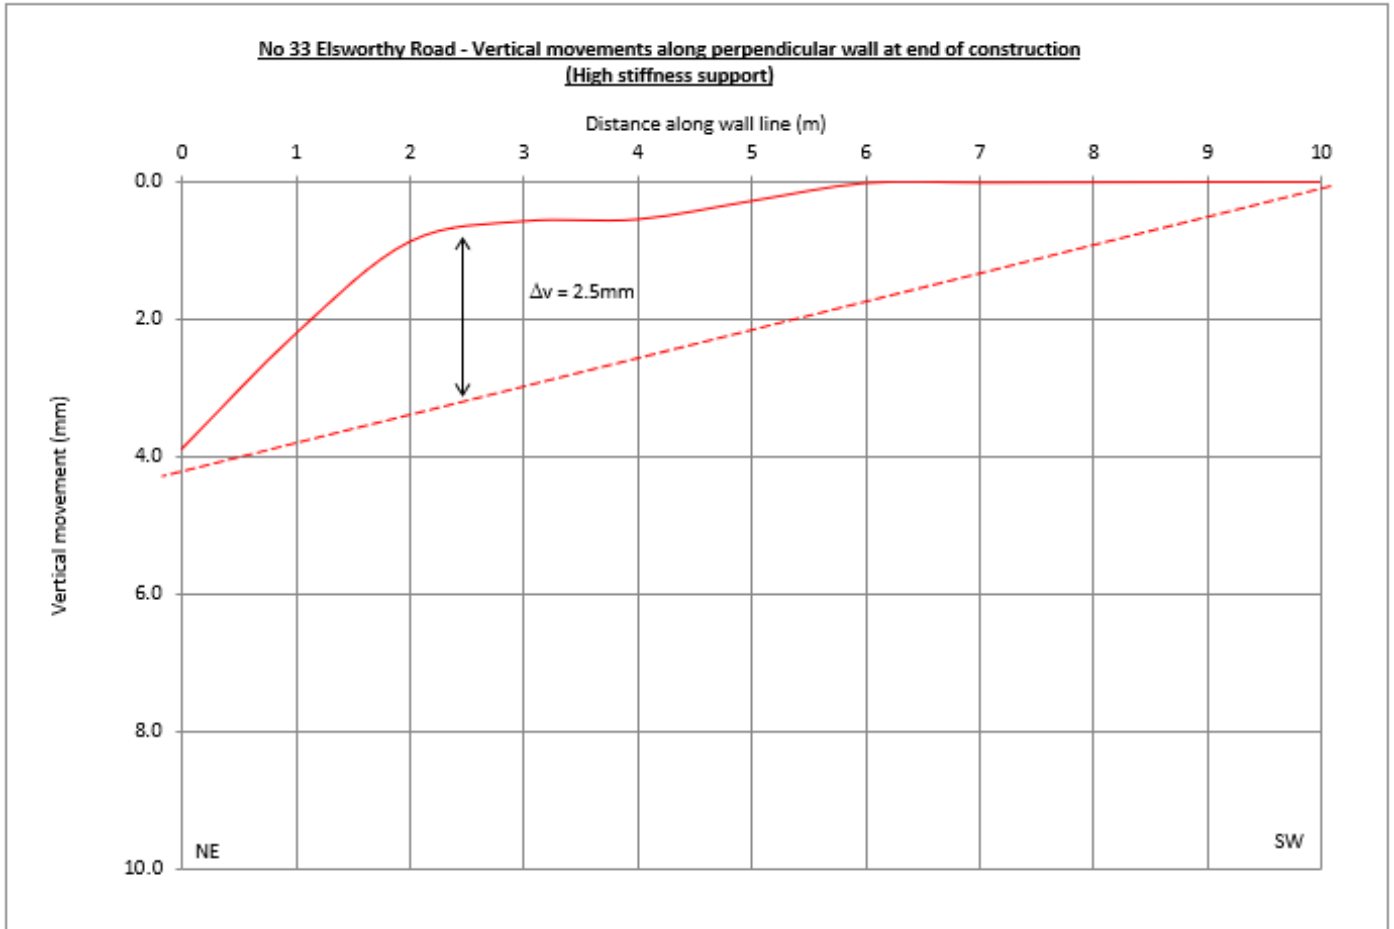
FIGURE 13

Settlement profile – No 33 Elsworthy Road perpendicular wall (High stiffness)

End of construction

Perpendicular wall - vertical movement at end of construction HIGH				
Distance along wall line (m)	Installation	Settlement (loading)	Settlement (excavation)	Net vertical movement at end of construction (mm)
	Estimated from CIRIA chart	Due to foundations - from Bouss spreadsheet (mm)	Settlement due to basement excavation - estimated from CIRIA chart	
0.0	2.0	0.4	1.5	3.9
1.0	1.0	0.2	1.0	2.2
2.0	0.0	0.1	0.8	0.9
3.0	0.0	0.1	0.5	0.6
4.0	0.0	0.1	0.5	0.6
5.0	0.0	0.0	0.3	0.3
6.0	0.0	0.0	0.0	0.0
7.0	0.0	0.0	0.0	0.0
8.0	0.0	0.0	0.0	0.0
9.0	0.0	0.0	0.0	0.0
10.0	0.0	0.0	0.0	0.0

Profiles of the assessed vertical movement along the line of this wall are shown for both high and intermediate stiffness support in Figures 13 to 16. The  $\Delta v$  values obtained from these profiles are used in assessing vertical strains for damage assessment.
