**GROUND MOVEMENT ANALYSIS REPORT**

**PROPOSED BASEMENT CONSTRUCTION:  
31 ELSWORTHY ROAD, LONDON NW3 3BY**

**Report ref:** **10588A/JRCB/R1**

**Date:** **29<sup>th</sup> September 2021**

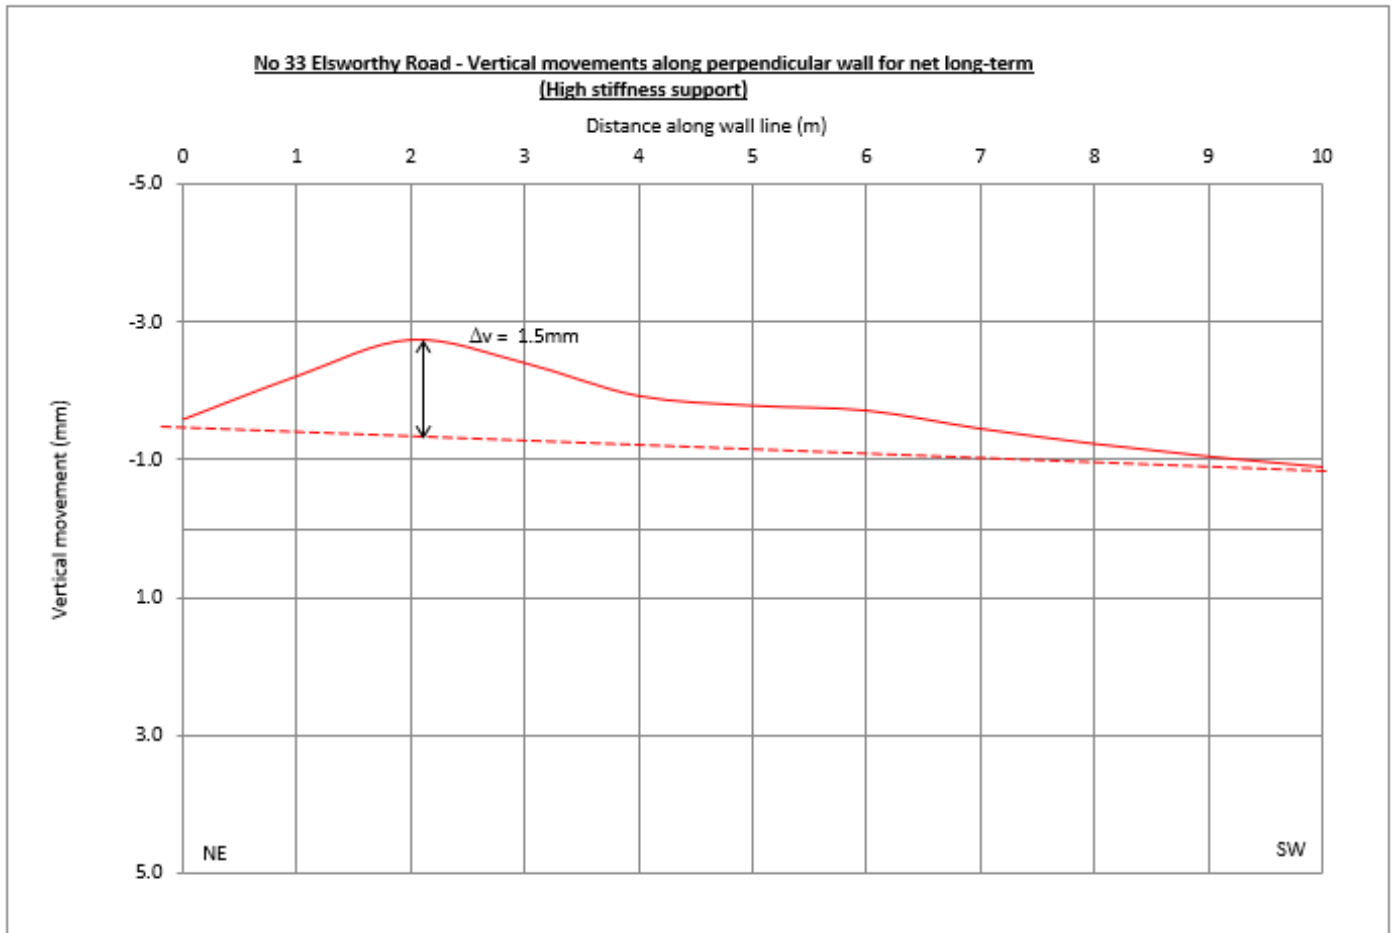
Settlement profile – No 33 Elsworthy Road perpendicular wall (High stiffness)

Long term

Distance along wall line (m)	Perpendicular wall - vertical movement long-term HIGH		
	Settlement (loading)	Heave (unloading)	Net total movement long-term (mm)
	Due to foundations - from Bouss spreadsheet (mm)	Post-construction heave - from Bouss spreadsheet (mm)	
0.0	0.5	-5.5	-1.6
1.0	0.3	-4.4	-2.2
2.0	0.2	-3.6	-2.8
3.0	0.1	-3.0	-2.4
4.0	0.1	-2.5	-1.9
5.0	0.0	-2.1	-1.8
6.0	0.0	-1.7	-1.7
7.0	0.0	-1.5	-1.5
8.0	0.0	-1.3	-1.2
9.0	0.0	-1.1	-1.1
10.0	0.0	-0.9	-0.9

(Note: total long term net is determined using the end of construction movement and the post construction movements)

Profiles of the assessed vertical movement along the line of this wall are shown for both high and intermediate stiffness support in Figures 13 to 16. The  $\Delta v$  values obtained from these profiles are used in assessing vertical strains for damage assessment.

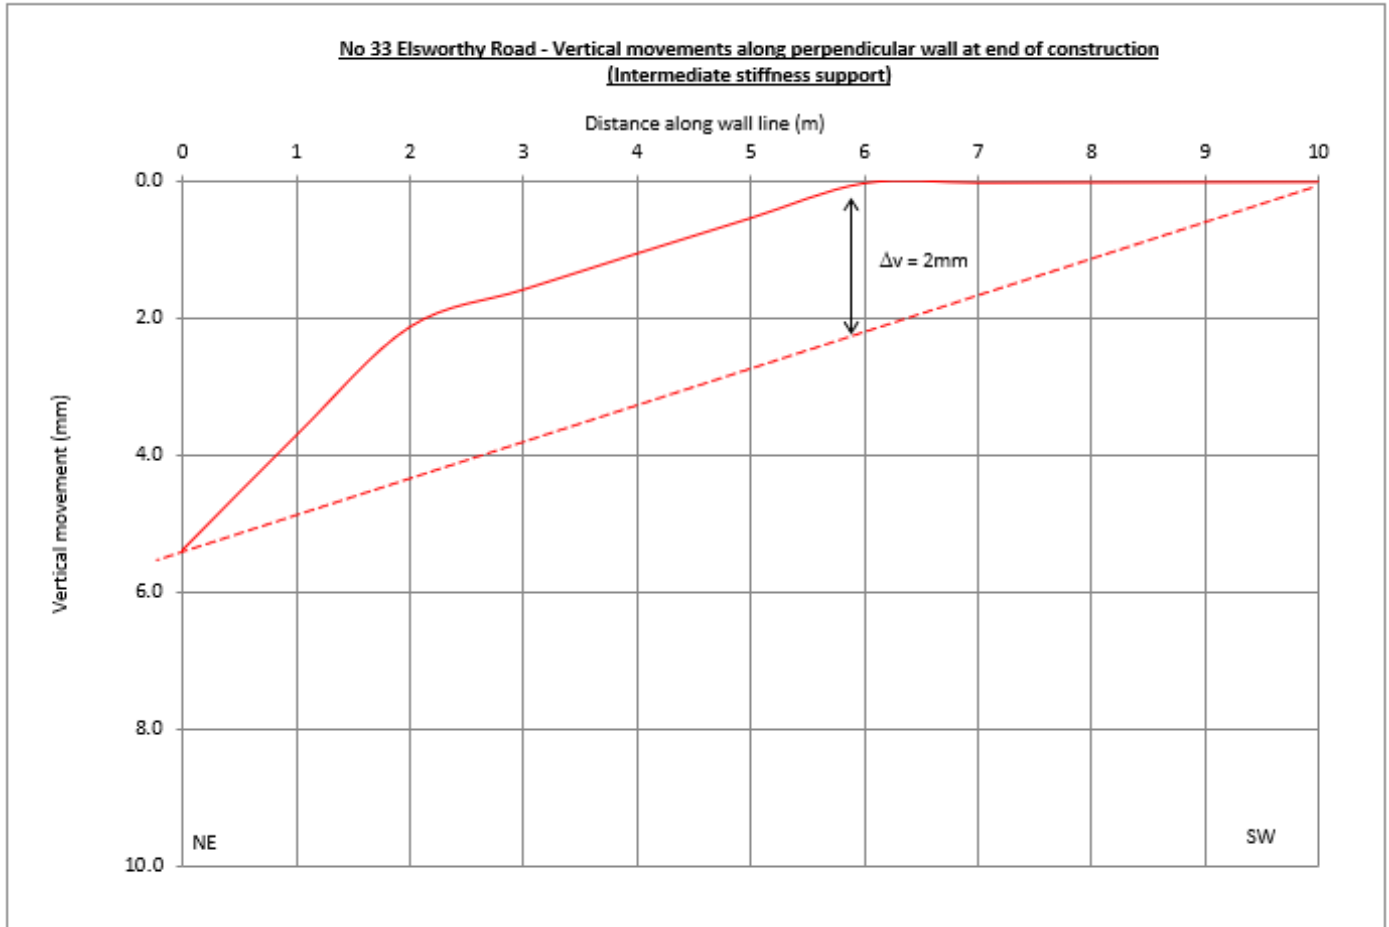
FIGURE 15

Settlement profile – No 33 Elsworthy Road perpendicular wall (Intermediate stiffness)

End of construction

Perpendicular wall - vertical movement at end of construction INTERMEDIATE					
Distance along wall line (m)	Installation	Settlement (loading)		Settlement (excavation)	Net vertical movement at end of construction (mm)
	Estimated from CIRIA chart	Due to foundations - from Bouss spreadsheet (mm)	Settlement due to basement excavation - estimated from CIRIA chart		
0.0	2.0	0.4	3.0	5.4	
1.0	1.0	0.2	2.5	3.7	
2.0	0.0	0.1	2.0	2.1	
3.0	0.0	0.1	1.5	1.6	
4.0	0.0	0.1	1.0	1.1	
5.0	0.0	0.0	0.5	0.5	
6.0	0.0	0.0	0.0	0.0	
7.0	0.0	0.0	0.0	0.0	
8.0	0.0	0.0	0.0	0.0	
9.0	0.0	0.0	0.0	0.0	
10.0	0.0	0.0	0.0	0.0

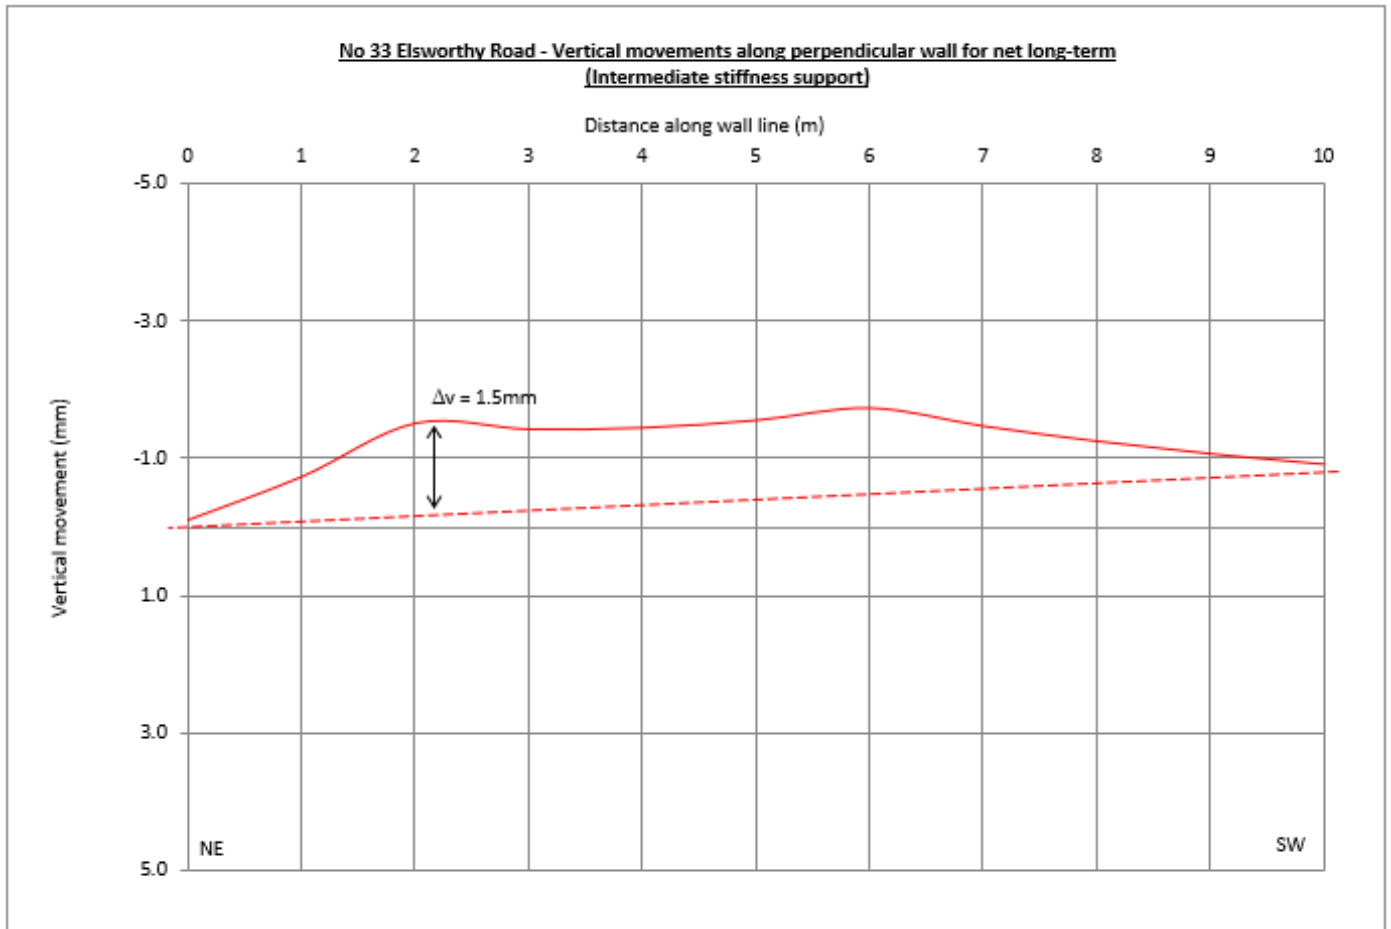
Settlement profile – No 33 Elsworthy Road perpendicular wall (Intermediate stiffness)

Long term

Distance along wall line (m)	Perpendicular wall - vertical movement long-term INT		Net total movement long-term (mm)
	Settlement (loading) Due to foundations - from Bouss spreadsheet (mm)	Heave (unloading) Post-construction heave - from Bouss spreadsheet (mm)	
0.0	0.5	-5.5	-0.1
1.0	0.3	-4.4	-0.7
2.0	0.2	-3.6	-1.5
3.0	0.1	-3.0	-1.4
4.0	0.1	-2.5	-1.4
5.0	0.0	-2.1	-1.5
6.0	0.0	-1.7	-1.7
7.0	0.0	-1.5	-1.5
8.0	0.0	-1.3	-1.2
9.0	0.0	-1.1	-1.1
10.0	0.0	-0.9	-0.9

(Note: total long term net movement is determined using the end of construction movement and the post construction movements)

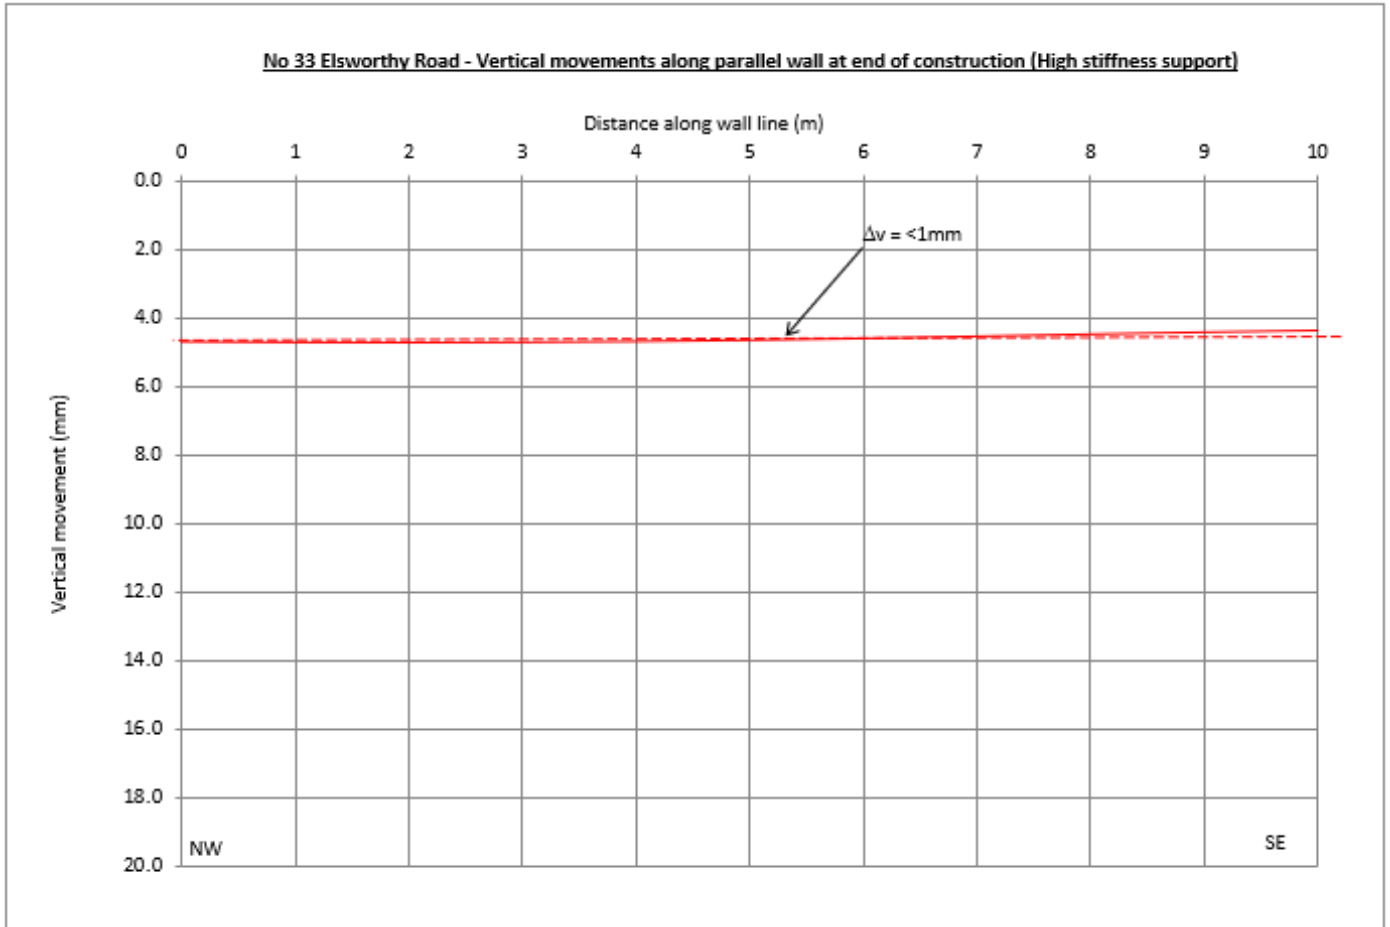
**FIGURE 17**

**Settlement profile – No 33 Elsworthy Road parallel wall (High stiffness)**

**End of construction**

<b>parallel wall - vertical movement at end of construction HIGH</b>				
Distance along wall line (m)	Installation	Settlement (loading)	Settlement (excavation)	Net vertical movement at end of construction (mm)
	Estimated from CIRIA chart	Due to foundations - from Bouss spreadsheet (mm)	Settlement due to basement excavation - estimated from CIRIA chart	
0.0	2.0	0.7	2.0	4.7
1.0	2.0	0.7	2.0	4.7
2.0	2.0	0.7	2.0	4.7
3.0	2.0	0.7	2.0	4.7
4.0	2.0	0.7	2.0	4.7
5.0	2.0	0.7	2.0	4.7
6.0	2.0	0.6	2.0	4.6
7.0	2.0	0.6	2.0	4.6
8.0	2.0	0.5	2.0	4.5
9.0	2.0	0.4	2.0	4.4
10.0	2.0	0.4	2.0	4.4

Profiles of the assessed vertical movement along the line of this wall are shown for both high and intermediate stiffness support in Figures 17 to 20. The  $\Delta v$  values obtained from these profiles are used in assessing vertical strains for damage assessment.

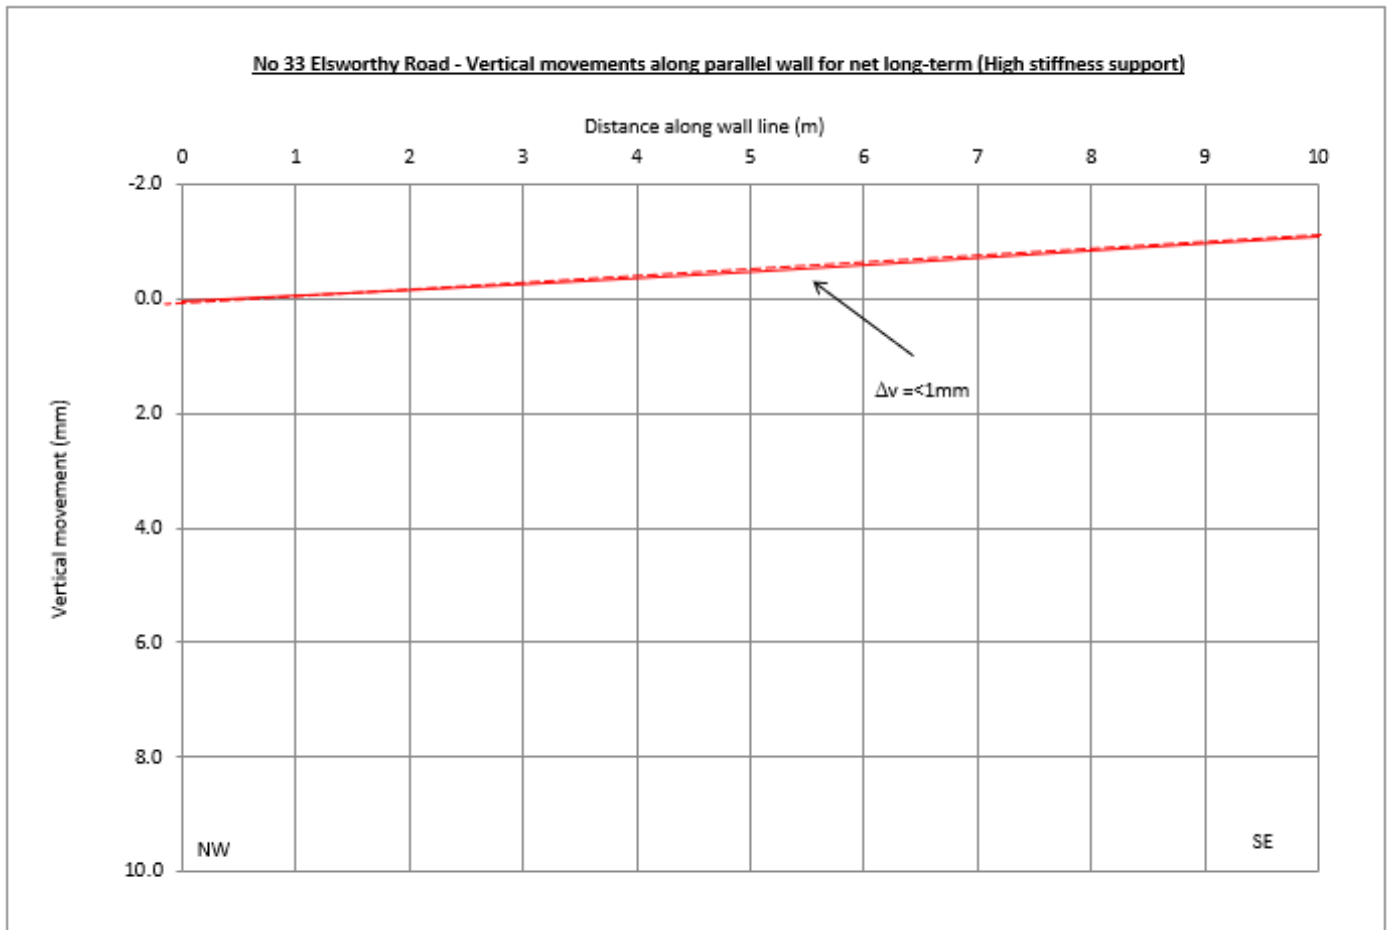
Settlement profile – No 33 Elsworthy Road parallel wall (High stiffness)

Long term

Distance along wall line (m)	parallel wall - vertical movement long-term HIGH		
	Settlement (loading)	Heave (unloading)	Net total movement long-term (mm)
	Due to foundations - from Bouss spreadsheet (mm)	Post-construction heave - from Bouss spreadsheet (mm)	
0.0	0.9	-4.6	0.1
1.0	1.0	-4.8	0.0
2.0	1.0	-4.9	-0.1
3.0	1.0	-5.0	-0.2
4.0	0.9	-5.0	-0.4
5.0	0.9	-5.1	-0.5
6.0	0.8	-5.2	-0.6
7.0	0.7	-5.3	-0.7
8.0	0.6	-5.3	-0.8
9.0	0.6	-5.4	-1.0
10.0	0.5	-5.5	-1.1

(Note: total long term net is determined using the end of construction movement and the post construction movements)

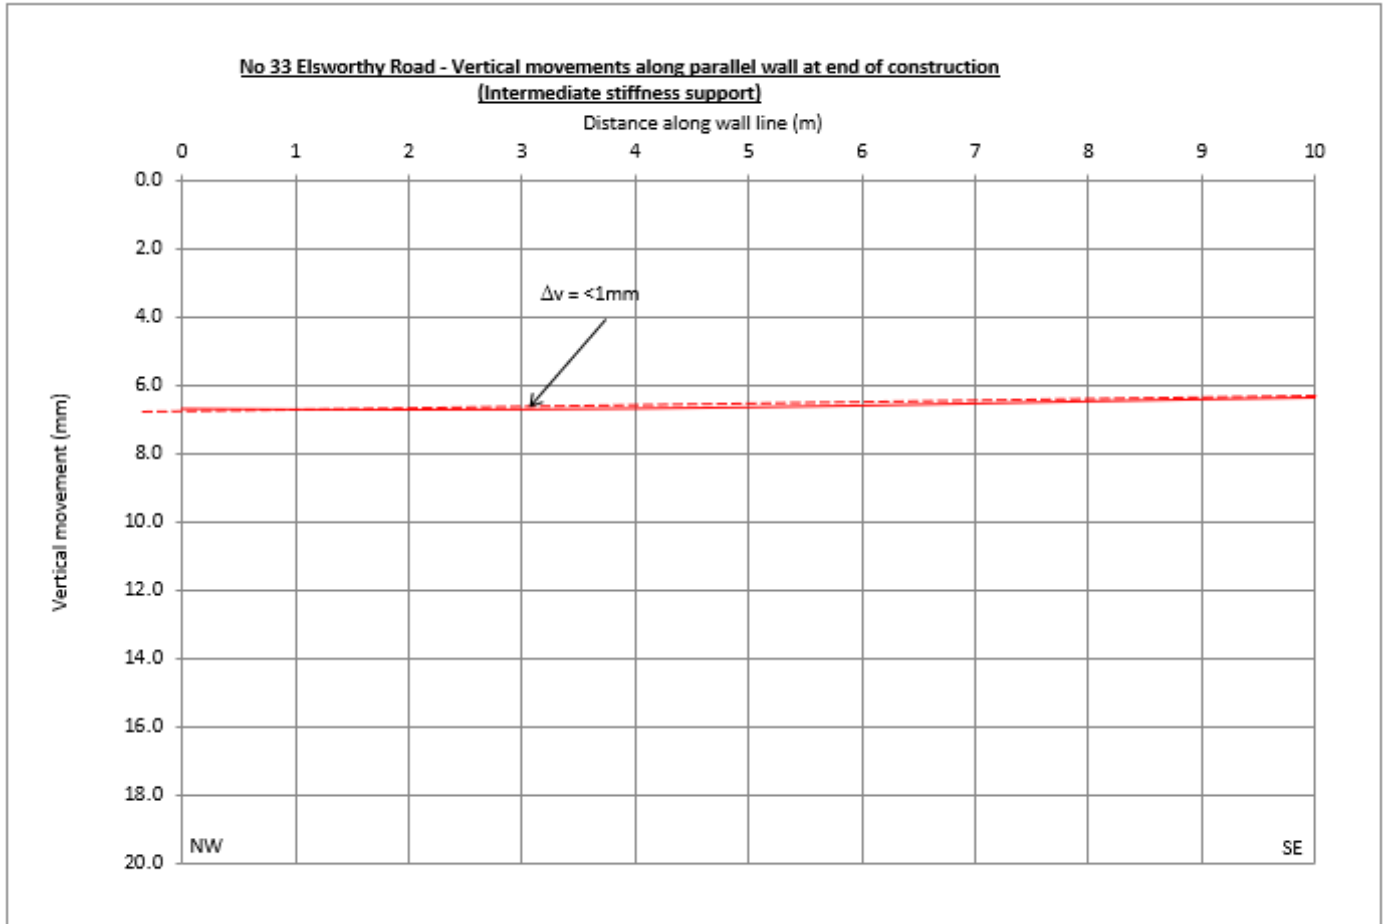
**FIGURE 19**

**End of construction**

<b>Parallel wall - vertical movement at end of construction Intermediate</b>				
Distance along wall line (m)	Installation	Settlement (loading)	Settlement (excavation)	Net vertical movement at end of construction (mm)
	Estimated from CIRIA chart	Due to foundations - from Bouss spreadsheet (mm)	Settlement due to basement excavation - estimated from CIRIA chart	
0.0	2.0	0.7	4.0	6.7
1.0	2.0	0.7	4.0	6.7
2.0	2.0	0.7	4.0	6.7
3.0	2.0	0.7	4.0	6.7
4.0	2.0	0.7	4.0	6.7
5.0	2.0	0.7	4.0	6.7
6.0	2.0	0.6	4.0	6.6
7.0	2.0	0.6	4.0	6.6
8.0	2.0	0.5	4.0	6.5
9.0	2.0	0.4	4.0	6.4
10.0	2.0	0.4	4.0	6.4

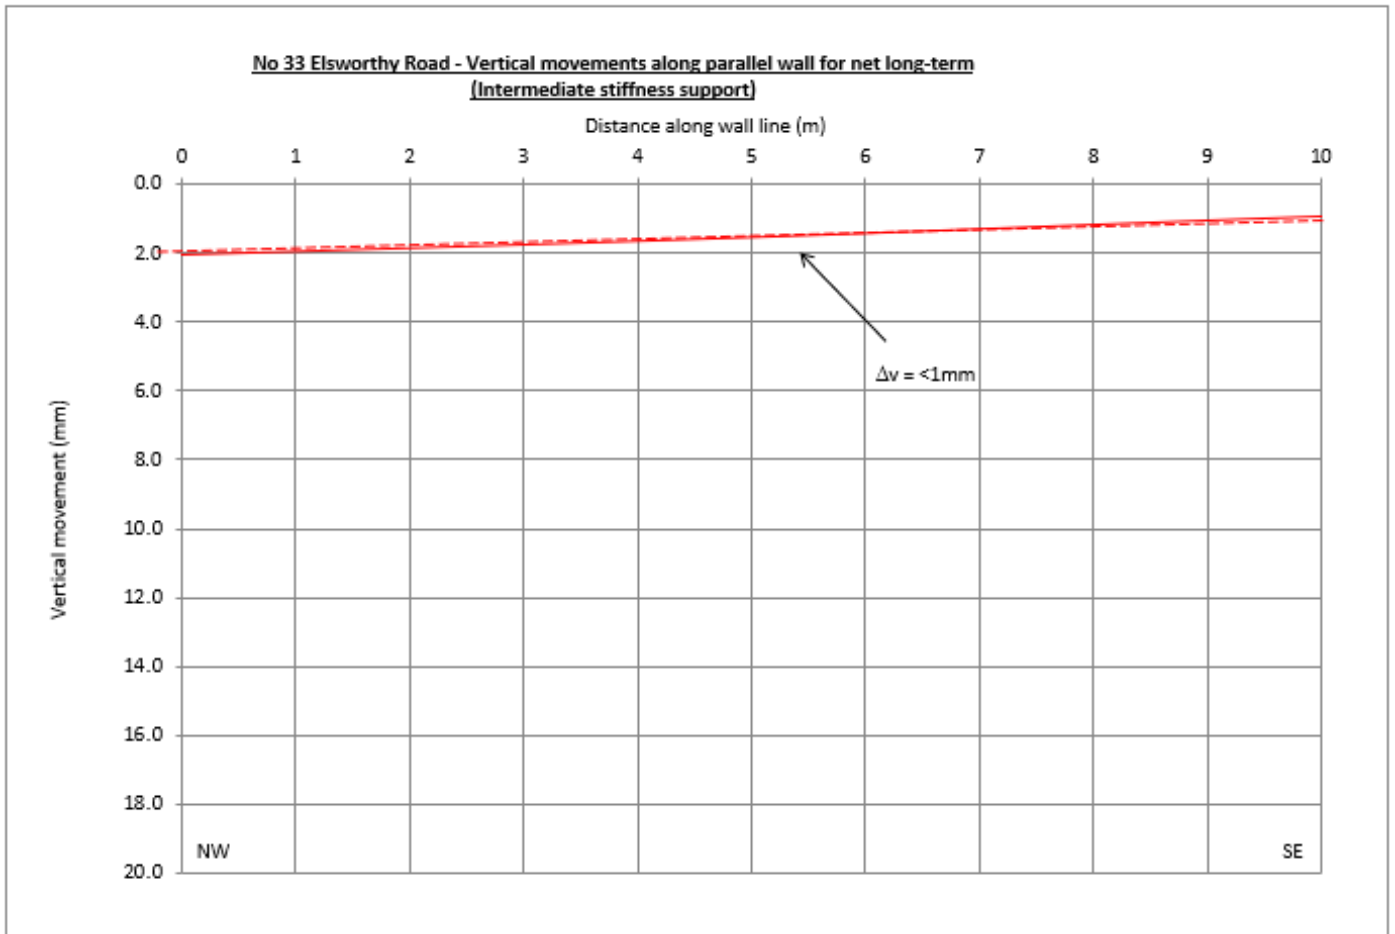
Long term

Distance along wall line (m)	Parallel wall - vertical movement long-term Intermediate		
	Settlement (loading)	Heave (unloading)	Net total movement long-term (mm)
	Due to foundations - from Bouss spreadsheet (mm)	Post-construction heave - from Bouss spreadsheet (mm)	
0.0	0.9	-4.6	2.1
1.0	1.0	-4.8	2.0
2.0	1.0	-4.9	1.9
3.0	1.0	-5.0	1.8
4.0	0.9	-5.0	1.6
5.0	0.9	-5.1	1.5
6.0	0.8	-5.2	1.4
7.0	0.7	-5.3	1.3
8.0	0.6	-5.3	1.2
9.0	0.6	-5.4	1.0
10.0	0.5	-5.5	0.9

(Note: total long term net movement is determined using the end of construction movement and the post construction movements)

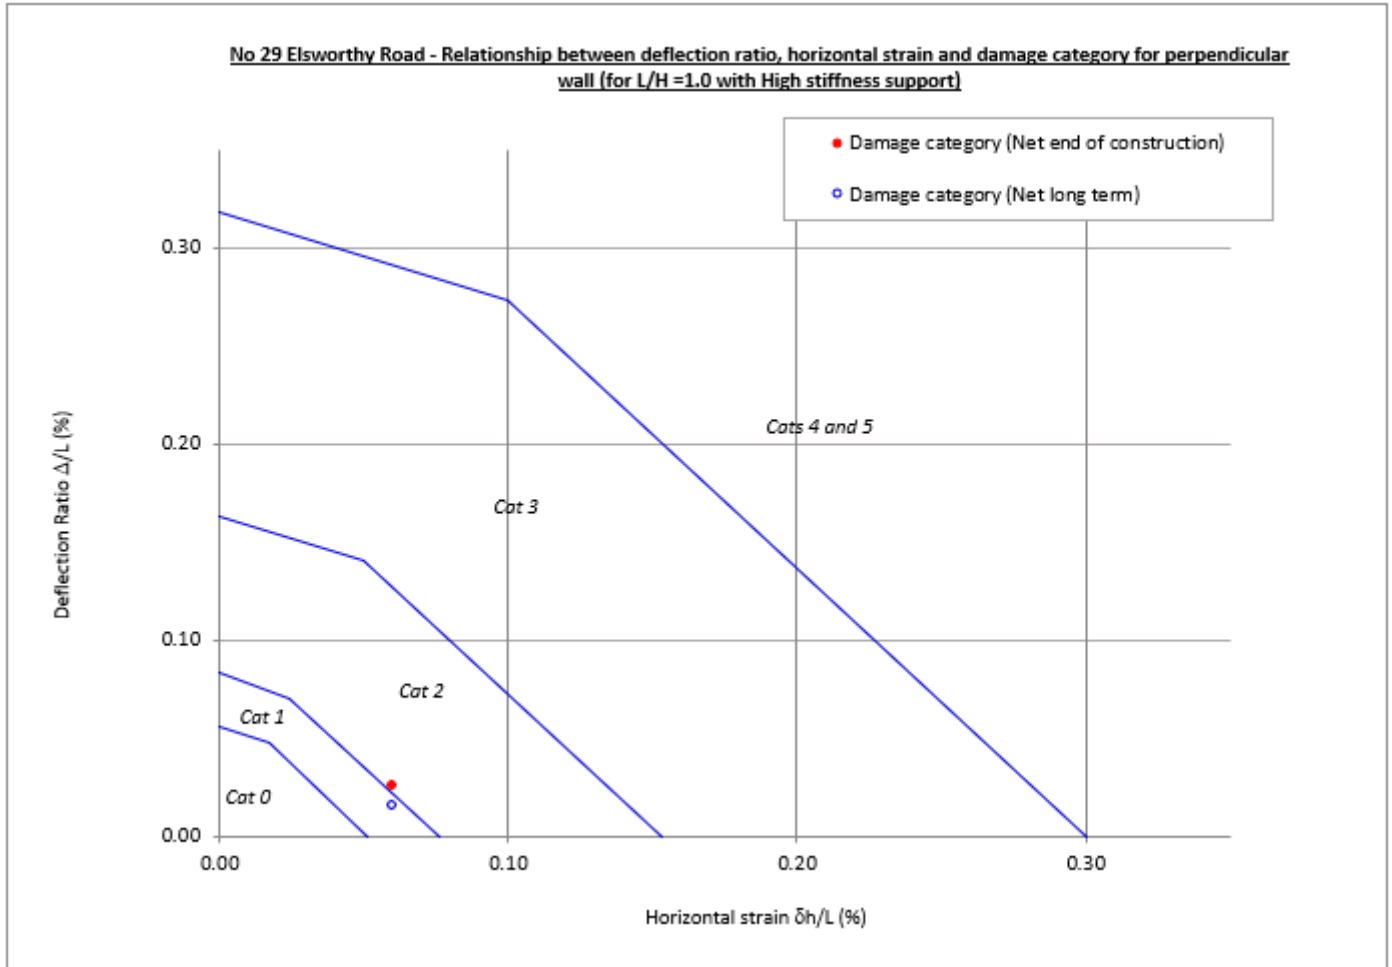
FIGURE 21

High stiffness

Vertical/horizontal movement (mm)	Wall length (m)	DR/HS
End of construction		
$\Delta v =$ 2.5	10.00	0.025
$\delta h =$ 6.0	10.00	0.060
Long term		
$\Delta v =$ 1.5	10.00	0.015
$\delta h =$ 6.0	10.00	0.060

The graphical results are shown in Figures 21 to 28 appended. A summary of the assessed damage categories is shown overleaf:

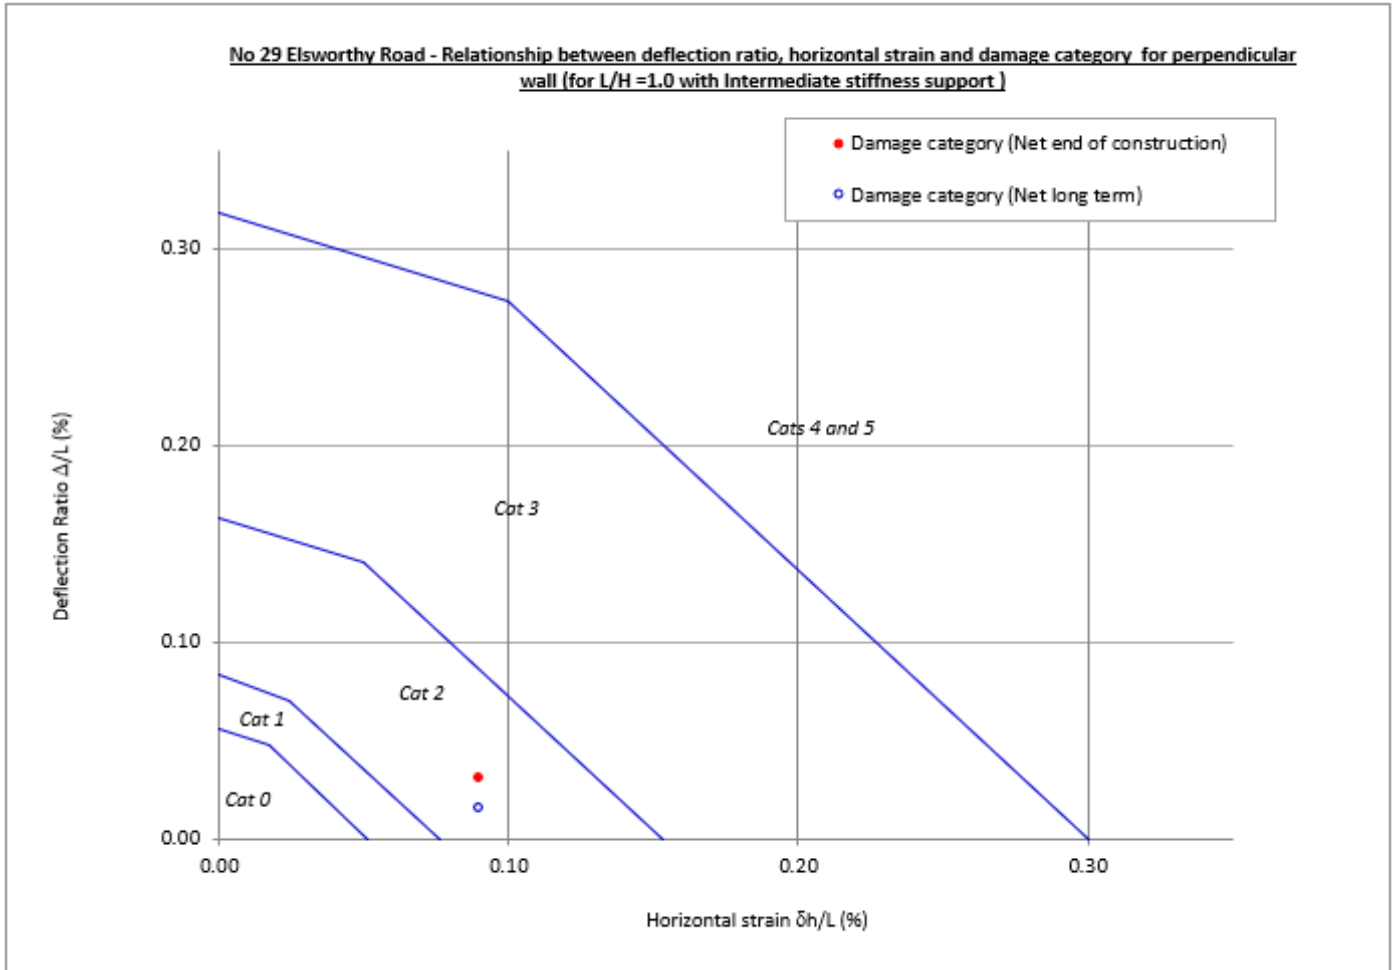
FIGURE 22

Intermediate stiffness

Vertical/horizontal movement (mm)	Wall length (m)	DR/HS
End of construction		
$\Delta v =$ 3.0	10.00	0.030
$\delta h =$ 9.0	10.00	0.090
Long term		
$\Delta v =$ 1.5	10.00	0.015
$\delta h =$ 9.0	10.00	0.090

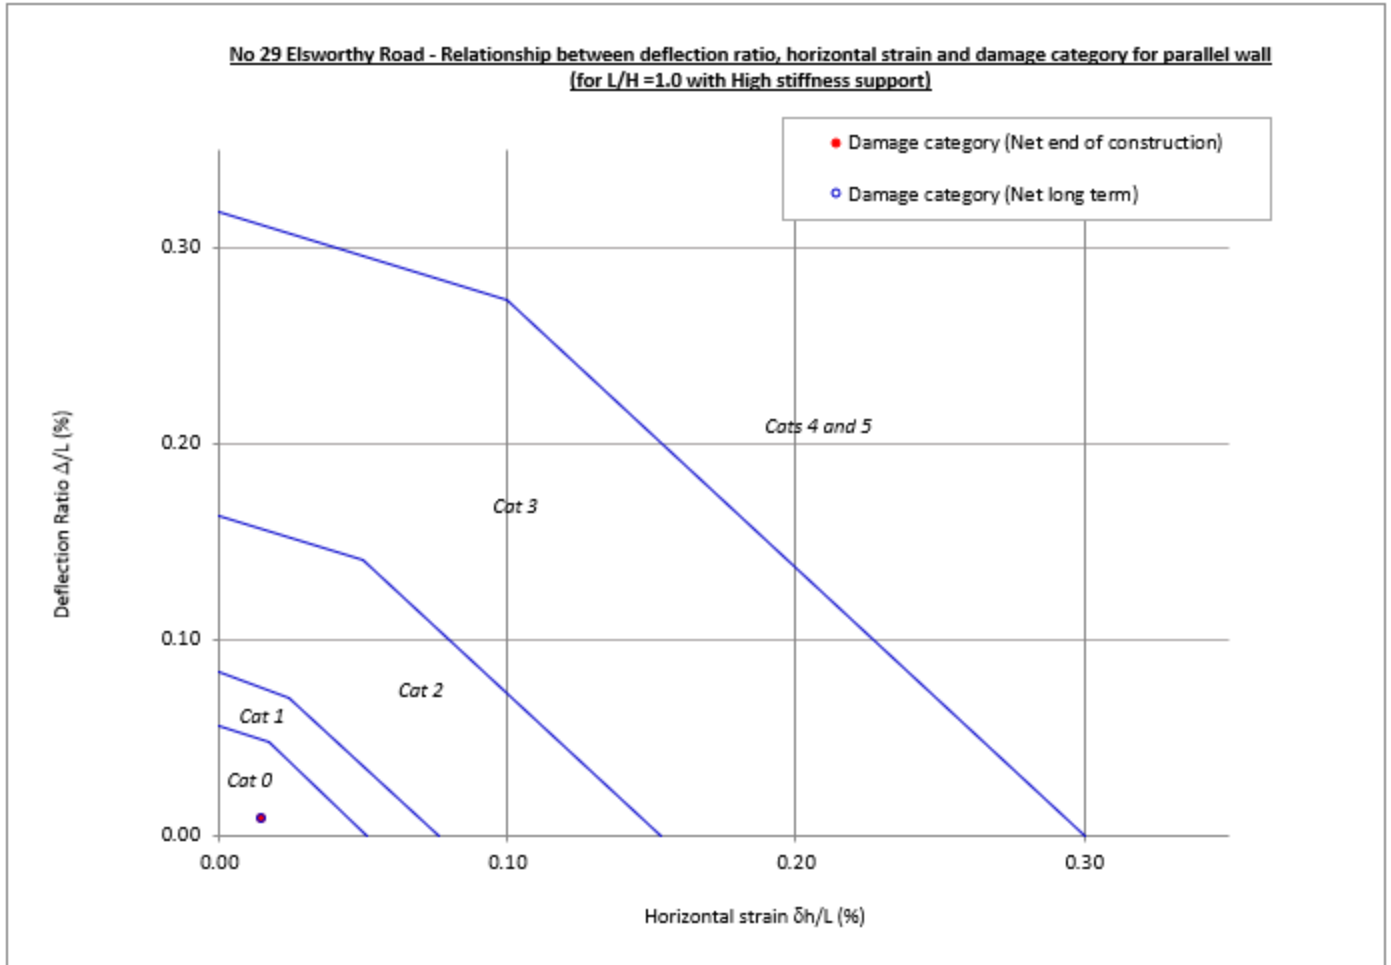
FIGURE 23

High stiffness

Vertical/horizontal movement (mm)	Wall length (m)	DR/HS
End of construction		
$\Delta v = 1.0$	13.00	0.008
$\delta h = 2.0$	13.00	0.015
Long term		
$\Delta v = 1.0$	13.00	0.008
$\delta h = 2.0$	13.00	0.015

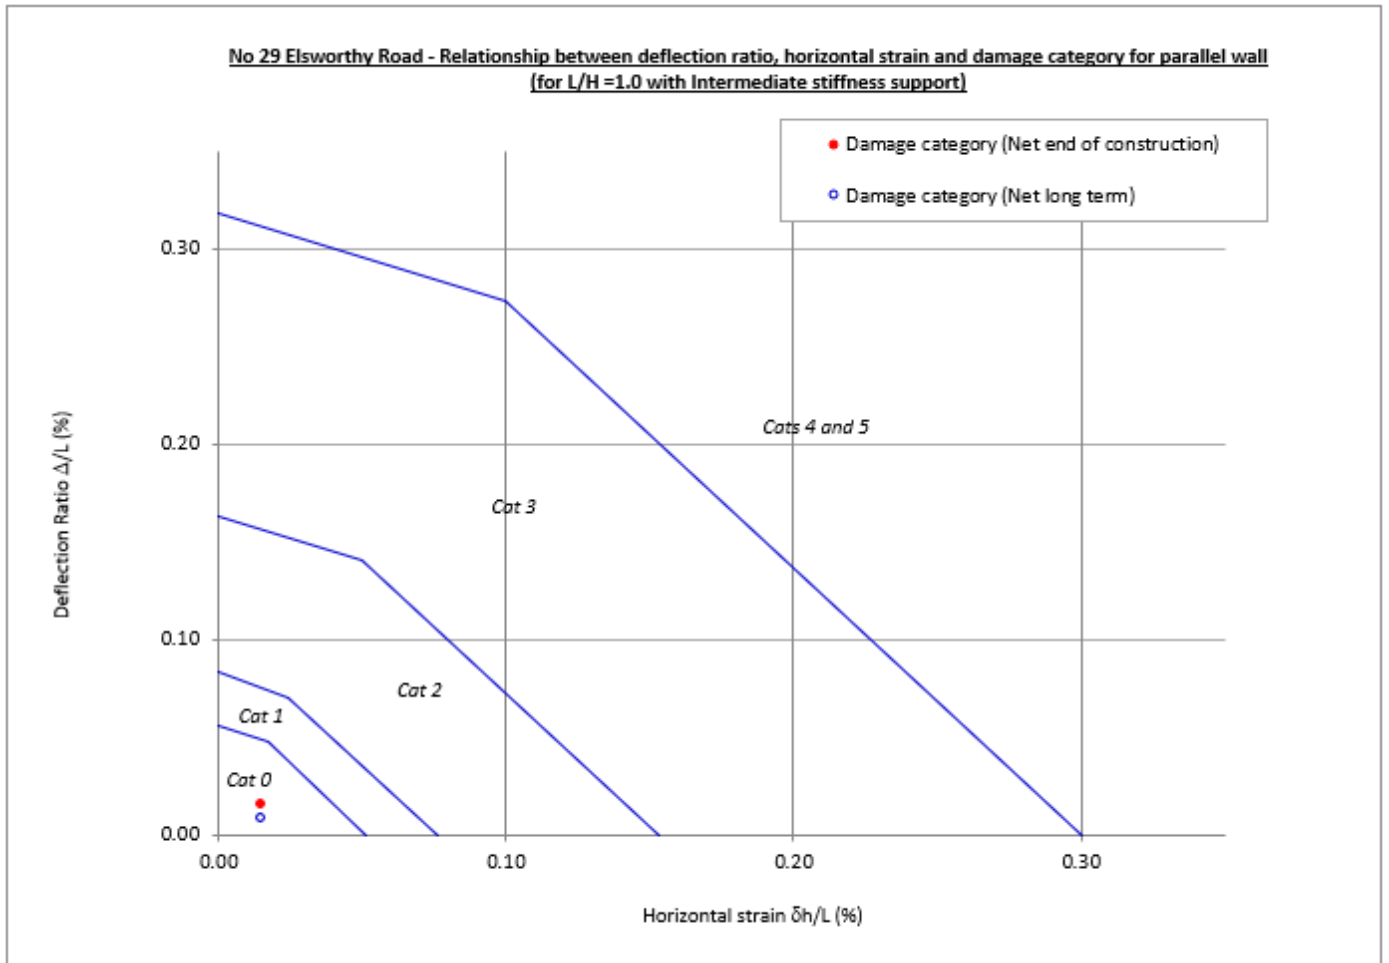
FIGURE 24

Intermediate stiffness

Vertical/horizontal movement (mm)		Wall length (m)	DR/HS
End of construction			
$\Delta v =$	2.0	13.00	0.015
$\delta h =$	2.0	13.00	0.015
Long term			
$\Delta v =$	1.0	13.00	0.008
$\delta h =$	2.0	13.00	0.015

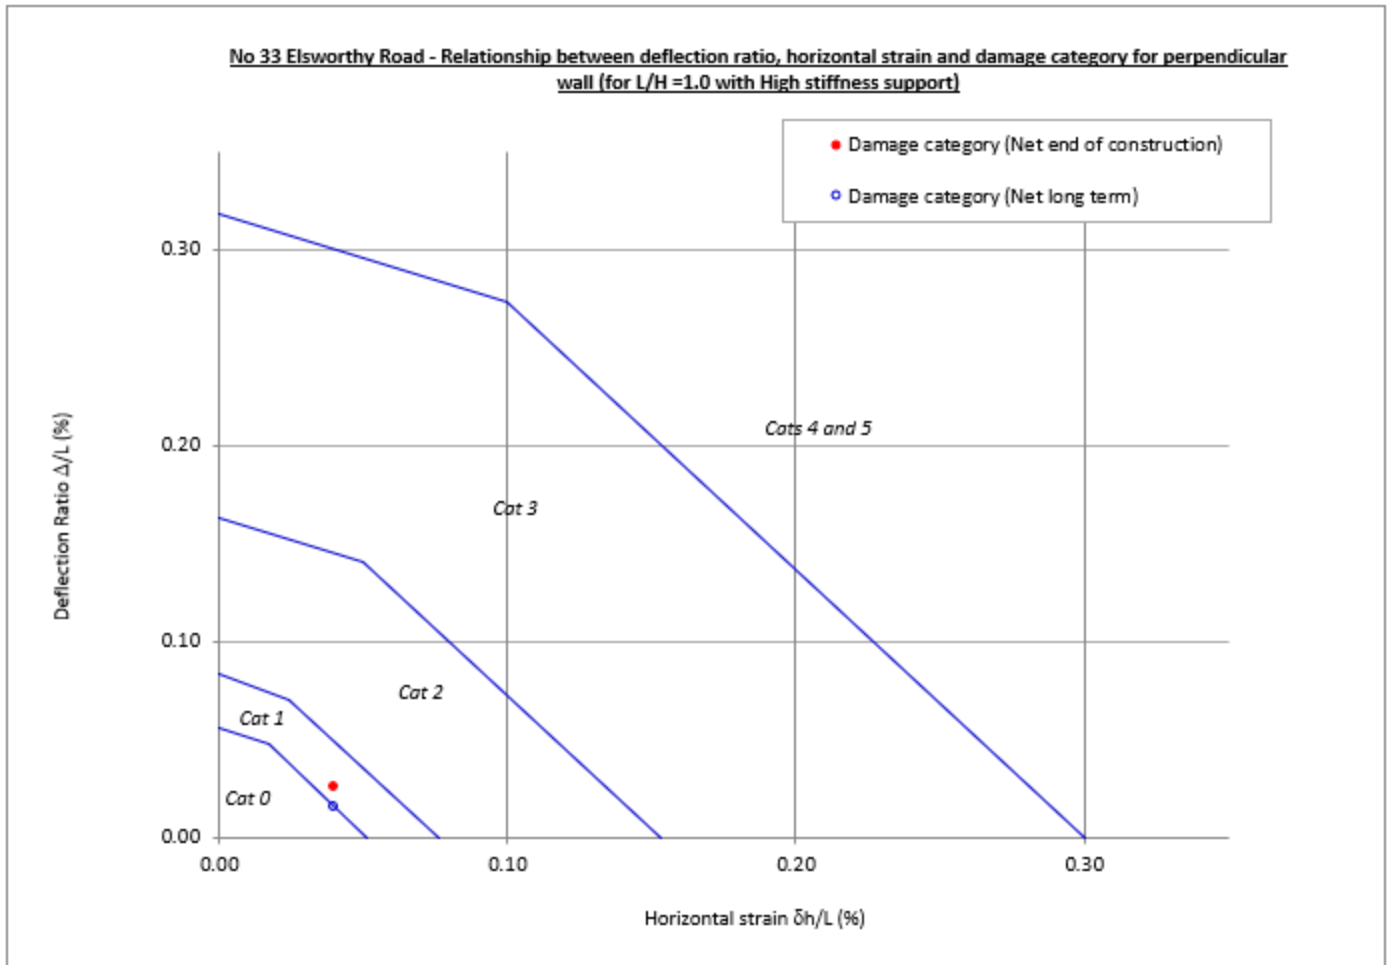
FIGURE 25

High stiffness

Vertical/horizontal movement (mm)	Wall length (m)	DR/HS
End of construction		
$\Delta v =$ 2.5	10.00	0.025
$\delta h =$ 4.0	10.00	0.040
Long term		
$\Delta v =$ 1.5	10.00	0.015
$\delta h =$ 4.0	10.00	0.040

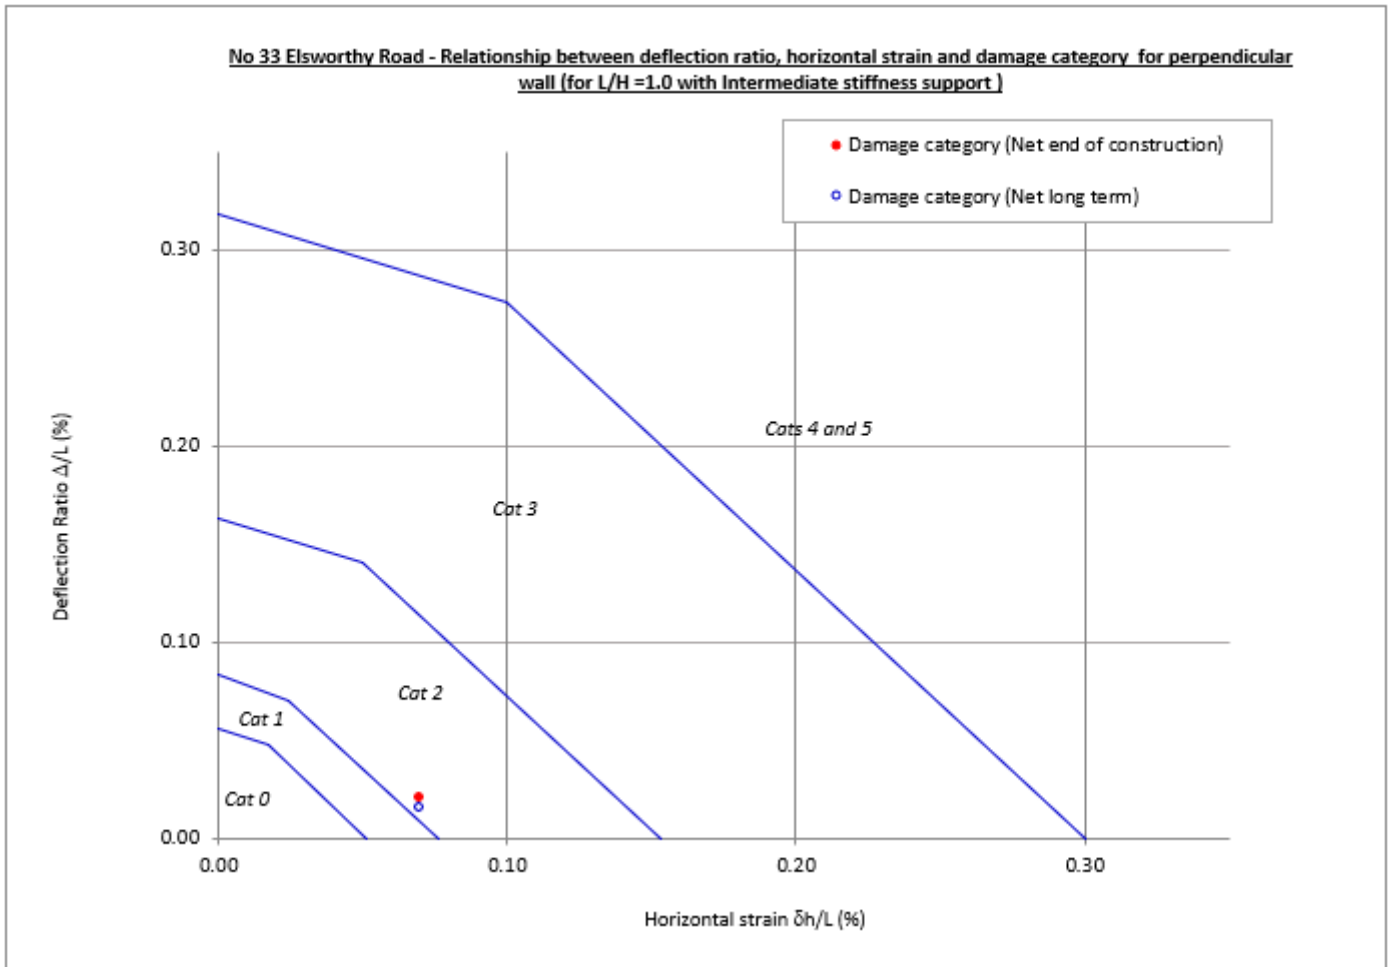
FIGURE 26

Intermediate stiffness

Vertical/horizontal movement (mm)	Wall length (m)	DR/HS
End of construction		
Δv = 2.0	10.00	0.020
δh = 7.0	10.00	0.070
Long term		
Δv = 1.5	10.00	0.015
δh = 7.0	10.00	0.070

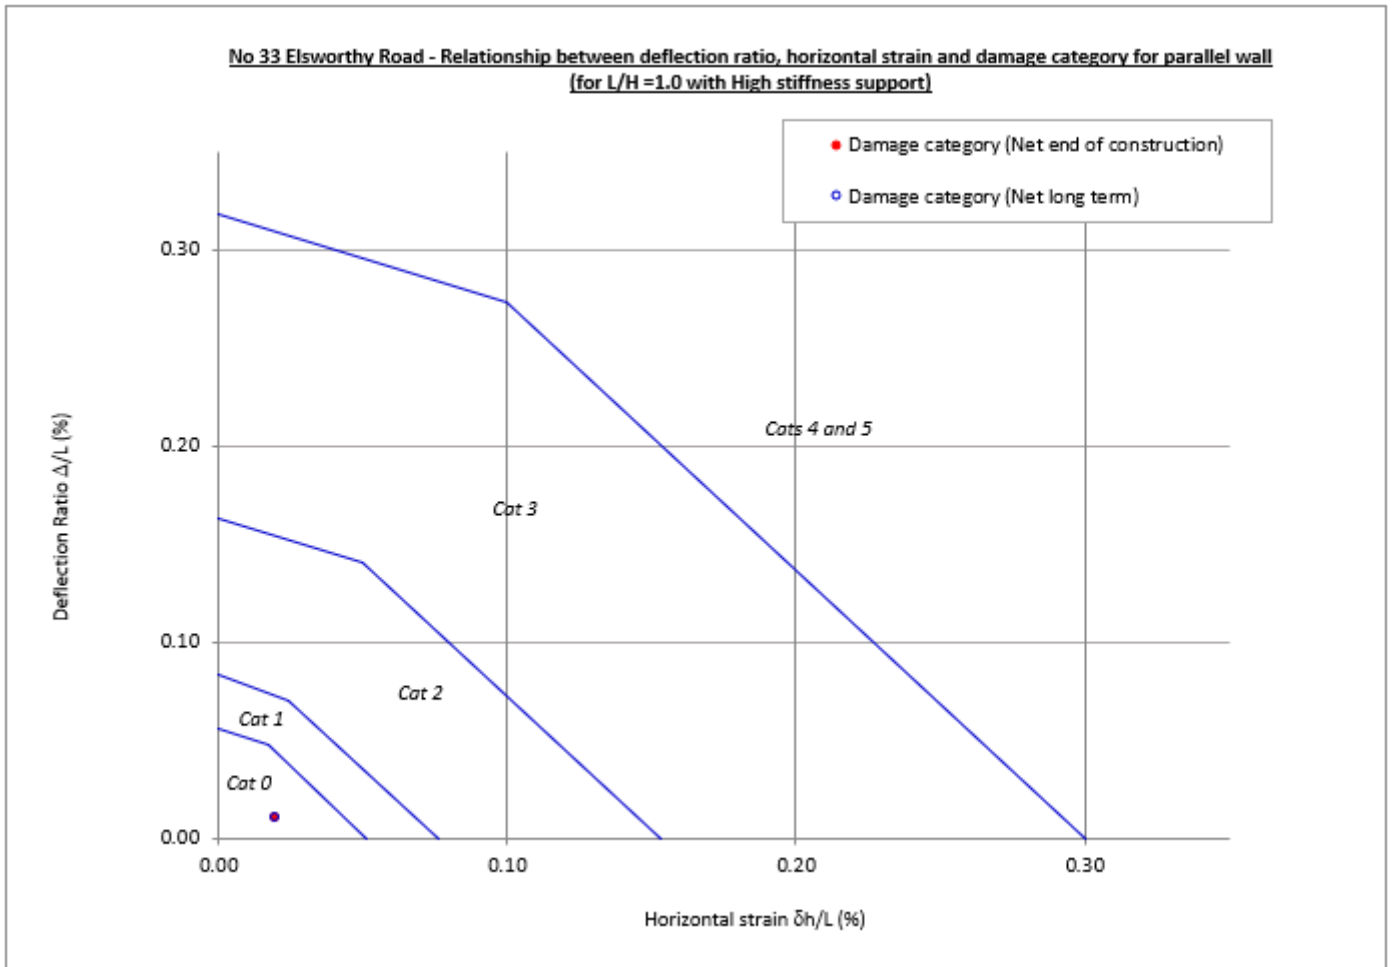
FIGURE 27

High stiffness

Vertical/horizontal movement (mm)	Wall length (m)	DR/HS
End of construction		
$\Delta v = 1.0$	10.00	0.010
$\delta h = 2.0$	10.00	0.020
Long term		
$\Delta v = 1.0$	10.00	0.010
$\delta h = 2.0$	10.00	0.020

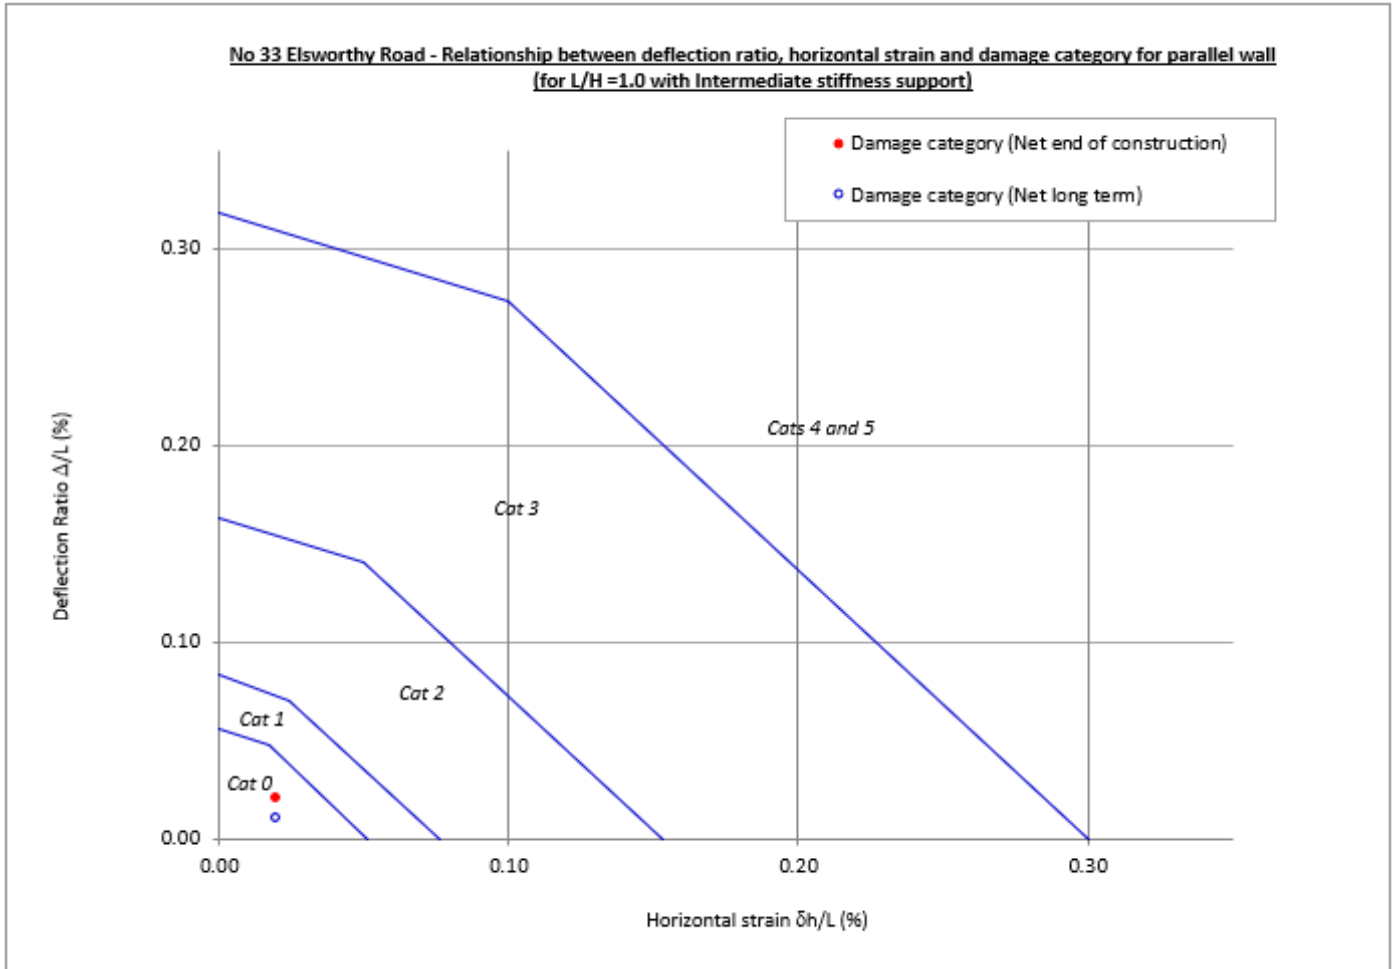
FIGURE 28

Intermediate stiffness

Vertical/horizontal movement (mm)	Wall length (m)	DR/HS
End of construction		
$\Delta v =$ 2.0	10.00	0.020
$\delta h =$ 2.0	10.00	0.020
Long term		
$\Delta v =$ 1.0	10.00	0.010
$\delta h =$ 2.0	10.00	0.020
