Environmental Monitoring Report Shorts Gardens, London WC2H

30th August 2021 - 22nd October 2021

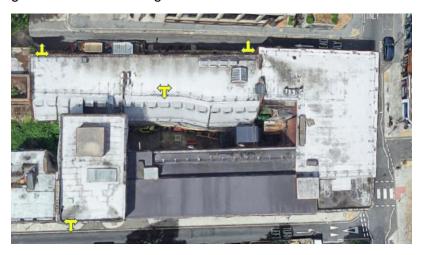
Sunbelt rentals were requested by Hush PMC to install and maintain 4 x Guardian 2 environmental monitoring stations around the Shorts Gardens project. The purpose of the monitoring was to gain data to indicate ambient noise, dust and vibration levels around the site. This would then form a baseline for when the development project begins. After an initial site survey, the following locations were chosen as prime points to install the units and give maximum coverage of the area.

The units were installed on 28th August 2021 with monitoring and reports starting WC 30th August 2021. Custom mounting brackets were pre-installed by Hush PMC to ensure the sensors were at a minimum distance from the building façade.
