LEVEL MONITORING - RELATIVE SURVEY READINGS

Provider Details		Client Details			Risk Address	
Name:	MHN Ltd	Insurance Co.:	NFU Mutual	Occupier:		
Date of Issue:	14/4/21	Client Name:	Crawford & Co	Address:		
		Contact:	Deller M	Address:		
		Email:		Town:		
		Client Ref:		County:		
		Address:		Post Code:		
		Address:		Tel Home:		
		Town:		Tel Work:		
		County:		Mobile:		
		Post Code:		Other:		
		Other Email:		Other:		
Monitoring Details						
Instruction Date:	21/5/19					
First Reading Date:	10/07/2019					
Maximum No Visits:	9					
Anticipated Expiry Date:	Jun 2021					
Monitoring Int:	2 Monthly

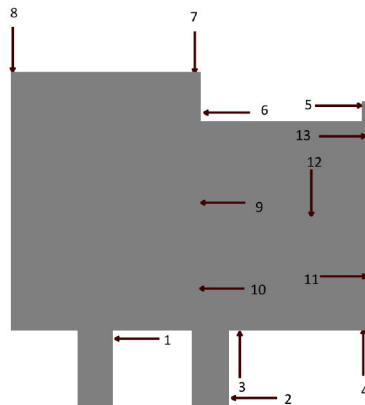
FRONT

- 14/04/2021
- New stations fixed.
- It was not possible to install all stations within a common brickcourse. Therefore initial readings cannot be interpreted as Distortion Data.
- Unable to sight through house. Front readings have been made relative to level station 1. Rear readings have been made relative to level station 8. They have assumed values of 10.0000m. If this is not appropriate, please advise if a deep datum is required?

- Further readings to be taken June 21
