## 65 Kingsway (ref: 2019/6270/L) – Listed Building Consent Condition discharge 4 – External Brickwork clean

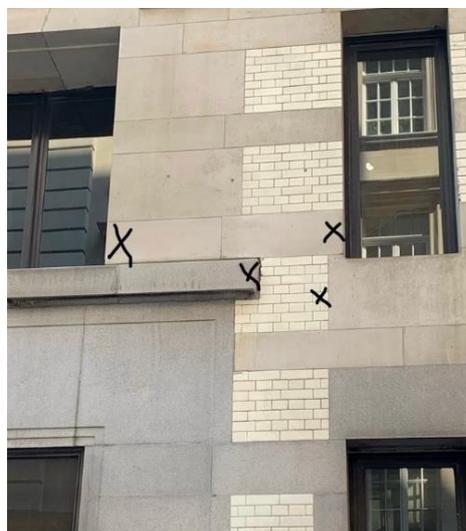
A sample selection of façade clean has been carried out and presented to the architect and heritage consultant for approval prior to continuing with the rest of the works. This is available to review on site by the LBC case officer and photographs can be seen below.

The façade will be cleaned using a non-abrasive Doff cleaning system. The Doff system will be set at the precise temperature to ensure the dirt is removed from the stone without damaging the surface.

Doff is a steam-based stone cleaning system. It can achieve temperatures of up to 150°C at the nozzle end. The operator is able to vary the temperature and pressure to remove many different types of biological matter.
