## **PM<sub>10</sub> Monitoring Report**

**August 2021**

2 Chester Road, London (N19 5BP)

Project no.	Project
10675.S	2 Chester Road, London (N19 5BP)

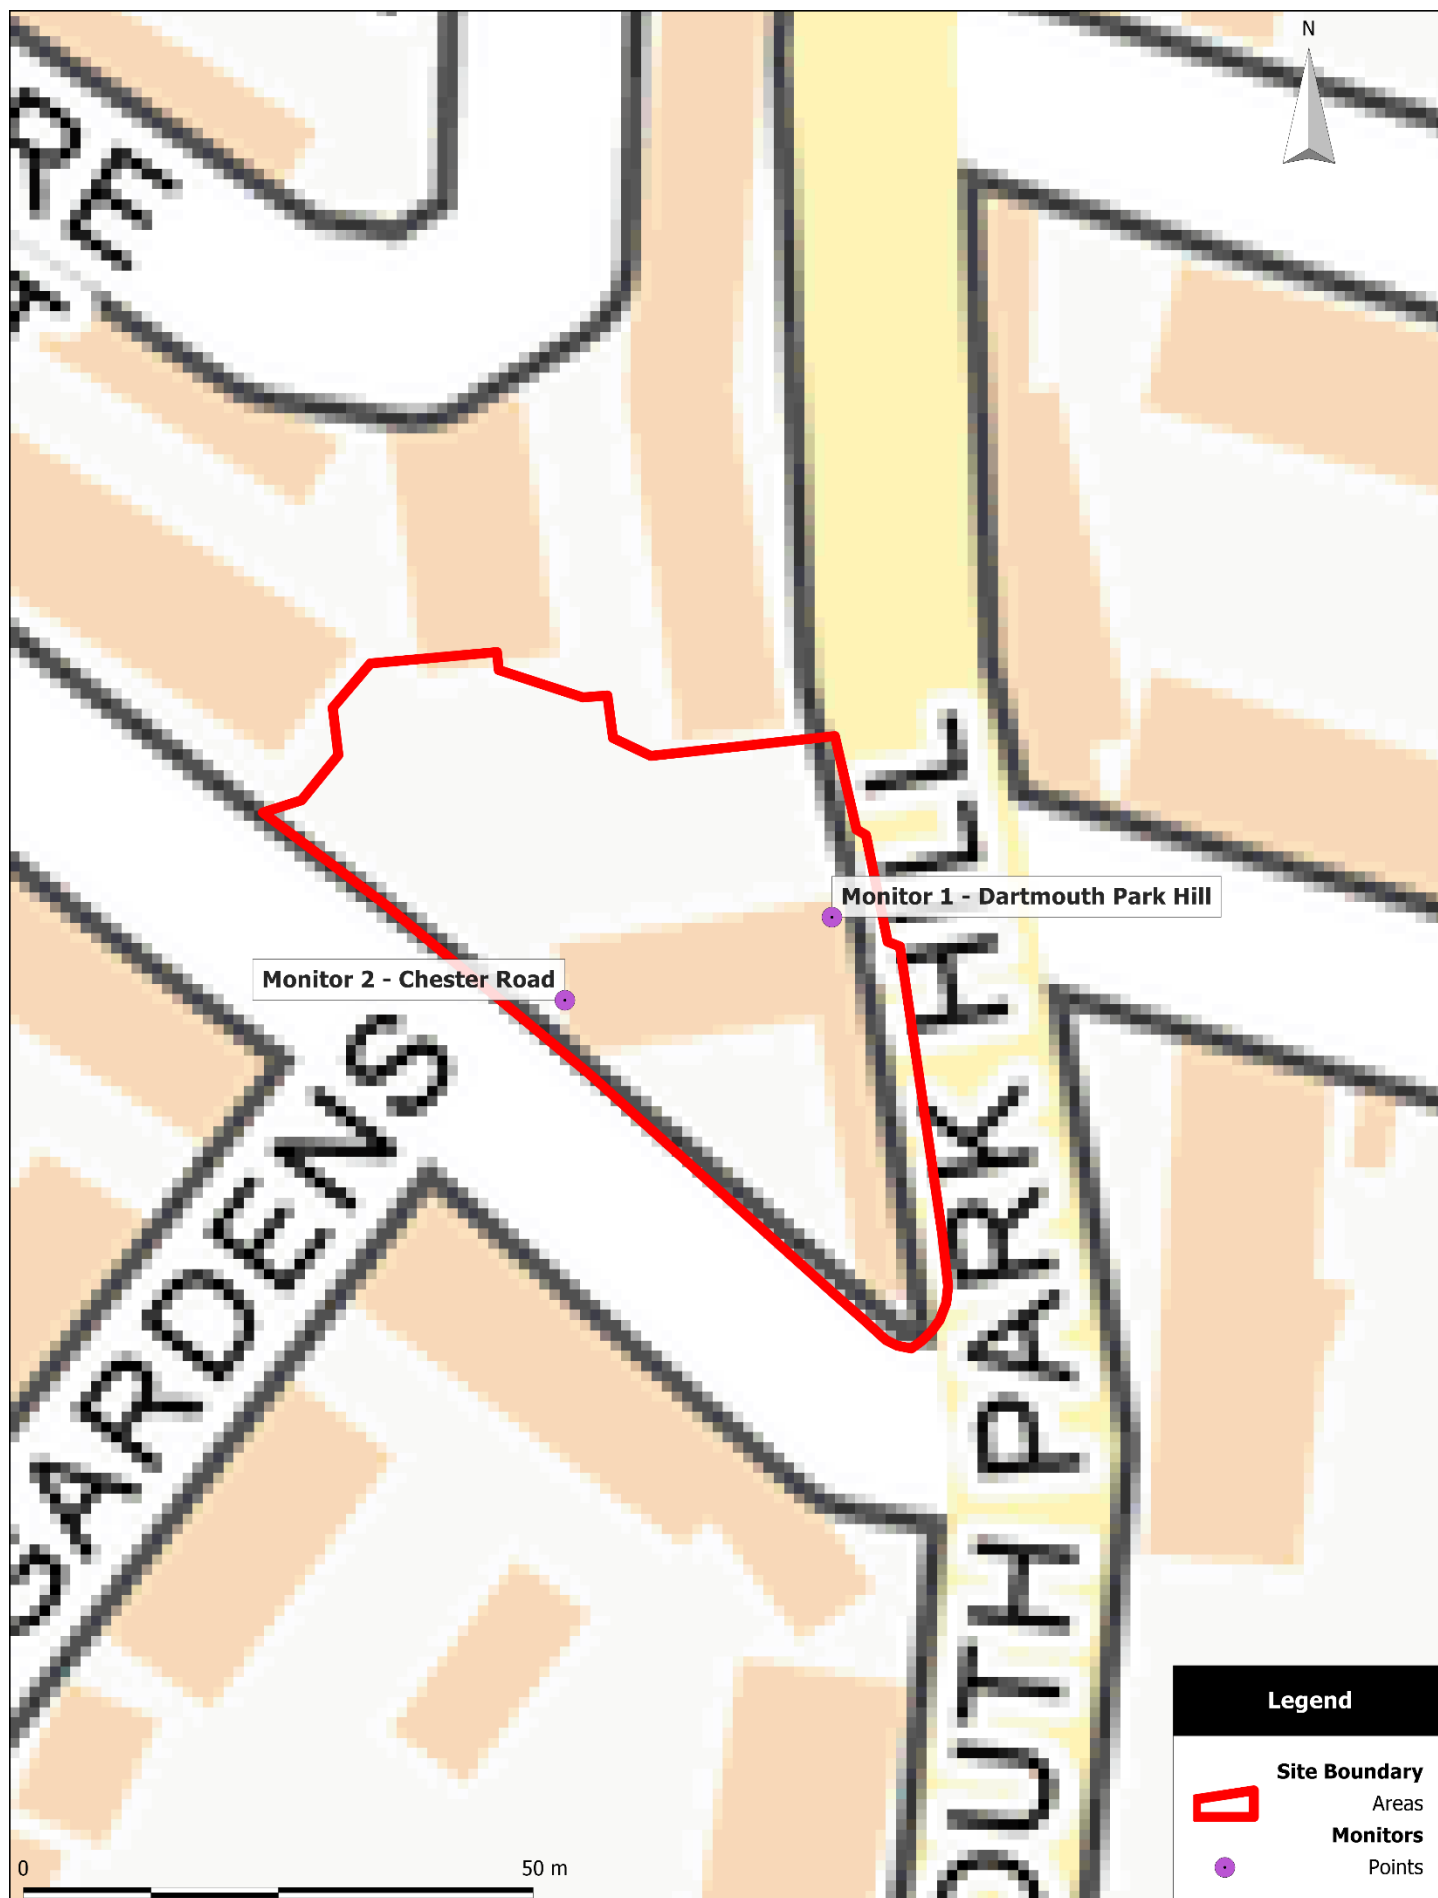
Figure 1: Monitoring Locations

- 1.9 A map of the dust monitoring locations has been provided in Figure 1. Photographs of the Dust Sentry units installed on site are provided in Figures 2 and 3.

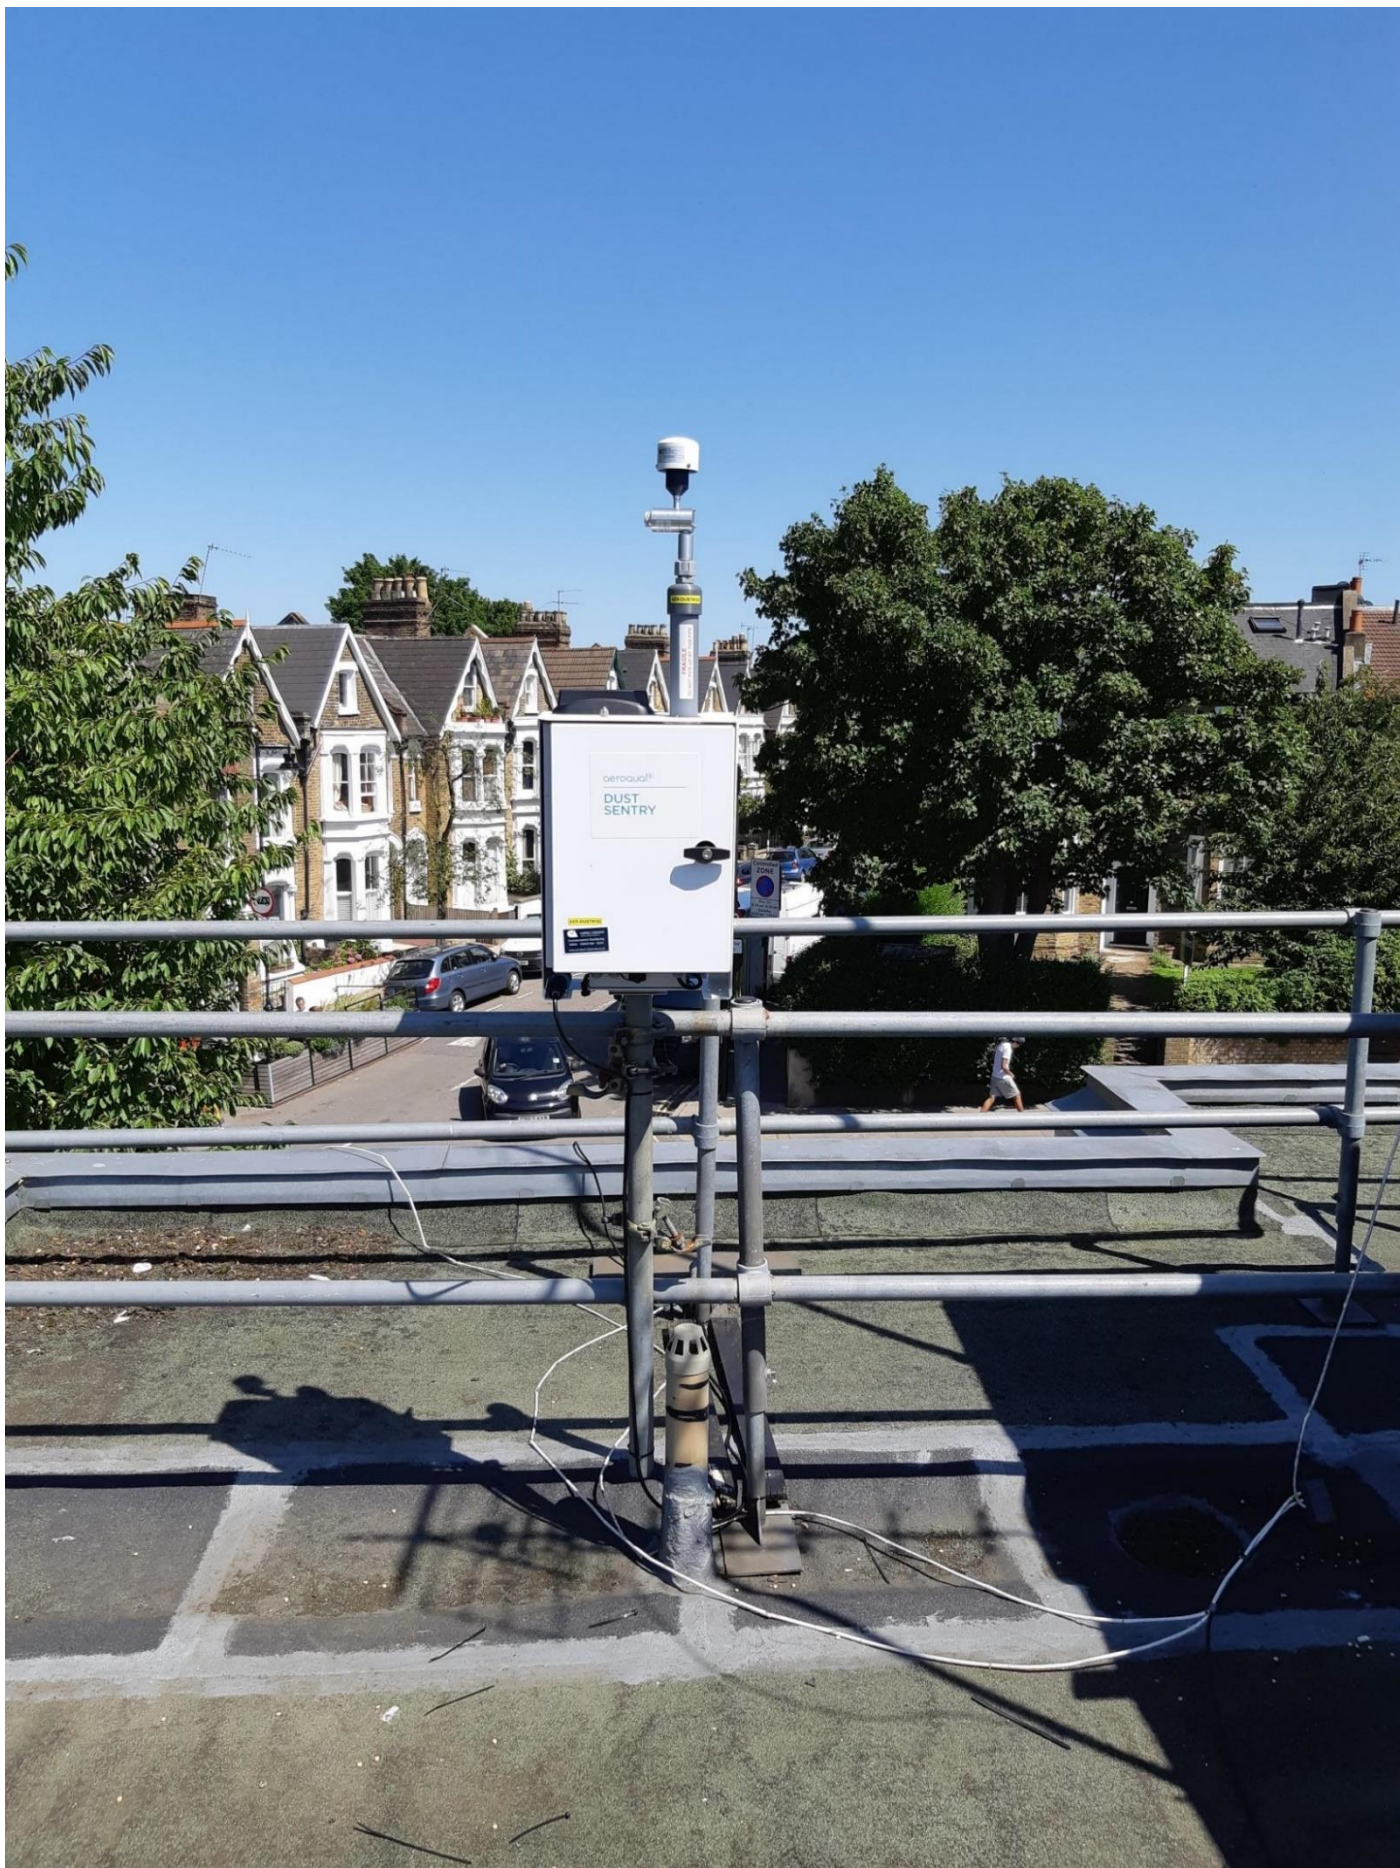
## Figure 2: Monitor 1 – Dartmouth Park Hill

Item	Monitor 1 – Chester Road	Monitor 2 – Dartmouth Park Hill
	ID: s/n 1620   #182 MP1	ID: s/n 1622   #183 MP2
Dust Monitor	Aeroqual Dust Sentry (MCERTS certified)	Aeroqual Dust Sentry (MCERTS certified)
Serial Number	DS 20052021-1620	DS 20052021-1622
Location	51.563084°N, -0.141199°E	51.563108°N, -0.140870°E
Inlet Height	c. 4.4m	c. 7.0m
Last Calibrated	14 <sup>th</sup> July 2021	14 <sup>th</sup> July 2021
Calibration Due	14 <sup>th</sup> July 2023	14 <sup>th</sup> July 2023
Installation	16 <sup>th</sup> July 2021	16 <sup>th</sup> July 2021

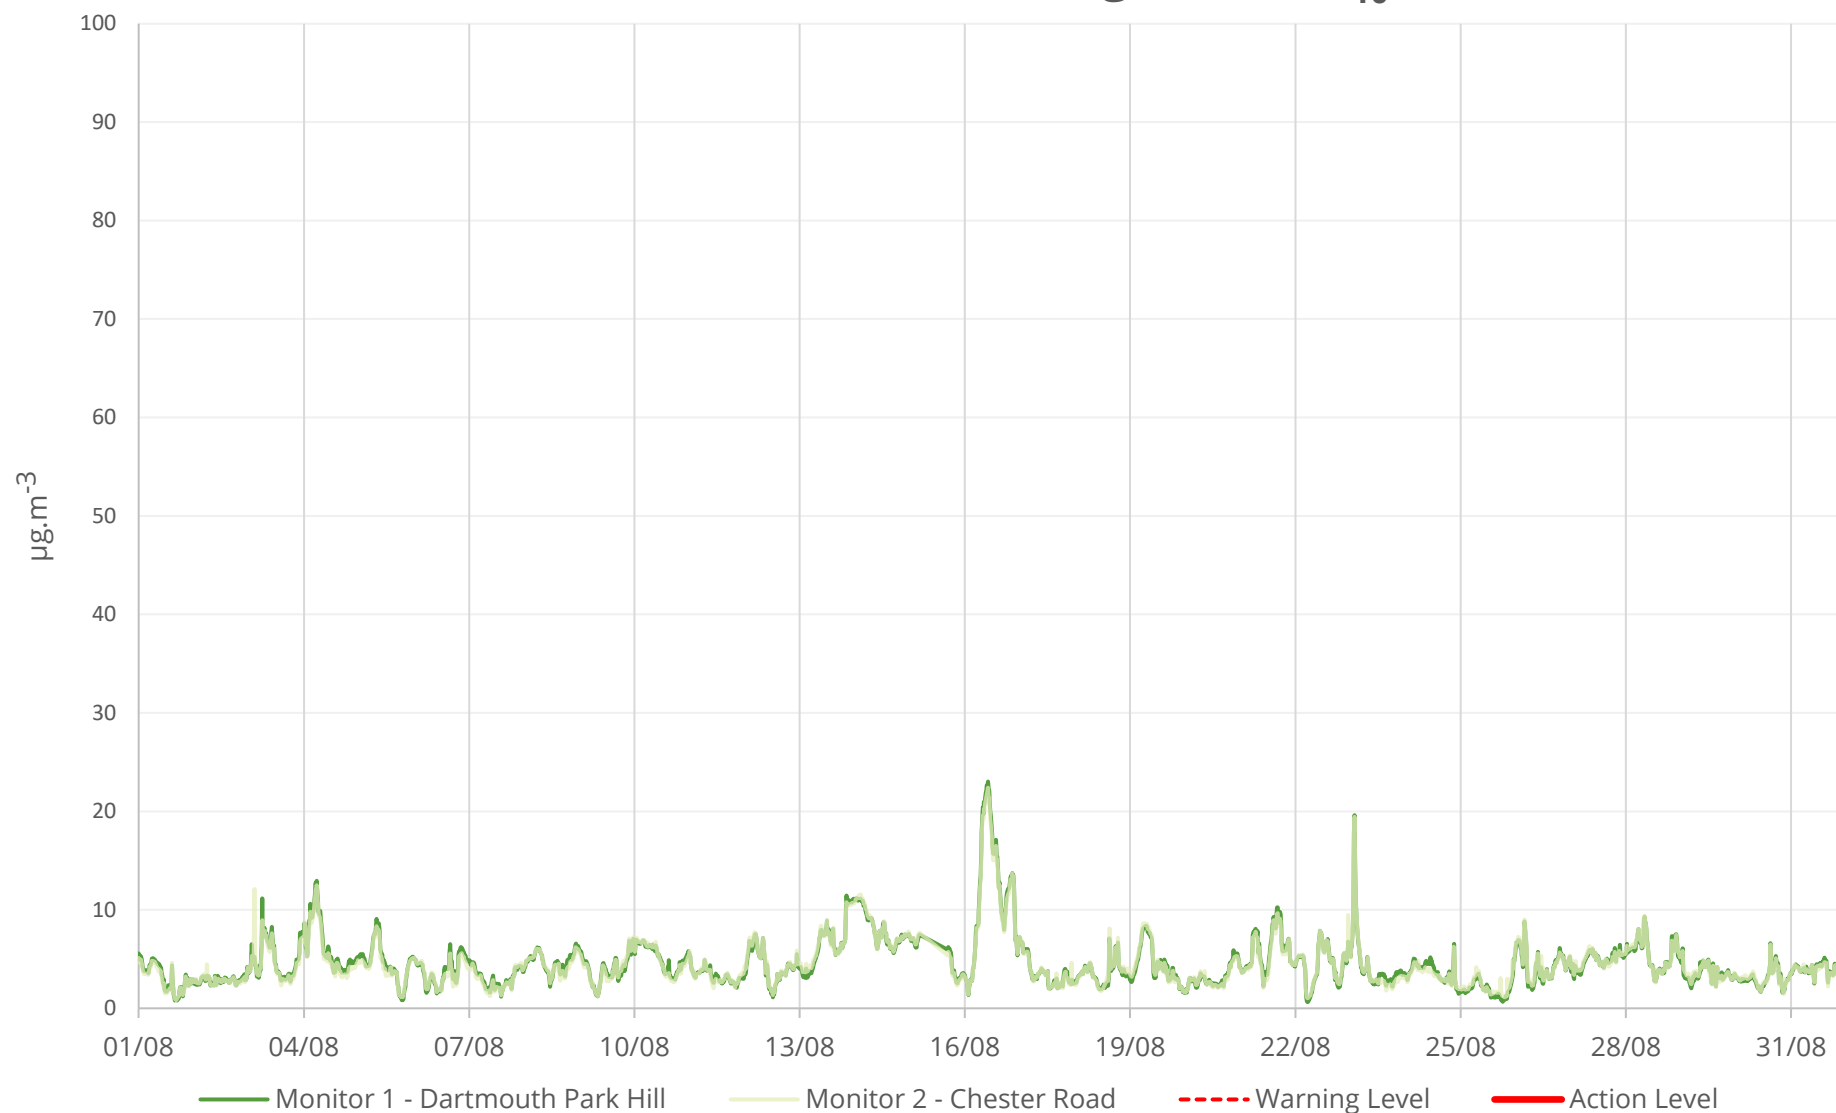
## Graph 1: 15-minute mean time-series

- 2.4 Graph 1 provides the 15-minute average PM<sub>10</sub> time-series for the monitoring period. It shows that there were no exceedances of the 15-minute 'Warning' level at either monitor during August 2021.

- 2.5 There were no exceedances of the 15-minute 'Action' trigger level at either monitor during this period. Overall, there is good agreement in the trend lines for both monitors which suggests that there are few significant localised dust sources in close proximity to either monitor.
- 2.6 Graph 2 provides the 1-hour average PM<sub>10</sub> time-series for the monitoring period. It shows that there are no exceedances of the 'Action' trigger level. Again, there is good agreement in the trend lines for both monitors, suggesting that there are few significant localised dust sources in close proximity to either monitor.

- 2.7 There were no exceedances of either the 15-minute 'Warning' level or 'Action' trigger level at either Monitor 1 or Monitor 2 throughout this monitoring period.
- 2.8 There were no exceedances of the 1-hour mean 'Action' trigger level during the monitoring period.
- 2.9 Overall, there is good agreement in the trend line for both monitors, indicating that there are few significant localised dust sources in proximity to either monitor.
- 2.10 Demolition and construction works are yet to commence on site. Therefore, the results presented within this report for August 2021 relate to the first period of baseline monitoring.
