## Very minor basement wall changes

### Basement Walls Comparison

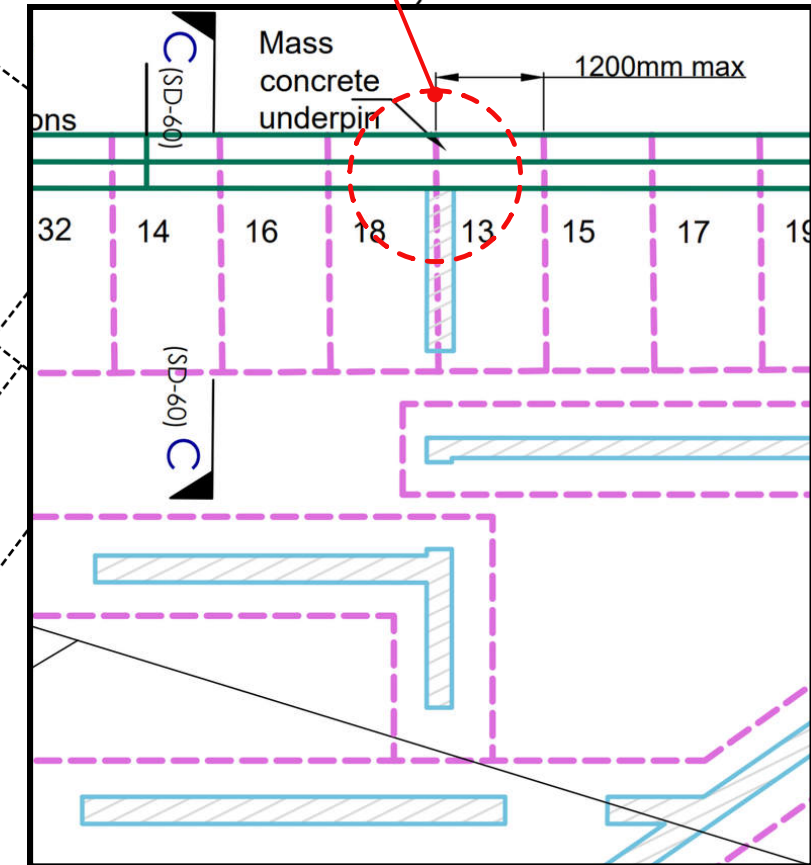
*BIA-150122 SL-50 Rev1  
Basement Layout.PDF*

Below; extract from the original BIA structural layout:

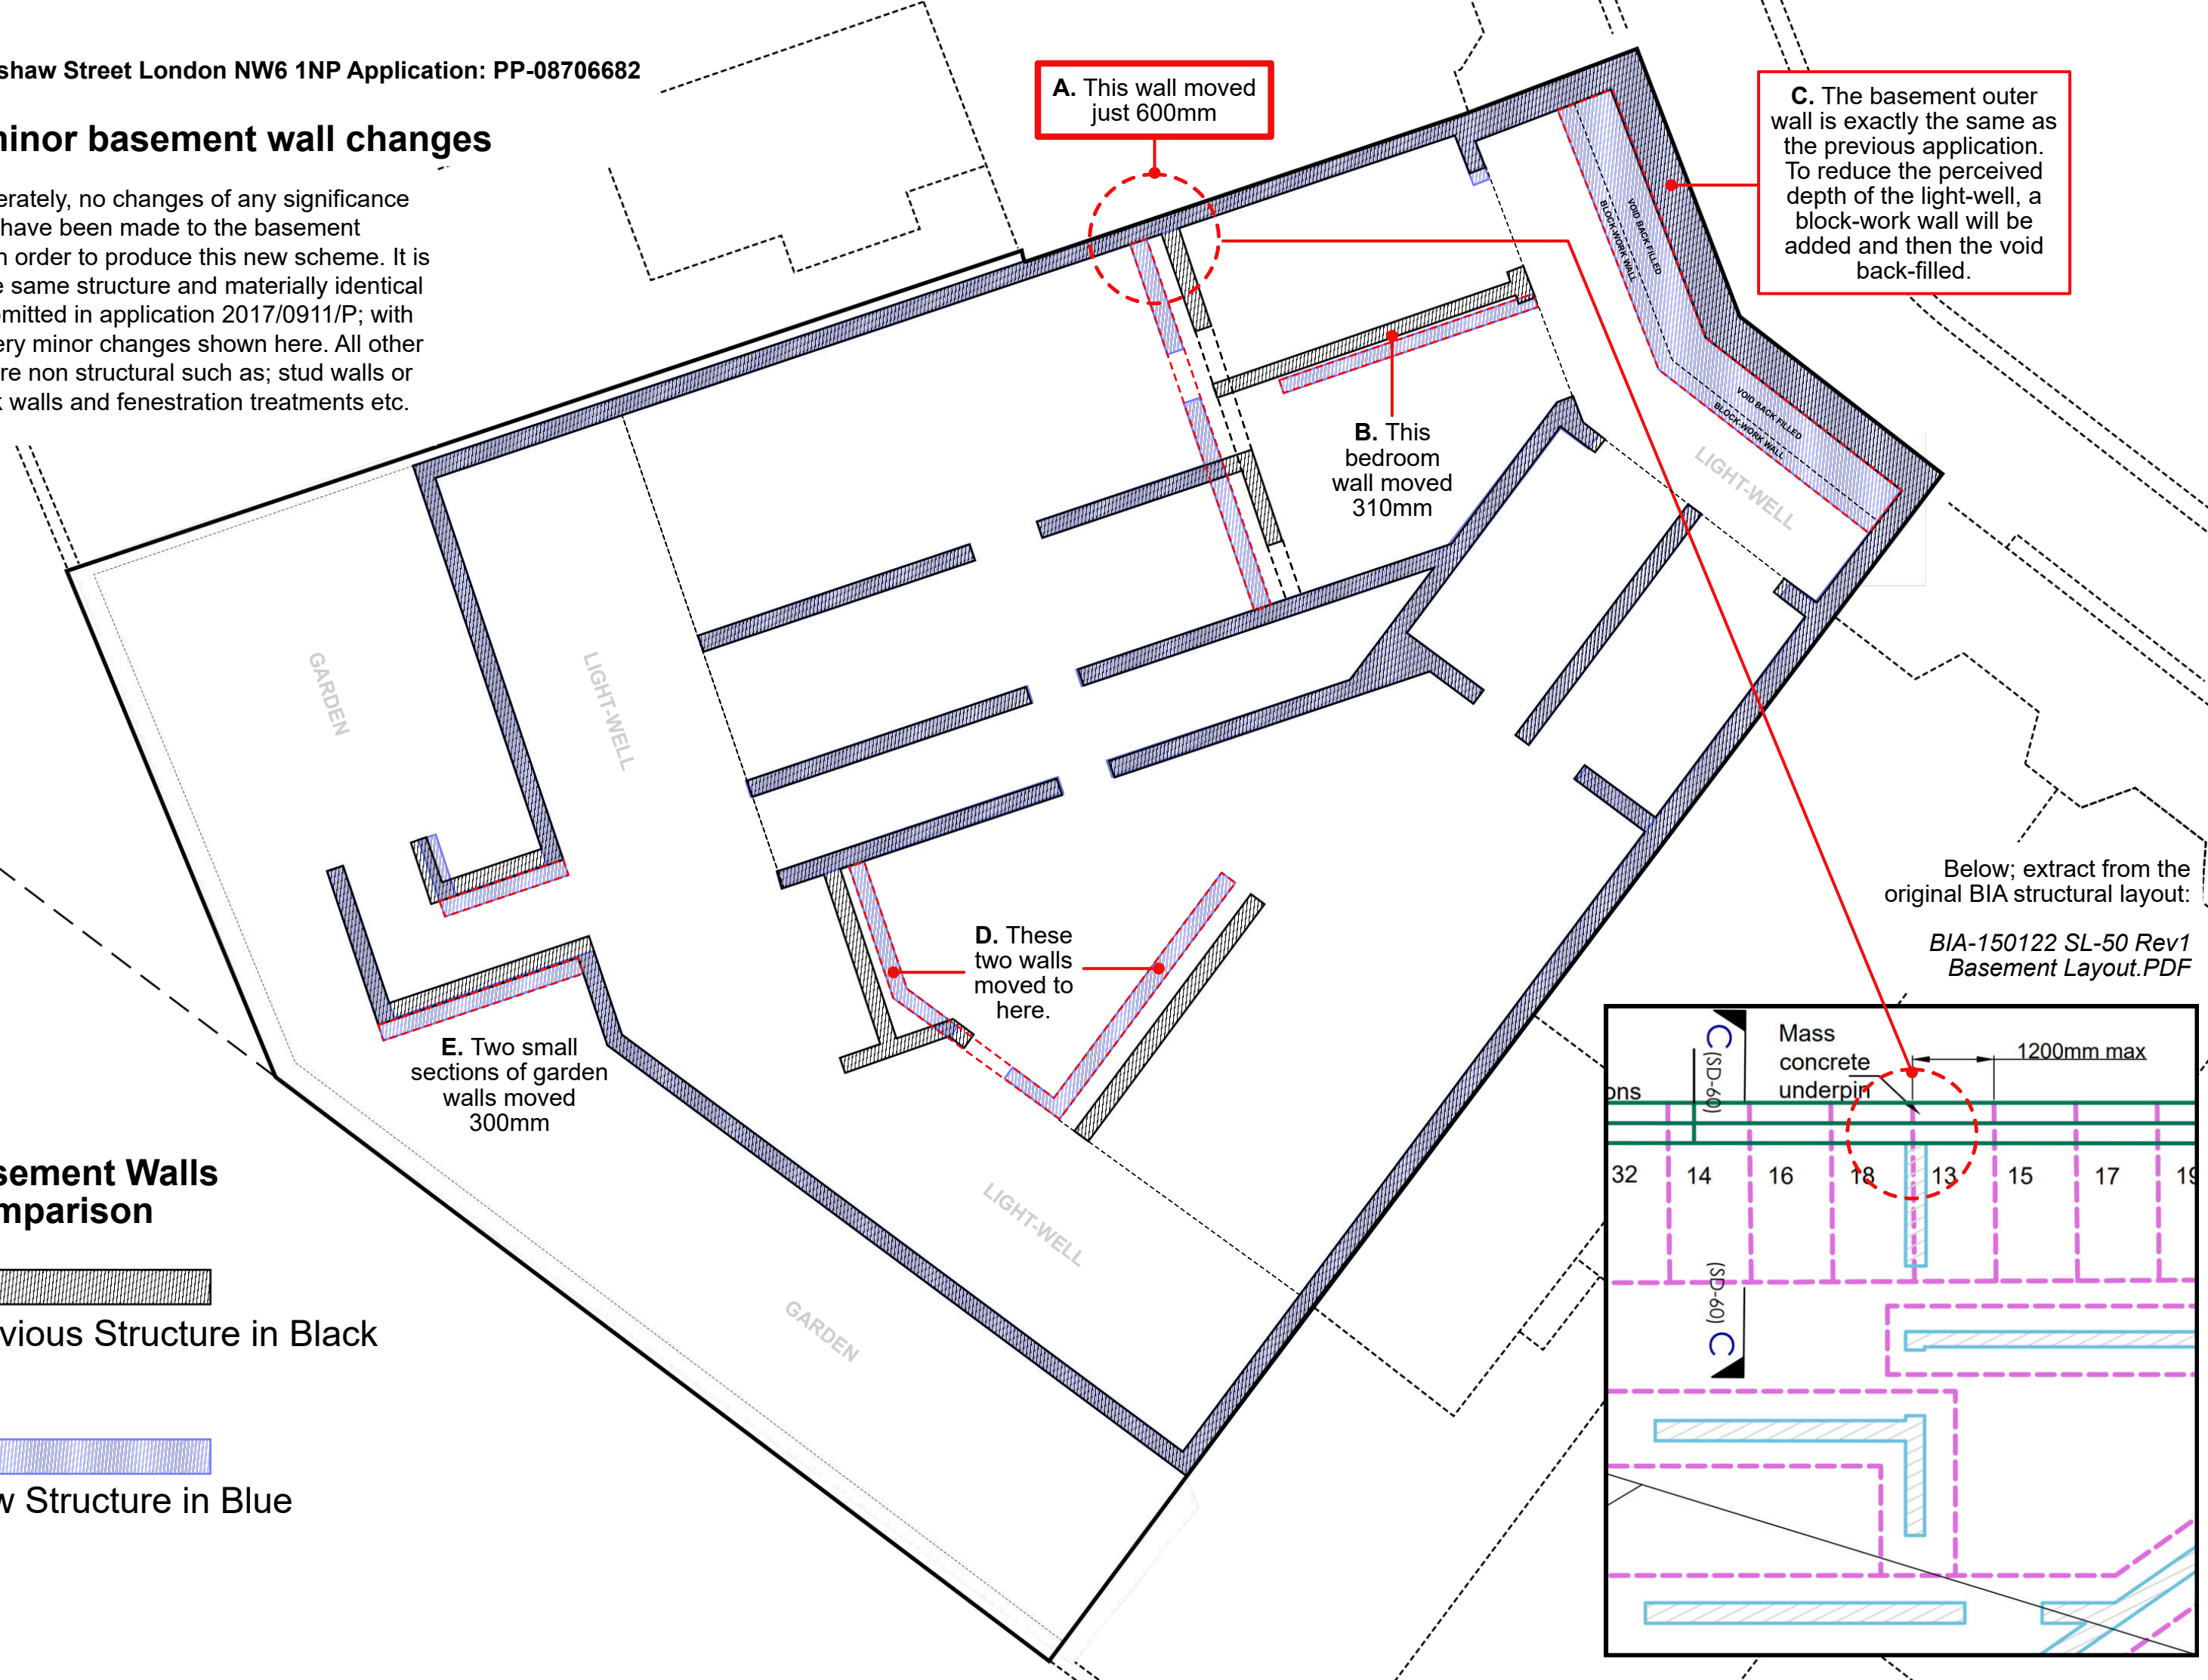
**A.** This wall moved just 600mm

**C.** The basement outer wall is exactly the same as the previous application. To reduce the perceived depth of the light-well, a block-work wall will be added and then the void back-filled.

**B.** This bedroom wall moved 310mm

**D.** These two walls moved to here.

**E.** Two small sections of garden walls moved 300mm

Previous Structure in Black

New Structure in Blue

Very deliberately, no changes of any significance to the BIA have been made to the basement structure in order to produce this new scheme. It is exactly the same structure and materially identical to that submitted in application 2017/0911/P; with only the very minor changes shown here. All other changes are non structural such as; stud walls or block work walls and fenestration treatments etc.
