# Basement Impact Assessment, 23 Ravenshaw Street, NW6 1PN

## Hydrogeology, Hydrology and Land Stability

1 June 2017

MAUND GEO-CONSULTING

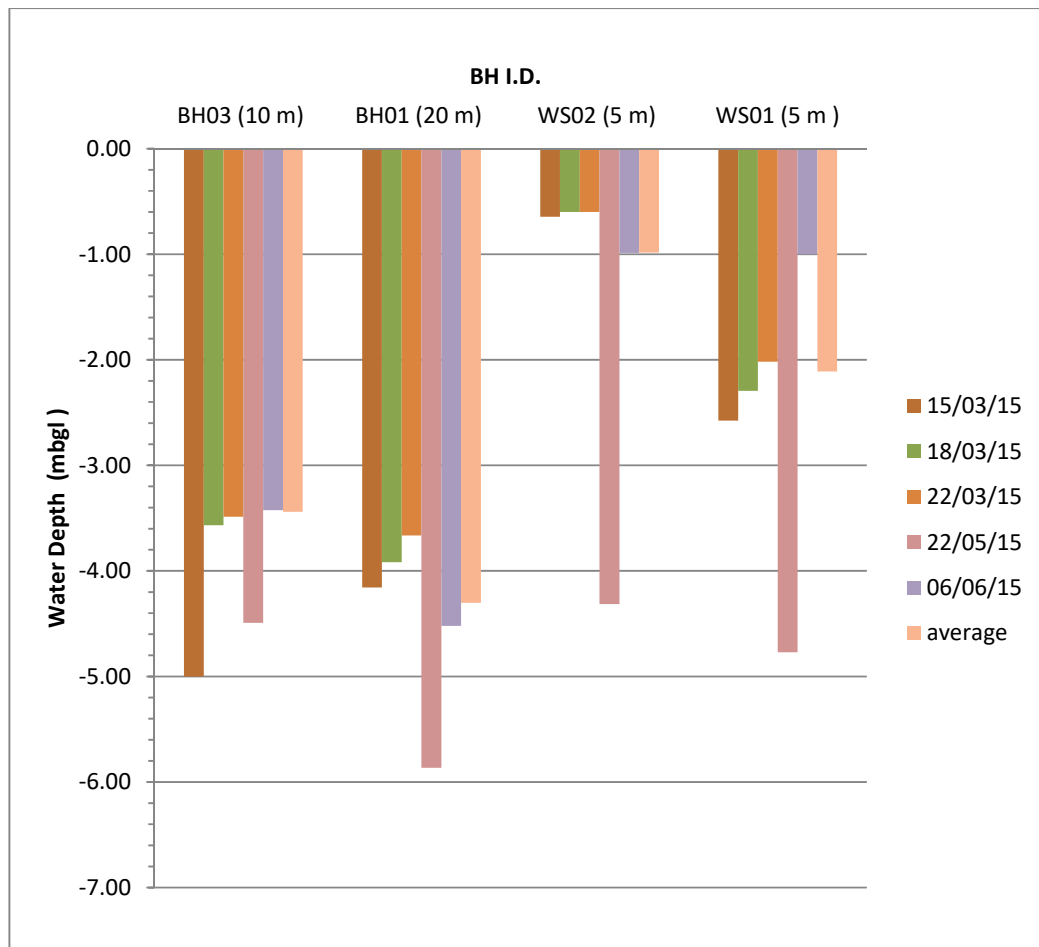
Figure 4.1 Groundwater monitoring Summary

During the ground investigations, groundwater was not encountered in BH1, BH3 and WS1. A seepage was recorded in WS2 at 3.0 mbgl.

Groundwater / gas installation were placed in BH1, BH3, WS1 and WS2 for further monitoring to check if groundwater had entered the installation over time. Subsequent monitoring in March to June 2015 indicated water in the installations at between 0.57 m (WS02) and 5.86 m (BH01) below ground level. An overall average groundwater level is 2.71 m below ground level over a four-month period. A summary of groundwater depth from monitoring is shown in Figure 4.1. Full monitoring details are included in Appendix D.

As discussed in Section 8.1.1 groundwater is not anticipated to effect the construction works. Groundwater has been measured at an average of 2.71 m bgl. If it is found that further to monitoring groundwater does impact the works, groundwater would be controlled by pumping to a tank prior to disposal by tanker to an approved facility. Alternatively discharge of the groundwater could be made to the sewer subject to an agreement from the local water company in terms of water quality, flow rate and quantity.

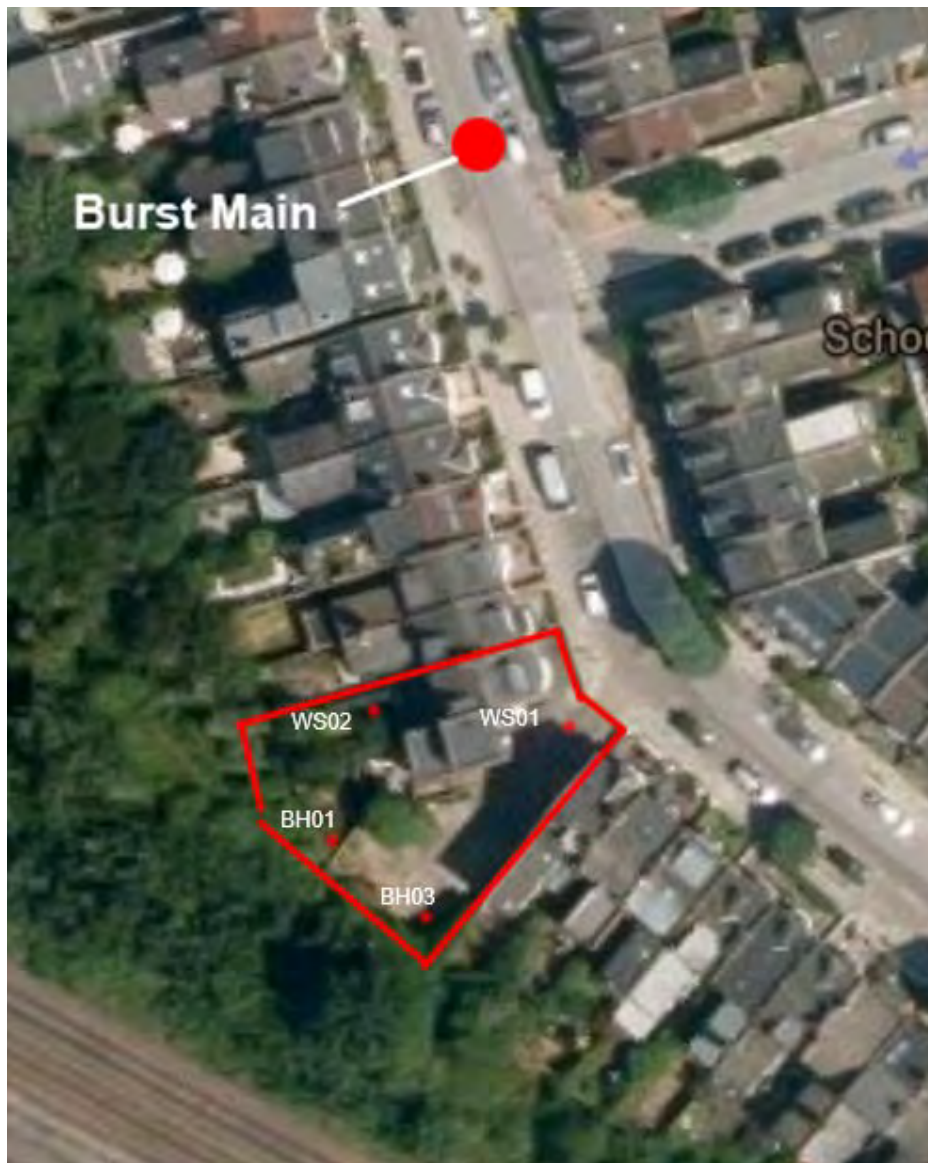
**Figure 4.2 Location of burst main relative to the site**

Due to the geology of the site being low permeability London Clay overlain by made ground of generally less than 1 m thickness it is concluded that the groundwater is perched water sitting on the London Clay. It is suspected that the water perched water level could in part be from the leakage of water pipes. There was a water main leakage during March / April 2015 at a higher level in Ravenshaw Street / Mill Lane, which flooded the ground above the relatively impermeable London Clay as shown in Figure 4.2.

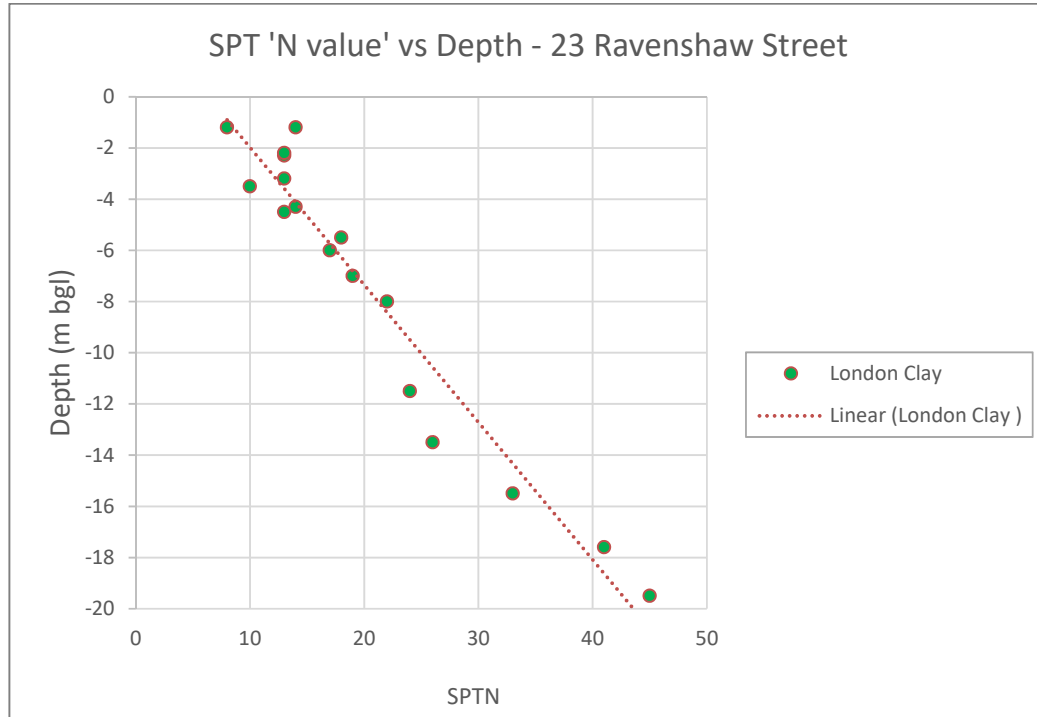
**Figure 4.3 SPT ‘N value’ against depth below ground level**

Using the plasticity index as a basis for determining the undrained cohesion from SPTs after Stroud and Butler (1974) a 'f1' of 4.5 has been applied to SPT values, giving a range of undrained cohesion from 36 to 99 kPa in the weathered London Clay and 108 to 203 kPa for the un-weathered London Clay from a depth of approximately 11m bgl. The increase of strength with depth on the basis of SPT N values is shown in Figure 4.3.

The anticipated formation level of the basement floor slab will be approximately 3.50 m below ground level. The undrained cohesion at the anticipated founding depth at 3.50 m is approximately 65 kPa or ‘firm’.

The SPT data indicates that a maximum safe bearing pressure at 3.5 m depth can be taken conservatively as 120 kPa, on the basis of undrained cohesion of 65 kPa based on a factor of safety of 3 to limit settlement to < 25 mm, in agreement with the foundation loading designed by the structural engineer.

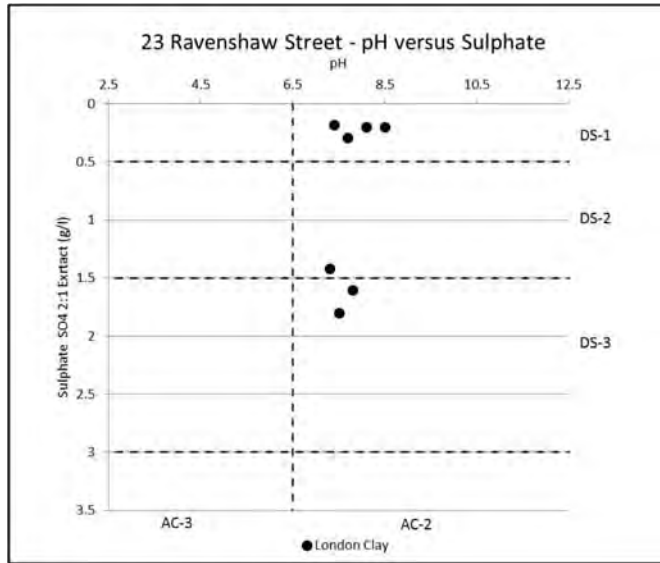
**Figure 4.4 Sulphate against pH**

Laboratory testing for sulphate (SO<sub>4</sub> in 2:1 water: soil) in accordance with BS 1377: Part 3 was carried out on 7 No. samples which range from 0.2 to 1.8 g/l. The higher sulphate levels are associated with the brown weathered clay, which is in agreement with visual examination in which selenite crystal were noted. The range of pH was from 7.5 to 8.5 or slightly alkaline as shown in Figure 4.4

The results of lab testing for sulphate and pH are summarised below in Figure 4.4. The full analysis is included in Appendix C. It is recommended that an overall design sulphate class of DS-3 and an Aggressive Chemical Environment for Concrete (ACEC) class of AC2 is adopted.
